Manejo de Riesgos en Valparaiso, Servicios Técnicos

Acronym: "MAR VASTO"

CERRO CORDILLERA PILOT PROJECT (VALPARAISO)

INDEX

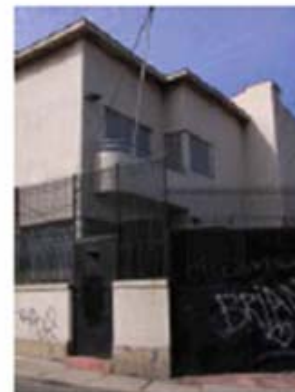
Arch. Style	Rationalism	Manzana	2024
Typology	Block building	Roles	2024-6
Num. of floors	2	Roles	2024-7
Occupancy	Lived	Roles	
Function - GF	Residence	Property	Private
Function - US	Residence	Landmark	
Functional characteristic	Residential	Roof gen. condition	Ordinary
Recent transformation	Renovation	Structure gen. condition	Ordinary
Undergoing transformation		Still house	No
Overall architectural quality	Medium	Still house (structure)	
General condition	Ordinary	Still house (condition)	
Level of integration	Good integration	Level of interest	Low
Intervention categories	Ordinary maintenance	Vulnerability (%)

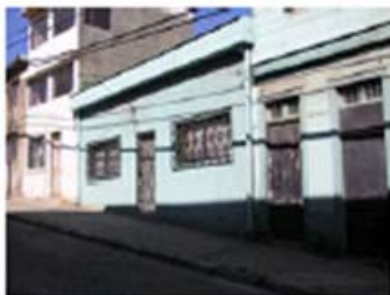
<u>Manzana</u>	
<u>Roles</u>	
<u>Roles</u>	
<u>Roles</u>	
<u>Property</u>	<u>Private</u>
<u>Landmark</u>	
<u>Roof gen. condition</u>	<u>Ordinary</u>
<u>Structure gen. condition</u>	<u>Good</u>
<u>Still house</u>	<u>No</u>
<u>Still house (structure)</u>	
<u>Still house (condition)</u>	
<u>Level of Interest</u>	<u>Low</u>
<u>Vulnerability (%)</u>	<u>13</u>

Arch. Style	Other
Typology	Row house
Num. of floors	3
Occupancy	Partially lived
Function - GF	Residence
Function - US	Residence
Functional characteristic	Residential

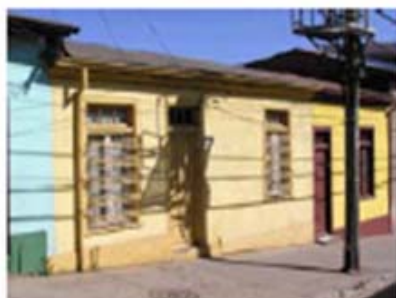
Arch. Style	
Typology	Row house
Num. of floors	1
Occupancy	Lived
Function - GF	Residence
Function - US	
Functional characteristic	Residential
Recent transformation	Renovation
Undergoing transformation	
Overall architectural quality	Medium
General condition	Ordinary
Level of Integration	Good Integration
Intervention categories	Ordinary maintenance

Manzana	
Roles	
Roles	
Roles	
Property	Private
Landmark	
Roof gen. condition	Ordinary
Structure gen. condition	Bad
Still house	No
Still house (structure)	
Still house (condition)	
Level of Interest	Medium
Vulnerability (%)

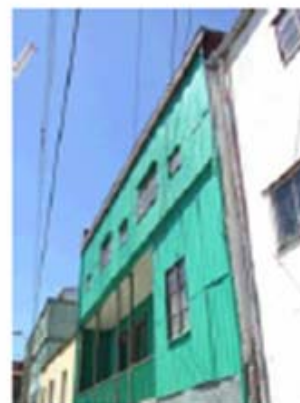
Arch. Style	Local
Typology	Row house
Num. of floors	3
Occupancy	Lived
Function - GF	Residence
Function - US	Residence
Functional characteristic	Residential
Recent transformation	Renovation
Undergoing transformation	
Overall architectural quality	Low
General condition	Ordinary
Level of Integration	Good integration
Intervention categories	Rehabilitation

Manzana	
Roles	
Roles	
Roles	
Property	Private
Landmark	
Roof gen. condition	Ordinary
Structure gen. condition	Ordinary
Still house	No
Still house (structure)	
Still house (condition)	
Level of Interest	Low
Vulnerability (%)	43

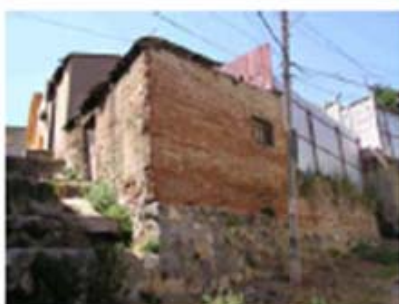
Arch. Style OtherManzana 2047Typology Row houseRoles 2047-2Num. of floors 1RolesOccupancy Not livedRolesFunction - GF ResidenceProperty PrivateFunction - USFunctional characteristic ResidentialLandmarkRecent transformationRoof gen. condition BadUndergoing transformationStructure gen. condition BadOverall architectural quality LowStill house NoGeneral condition BadStill house (structure)Still house (condition)Level of Integration ContrastLevel of Interest LowIntervention categories DemolitionVulnerability (%)

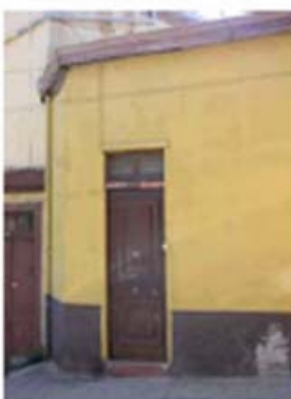
Arch. Style Local-highTypology Block buildingNum. of floors 2Occupancy Not livedFunction - GF ResidenceFunction - US ResidenceFunctional characteristic ResidentialRecent transformationUndergoing transformationOverall architectural quality HighGeneral condition BadLevel of Integration Strong identityIntervention categories RehabilitationManzana 2091Roles 2091-5RolesRolesProperty PrivateLandmark OutRoof gen. condition OrdinaryStructure gen. condition BadStill house NoStill house (structure)Still house (condition)Level of Interest HighVulnerability (%) 55

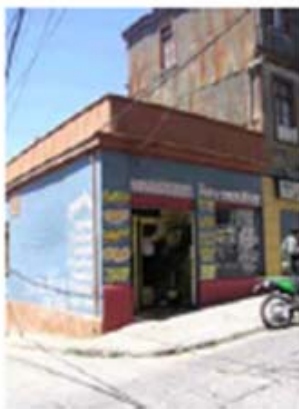
Arch. Style	Local	Manzana	2091
Typology	Block building	Roles	2091-19
Num. of floors	1	Roles	
Occupancy	Partially lived	Roles	
Function - GF	Residence	Property	Private
Function - US			
Functional characteristic	Residential	Landmark	
Recent transformation		Roof gen. condition	Bad
Undergoing transformation		Structure gen. condition	Ordinary
Overall architectural quality	Low	Still house	No
General condition	Bad	Still house (structure)	
		Still house (condition)	
Level of Integration	Good Integration	Level of Interest	Low
Intervention categories	Re-development	Vulnerability (%)
