Manejo de Riesgos en Valparaiso, Servicios Técnicos

Acronym: "MAR VASTO"

EVALUATION OF THE VULNERABILITY OF THREE CHURCHES IN VALPARAISO AND NUMERICAL CALCULATIONS

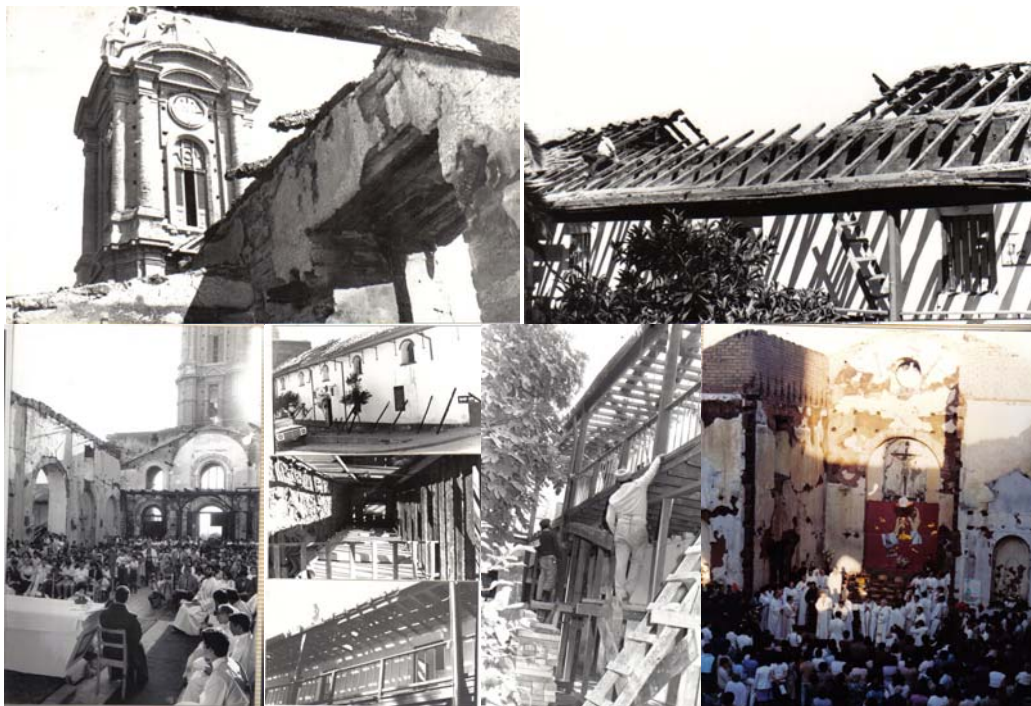
In 1983, the church naves were burned by a fire (Fig. 16) and later reconstructed using similar techniques.

Figure 16: Fire damage in 1983 at San Francisco.

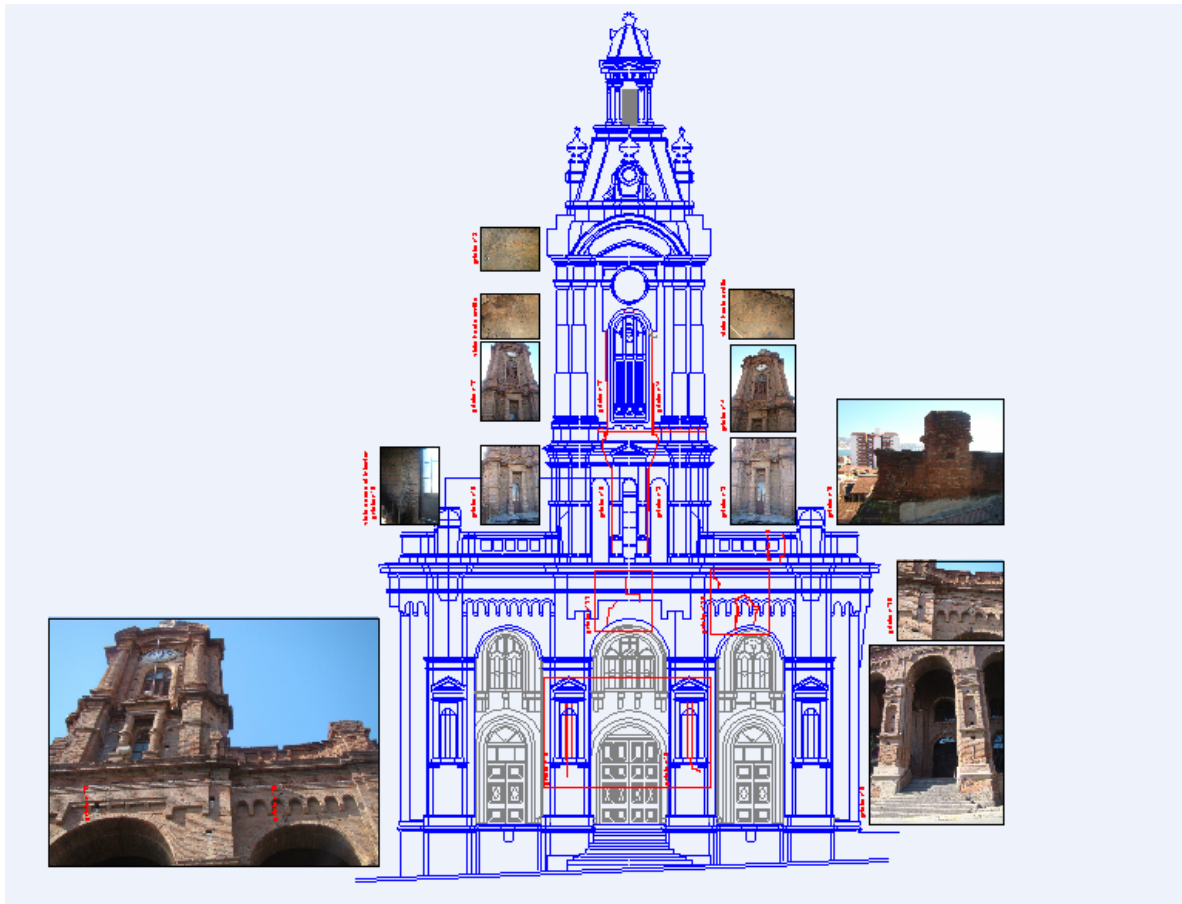
A summary of the damage assessment (thanks also to a contribution of Claudia Zuñiga, OGP), is shown in detail by Fig. 17. The most worrying situation is clearly in the façade and the bell-tower.

Figure 17: Summary of damage assessment at San Francisco, made by Arch. Claudia Zuñiga (OGP).

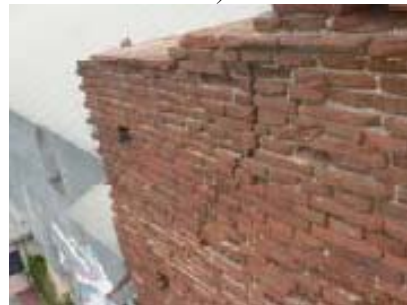
Fn)

Figure 18: Damage in the façade.

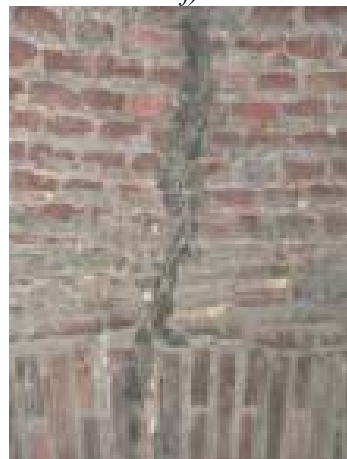
Dh)

Figure 20: Damage in the internaldomes.

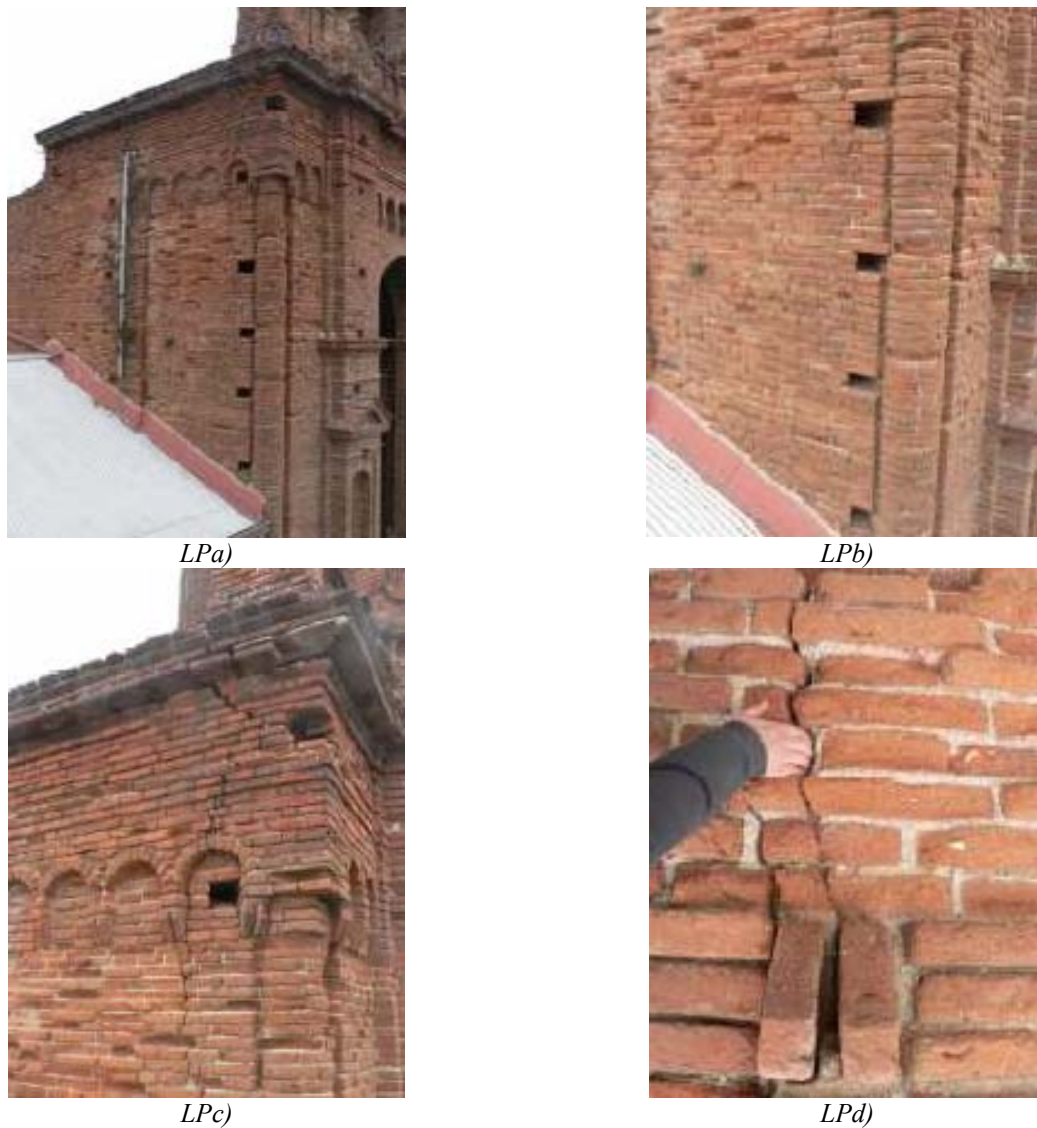
The damage assessment is shown by Fig. 21. Pictures *LPa* and *LPb* give an overall view, while *LPc* and *LPd* show the damage. Also in this case, a vertical crack along the wall upper part is evident (with a façade detachment from the lateral walls), that can drive to an out-of-plane overturning mechanism in case of seismic event.

Figure 21: Damage in the lateral prospect.

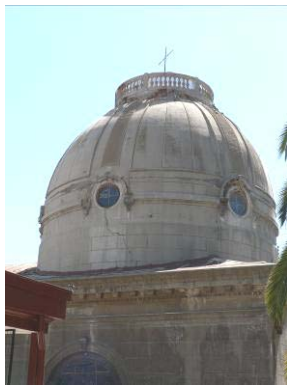
View of the main dome of the church: some diagonal cracks are visible near the round openings, probably due to torsional effects

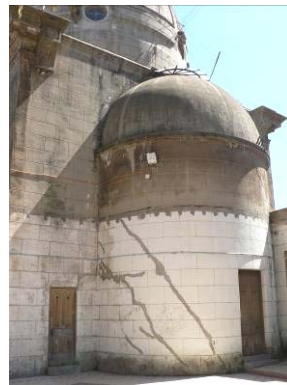
View of the South apse: the diagonal cracks at the basis of the walls are probably related to overturning mechanisms associated to torsional effects

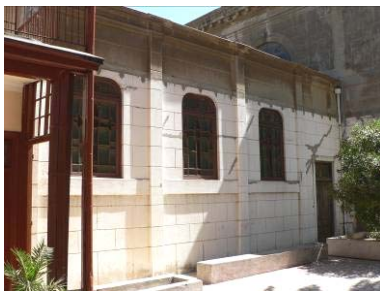
View of the West apse (chapel): some diagonal shear cracks are well visible in the lateral walls, between the openings

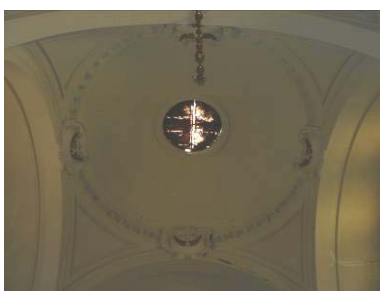
View of one of the two domes of the main nave: no particular cracks are visible on these structural elements

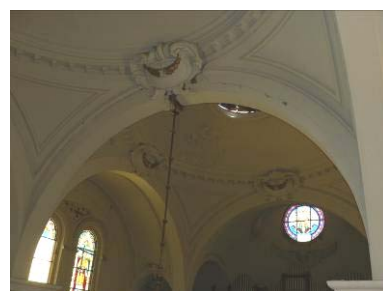
View of the triumphal arch between the two domes of the main nave: some longitudinal and radial cracks, related to an in-plane seismic action, are present

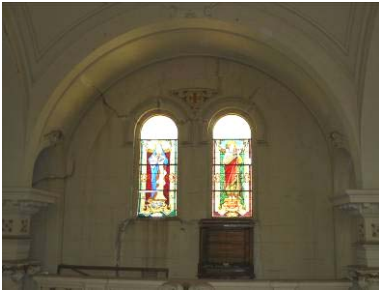
View of the lateral walls of the main nave: some diagonal cracks are present, starting from the openings

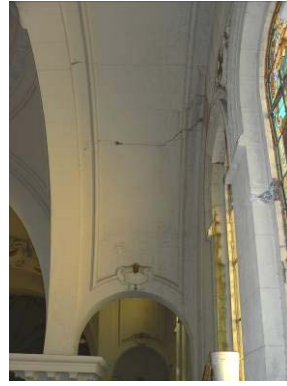
View of one of the lateral arches of the main nave: some radial cracks are present

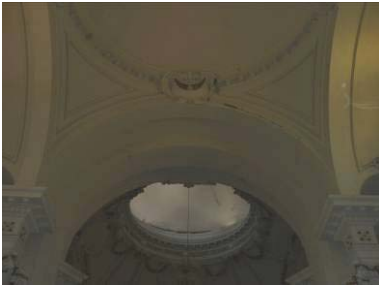
View of the triumphal arch between the main nave and the presbytery: some longitudinal and radial cracks, related to an in-plane seismic action, are present

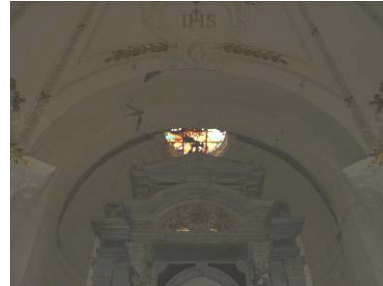
View of the triumphal arch between the presbytery and the South apse: some longitudinal and radial cracks, related to an in-plane seismic action, are present

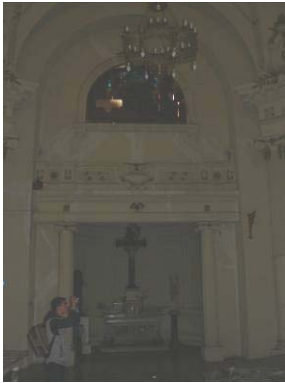
View of the East apse: some diagonal shear cracks are present, starting from the openings area

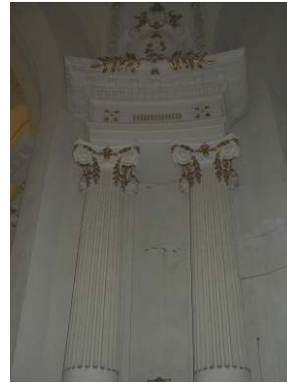
View of the presbytery's columns that support the main dome: no particular cracks are visible on these structural elements

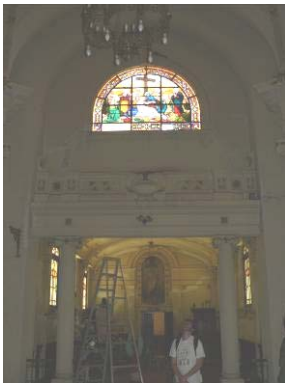
View of the West apse: some diagonal shear cracks are present, starting from the openings area

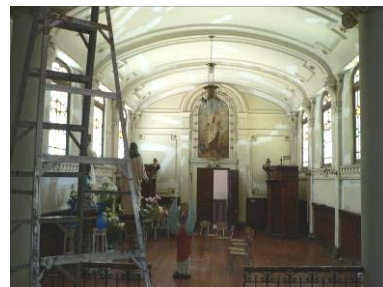
Internal view of the West apse: some cracks are present even in the covering vault

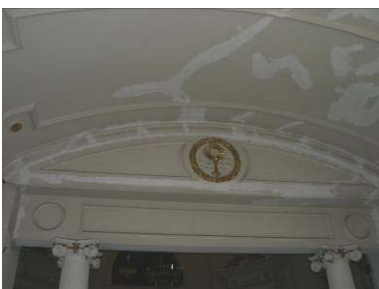
Internal view of the West apse: some cracks are present even in the covering vault

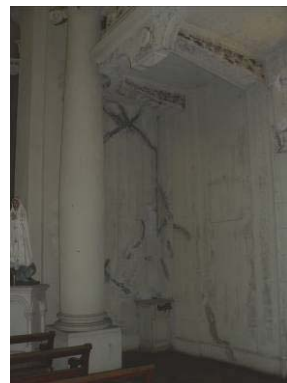
View of the wall that separates the main nave and the presbytery: some diagonal cracks are present in this corner

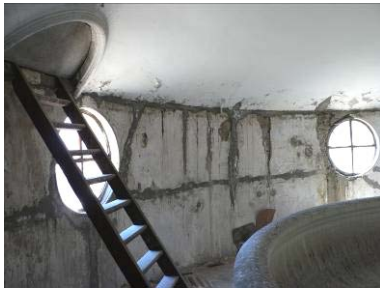
Internal view of the main dome: the horizontal cracks are probably related to a rigid torsion of the upper part of the dome

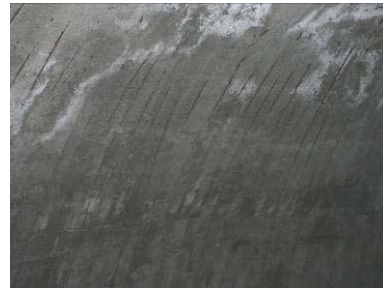
Internal view of the main dome: the steel bars of the primitive reinforced concrete are clearly visible

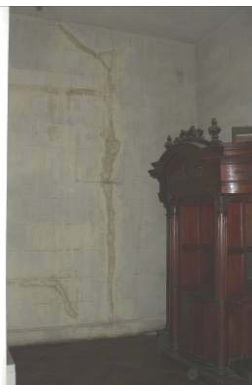
Internal view of the façade wall: a vertical crack is present in the lateral wall nearby the façade wall, probably related to an overturning mechanism of the façade wall

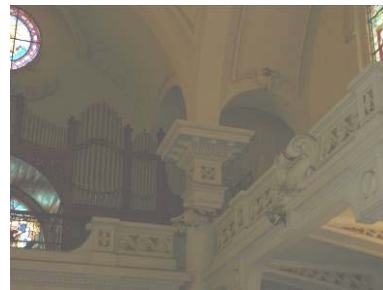
Internal view of the façade area: each column support different horizontal forces related to the different arches and vaults it support
