PROGETTO MAR VASTO
“Manejo de riesgos en Valparaiso”
Conferenza finale del Progetto BID

Chiesa e Convento di San Fransisco, Cerro Baron, Valparaiso, Chile
29 Settembre 2008

L'investigazione sulle tre chiese (San Francisco,
Hermanas de La Providencia, La Matriz):
indagine di vulnerabilità

Ing. Marco Munari
Dipartimento di Costruzioni e Trasporti
Università di Padova – Italia

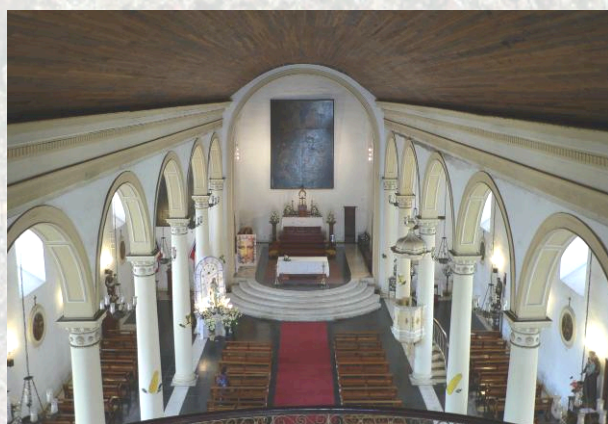
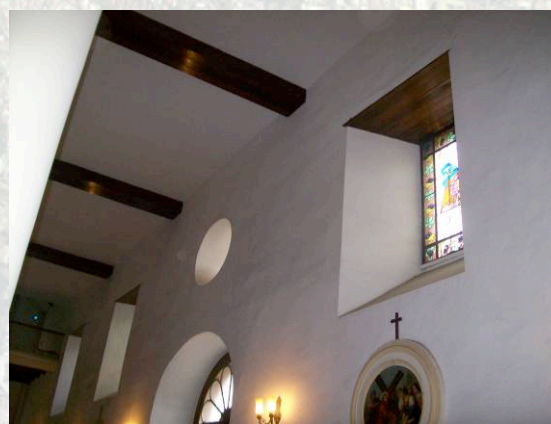
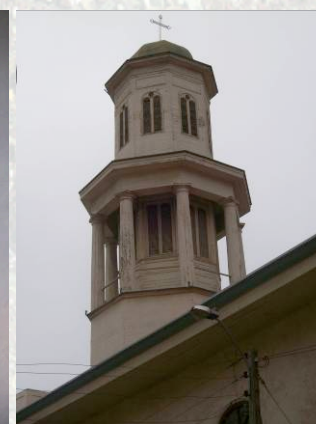
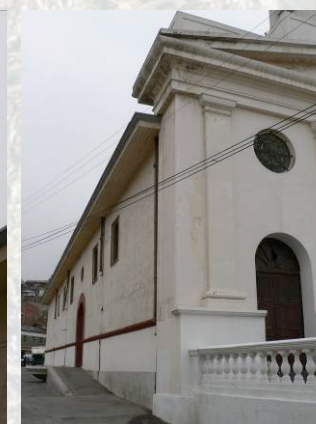
Failure mechanism	
1 OVERTURNING OF THE FACADE	16 OVERTURNING OF THE APSE
2 OVERTURNING OF THE GABLE	18 VAULTS OF THE APSE AND OF THE PRESBYTERY
3 SHEAR MECHANISMS IN THE FACADE	10-22 OVERTURNING OF OTHER WALLS (TRANSEPT FAÇADE, CHAPELS)
5 TRANSVERSAL VIBRATION OF NAVE	11-17-23 SHEAR FAILURE OTHER WALLS (TRANSEPT, CHAPELS, APSE, PRESBYTERY)
6-7 LONGITUDINAL VIBRATION OF THE CENTRAL AND LATERAL NAVE	19-20-21 HAMMERING AND DAMAGE IN THE ROOF COVERING
8 VAULTS OF THE CENTRAL NAVE	25 INTERACTION BETWEEN ELEMENTS OF DIFFERENT BEHAVIOUR
9 VAULTS OF THE LATERAL NAVES	26 OVERTURNING OF STANDING OUT ELEMENTS
13 KINEMATISM IN THE TRIUMPHAL ARCHES	27 GLOBAL COLLAPSE OF THE BELL TOWER
14 COLLAPSE OF THE DOME AND THE TIBURIO	28 MECHANISMS IN THE BELL CELL
Global index damage = 8%	Local index damage -

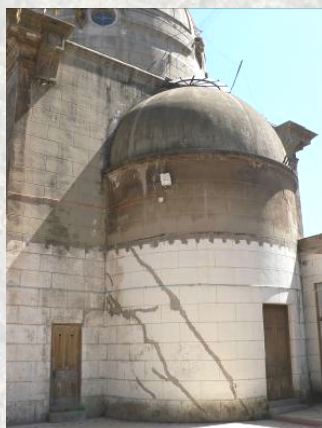
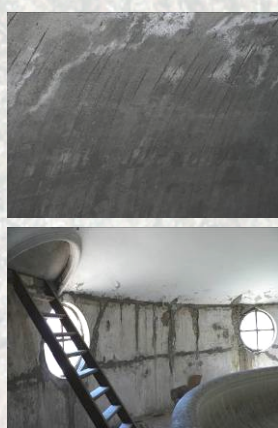
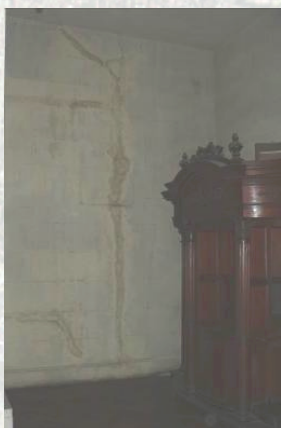
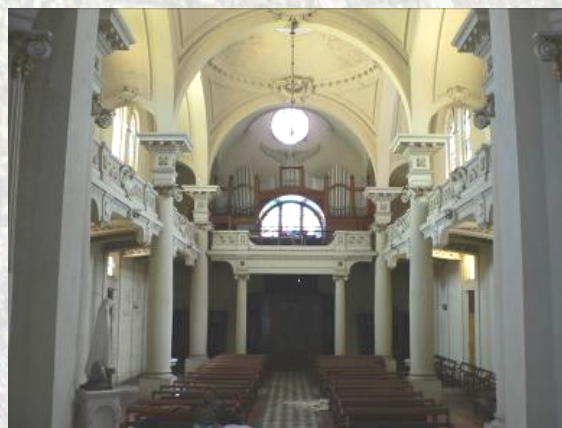
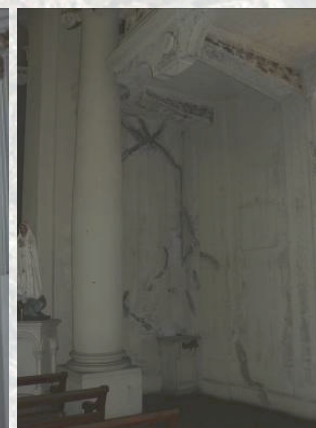
Failure mechanism	
1 OVERTURNING OF THE FACADE	16 OVERTURNING OF THE APSE
2 OVERTURNING OF THE GABLE	18 VAULTS OF THE APSE AND OF THE PRESBYTERY
3 SHEAR MECHANISMS IN THE FACADE	10-22 OVERTURNING OF OTHER WALLS (TRANSEPT FAÇADE, CHAPELS)
5 TRANSVERSAL VIBRATION OF NAVE	11-17-23 SHEAR FAILURE OTHER WALLS (TRANSEPT, CHAPELS, APSE, PRESBYTERY)
6-7 LONGITUDINAL VIBRATION OF THE CENTRAL AND LATERAL NAVE	19-20-21 HAMMERING AND DAMAGE IN THE ROOF COVERING
8 VAULTS OF THE CENTRAL NAVE	25 INTERACTION BETWEEN ELEMENTS OF DIFFERENT BEHAVIOUR
9 VAULTS OF THE LATERAL NAVES	26 OVERTURNING OF STANDING OUT ELEMENTS
13 KINEMATISM IN THE TRIUMPHAL ARCHES	27 GLOBAL COLLAPSE OF THE BELL TOWER
14 COLLAPSE OF THE DOME AND THE TIBURIO	28 MECHANISMS IN THE BELL CELL
Global index damage = 58%	
Local index damage -

Possibile intervento per evitare la perdita di questo monumento: isolamento sismico alla base

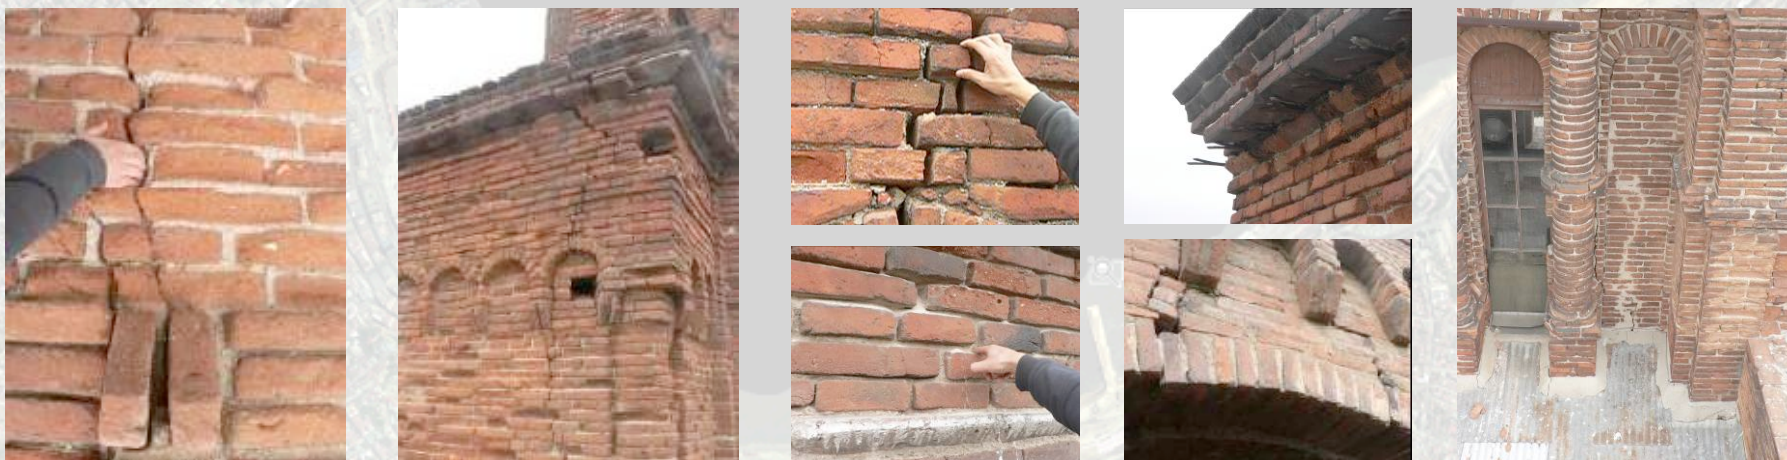
1 OVERTURNING OF THE FAÇADE	16 OVERTURNING OF THE APSE
2 OVERTURNING OF THE GABLE	18 VAULTS OF THE APSE AND OF THE PRESBYTERY
3 SHEAR MECHANISMS IN THE FAÇADE	10-22 OVERTURNING OF OTHER WALLS (TRANSEPT FAÇADE, CHAPELS)
5 TRANSVERSAL VIBRATION OF NAVE	11-17-23 SHEAR FAILURE OTHER WALLS (TRANSEPT, CHAPELS, APSE, PRESBYTERY)
6-7 LONGITUDINAL VIBRATION OF THE CENTRAL AND LATERAL NAVE	19-20-21 HAMMERING AND DAMAGE IN THE ROOF COVERING
8 VAULTS OF THE CENTRAL NAVE	25 INTERACTION BETWEEN ELEMENTS OF DIFFERENT BEHAVIOUR
9 VAULTS OF THE LATERAL NAVES	26 OVERTURNING OF STANDING OUT ELEMENTS
13 KINEMATISM IN THE TRIUMPHAL ARCHES	27 GLOBAL COLLAPSE OF THE BELL TOWER
14 COLLAPSE OF THE DOME AND THE TIBURIO	28 MECHANISMS IN THE BELL CELL
Global index damage = 33%	Local index damage on the facade = 66%
