Manejo de Riesgos en Valparaiso, Servicios Técnicos

Acronym: "MAR VASTO"

CERRO CORDILLERA PILOT PROJECT (VALPARAISO)

INDEX

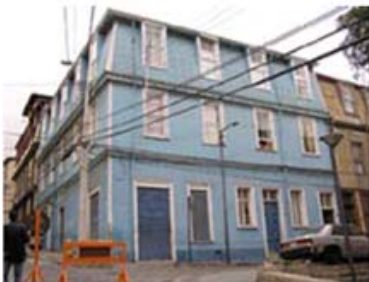
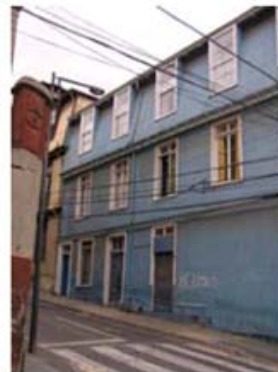
Recent transformation	
Undergoing transformation	
Overall architectural quality	Medium
General condition	Ordinary

Roof gen. condition	Ordinary
Structure gen. condition	Ordinary
Stilt house	No
Stilt house (structure)	
Stilt house (condition)

Level of integration	Strong identity
Intervention categories	Ordinary maintenance

Level of interest	High
Vulnerability (%)	65

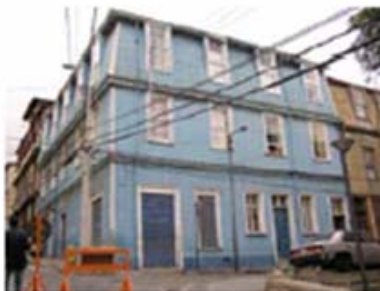
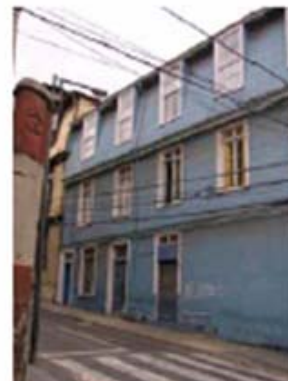
Arch. Style Local-highTypology Block buildingNum. of floors 3Occupancy LivedFunction - GF Neibrough's commerceFunction - US ResidenceFunctional characteristic MultifunctionalRecent transformationUndergoing transformationOverall architectural quality MediumGeneral condition OrdinaryLevel of integration Strong identityIntervention categories Ordinary maintenanceManzana 2025Roles 2025-8RolesRolesProperty PrivateLandmark InRoof gen. condition OrdinaryStructure gen. condition OrdinaryStilt house NoStilt house (structure)Stilt house (condition)Level of interest HighVulnerability (%) 66

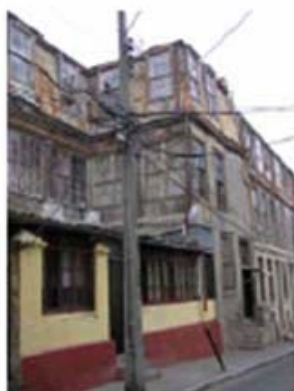
<u>Arch. Style</u>	<u>Local-high</u>
<u>Typology</u>	<u>Block building</u>
<u>Num. of floors</u>	<u>3</u>
<u>Occupancy</u>	<u>Lived</u>
<u>Function - GF</u>	<u>Residence</u>
<u>Function - US</u>	<u>Residence</u>
<u>Functional characteristic</u>	<u>Residential</u>

<u>Recent transformation</u>	
<u>Undergoing transformation</u>	
<u>Overall architectural quality</u>	<u>High</u>
<u>General condition</u>	<u>Bad</u>

<u>Level of integration</u>	<u>Strong identity</u>
<u>Intervention categories</u>	<u>Restoration</u>

<u>Manzana</u>	<u>2025</u>
<u>Roles</u>	<u>2025-7</u>
<u>Roles</u>	
<u>Roles</u>	
<u>Property</u>	<u>Private</u>
<u>Landmark</u>

<u>Roof gen. condition</u>	<u>Ordinary</u>
<u>Structure gen. condition</u>	<u>Bad</u>
<u>Stilt house</u>	<u>No</u>
<u>Stilt house (structure)</u>	
<u>Stilt house (condition)</u>

<u>Level of interest</u>	<u>High</u>
<u>Vulnerability (%)</u>

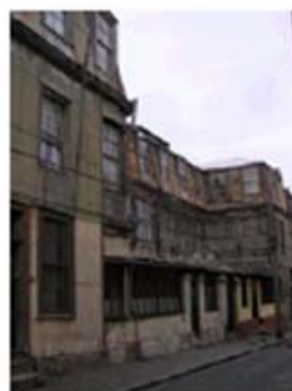
Arch. Style Local-highTypology Block buildingNum. of floors 3Occupancy LivedFunction - GF ResidenceFunction - US ResidenceFunctional characteristic ResidentialRecent transformationUndergoing transformationOverall architectural quality MediumGeneral condition OrdinaryLevel of integration Strong identityIntervention categories RestorationManzana 2025Roles 2025-6RolesRolesProperty PrivateLandmark OutRoof gen. condition OrdinaryStructure gen. condition OrdinaryStilt house NoStilt house (structure)Stilt house (condition)Level of interest MediumVulnerability (%)

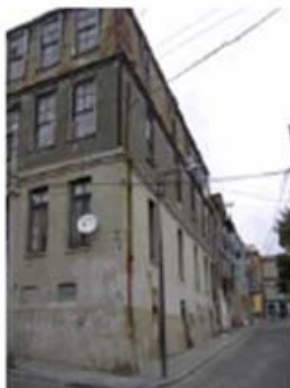
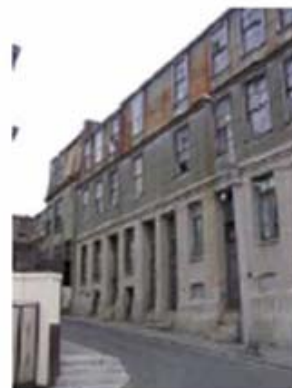
Arch. Style Local-highTypology Block buildingNum. of floors 2Occupancy LivedFunction - GF ResidenceFunction - US ResidenceFunctional characteristic ResidentialRecent transformationUndergoing transformationOverall architectural quality MediumGeneral condition BadLevel of integration Strong identityIntervention categories RehabilitationManzana 2025Roles 2025-1RolesRolesProperty PrivateLandmarkRoof gen. condition BadStructure gen. condition BadStilt house NoStilt house (structure)Stilt house (condition)Level of interest HighVulnerability (%) 41

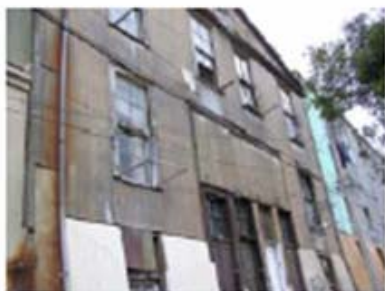
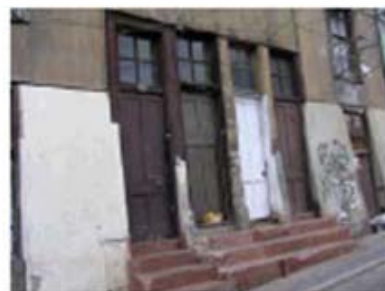
General condition Ordinary

Roof gen. condition Ordinary

Structure gen. condition Ordinary

Vulnerability (%) 40

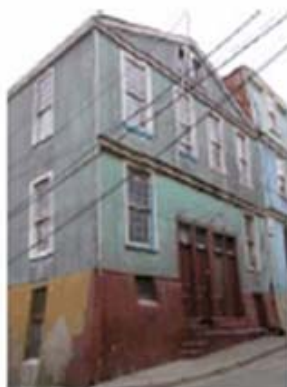
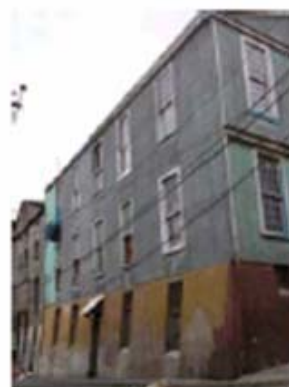
General condition Ordinary

Roof gen. condition Bad

Structure gen. condition Ordinary

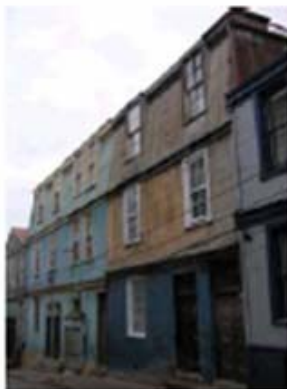
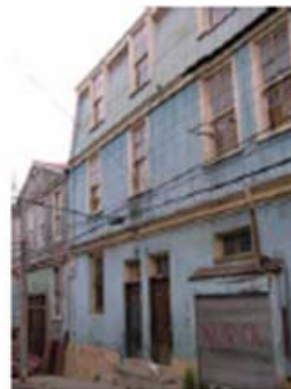
General condition Good

Roof gen. condition Ordinary

Structure gen. condition Good

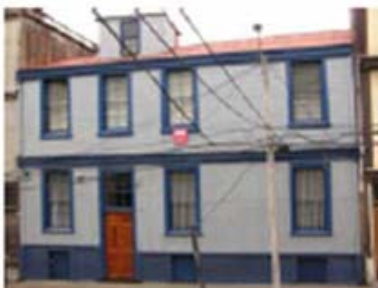
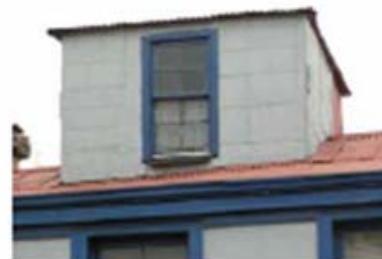
General condition Ordinary

Roof gen. condition Ordinary

Structure gen. condition Ordinary

Vulnerability (%) 55

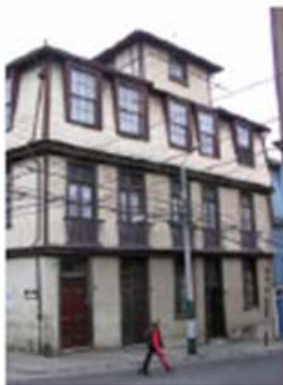
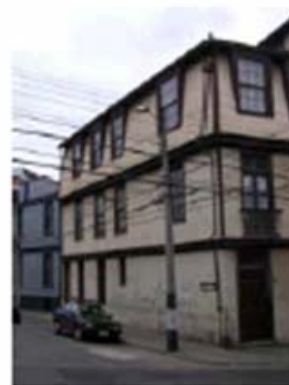
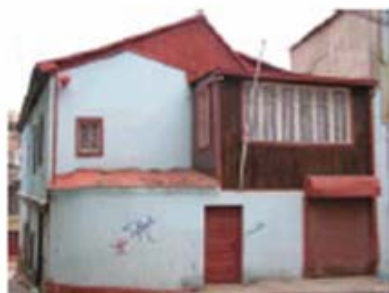
Manzana 2011

General condition Ordinary

Intervention categories Ordinary maintenance

Roof gen. condition Ordinary

Structure gen. condition Ordinary

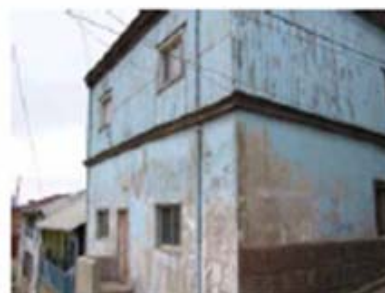
General condition Ordinary

Roof gen. condition Good

Structure gen. condition Ordinary

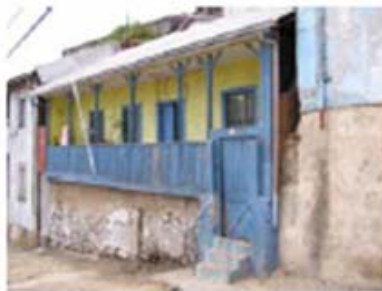
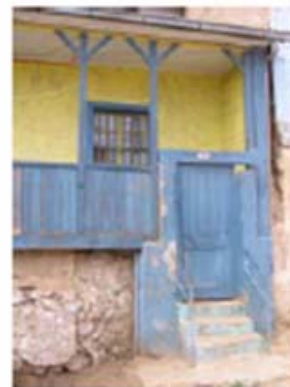
General condition Bad

Roof gen. condition Bad

Structure gen. condition Bad

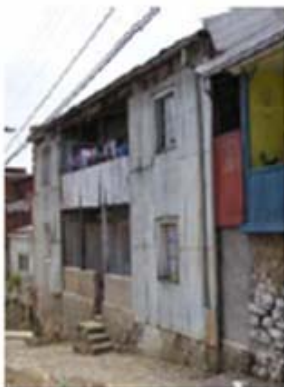
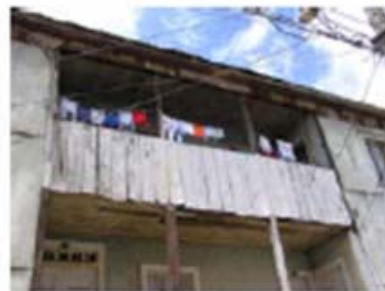
Arch. Style	Other
Typology	Block building
Num. of floors	1
Occupancy	Lived
Function - GF	Residence
Function - US	
Functional characteristic	Residential
Recent transformation	
Undergoing transformation	
Overall architectural quality	Low
General condition	Bad
Level of integration	Strong identity
Intervention categories	Re-development

Manzana	2011
Roles	2011-8
Roles	
Roles	
Property	Private
Landmark	
Roof gen. condition	Bad
Structure gen. condition	Bad
Still house	No
Still house (structure)	
Still house (condition)	
Level of interest	Low
Vulnerability (%)

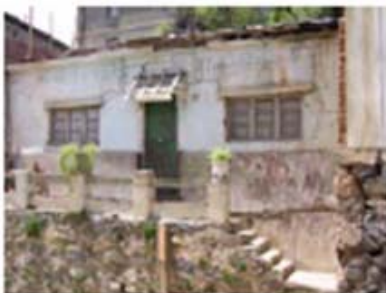
General condition Good

Roof gen. condition Good

Structure gen. condition Good

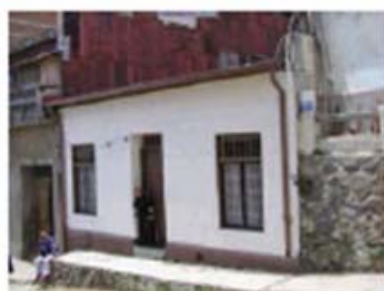
Arch. Style	Other
Typology	Block building
Num. of floors	2
Occupancy	Lived
Function - GF	Residence
Function - US	Residence
Functional characteristic	Residential

Recent transformation	Rehabilitation
Undergoing transformation	
Overall architectural quality	Low
General condition	Ordinary

Roof gen. condition	Bad
Structure gen. condition	Ordinary
Still house	No
Still house (structure)	
Still house (condition)

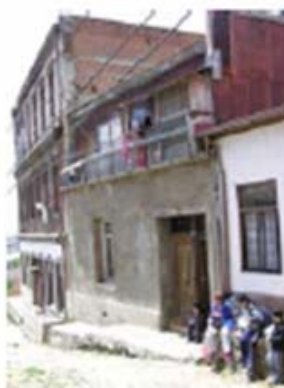
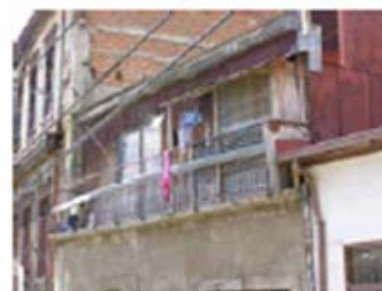
<u>Arch. Style</u>	<u>Local-high</u>
<u>Typology</u>	<u>Block building</u>
<u>Num. of floors</u>	<u>3</u>
<u>Occupancy</u>	<u>Partially lived</u>
<u>Function - GF</u>	<u>Residence</u>
<u>Function - US</u>	<u>Residence</u>
<u>Functional characteristic</u>	<u>Residential</u>
<u>Recent transformation</u>	
<u>Undergoing transformation</u>	
<u>Overall architectural quality</u>	<u>High</u>
<u>General condition</u>	<u>Bad</u>
<u>Level of integration</u>	<u>Strong identity</u>
<u>Intervention categories</u>	<u>Rehabilitation</u>

<u>Manzana</u>	<u>2011</u>
<u>Roles</u>	<u>2011-5</u>
<u>Roles</u>	
<u>Roles</u>	
<u>Property</u>	<u>Private</u>
<u>Landmark</u>	<u>Out</u>
<u>Roof gen. condition</u>	<u>Bad</u>
<u>Structure gen. condition</u>	<u>Bad</u>
<u>Still house</u>	<u>No</u>
<u>Still house (structure)</u>	
<u>Still house (condition)</u>	
<u>Level of interest</u>	<u>High</u>
<u>Vulnerability (%)</u>	<u>48</u>

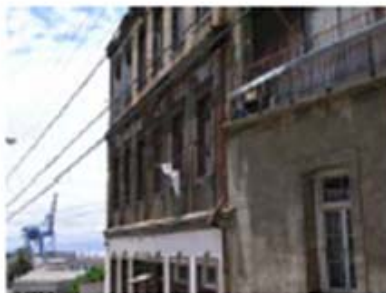
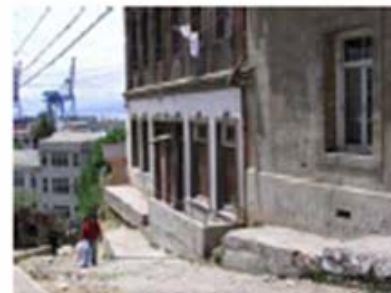
General condition Ordinary

Roof gen. condition Ordinary

Structure gen. condition Good

Level of Interest High

Vulnerability (%) 49

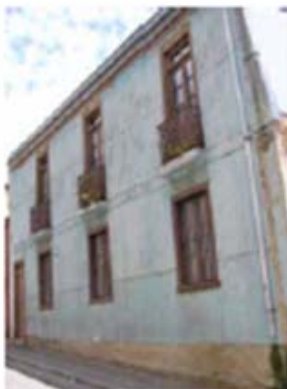
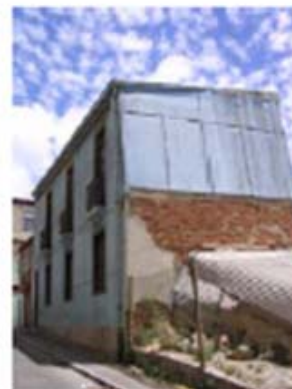
General condition Good

Roof gen. condition Good

Structure gen. condition Good

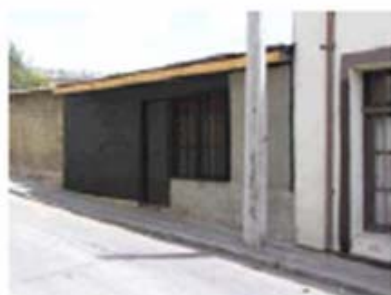
<u>Arch. Style</u>	<u>Rationalism</u>
<u>Typology</u>	<u>Block building</u>
<u>Num. of floors</u>	<u>2</u>
<u>Occupancy</u>	<u>Lived</u>
<u>Function - GF</u>	<u>Residence</u>
<u>Function - US</u>	<u>Residence</u>
<u>Functional characteristic</u>	<u>Residential</u>

<u>Manzana</u>	<u>2024</u>
<u>Roles</u>	<u>2024-2</u>
<u>Roles</u>	
<u>Roles</u>	
<u>Property</u>	<u>Private</u>
<u>Landmark</u>

<u>Recent transformation</u>	<u>Renovation</u>
<u>Undergoing transformation</u>	
<u>Overall architectural quality</u>	<u>Low</u>
<u>General condition</u>	<u>Ordinary</u>

<u>Roof gen. condition</u>	<u>Good</u>
<u>Structure gen. condition</u>	<u>Good</u>
<u>Still house</u>	<u>No</u>
<u>Still house (structure)</u>	
<u>Still house (condition)</u>

<u>Level of integration</u>	<u>Good integration</u>
<u>Intervention categories</u>	<u>Ordinary maintenance</u>

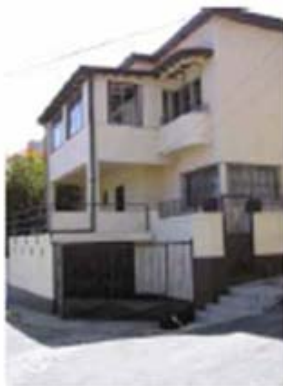
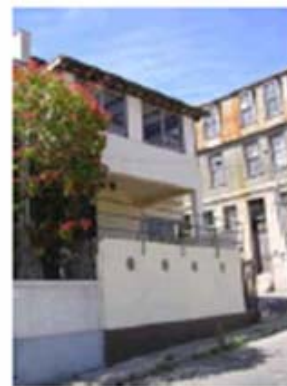
General condition Ordinary

Roof gen. condition Ordinary

Structure gen. condition Ordinary

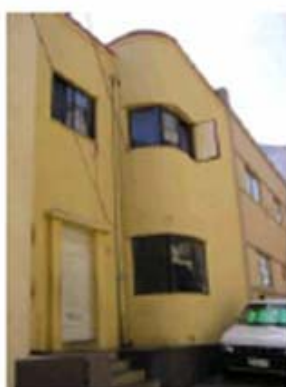
General condition Good

Roof gen. condition Ordinary

Structure gen. condition Good

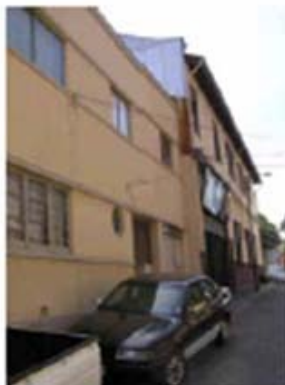
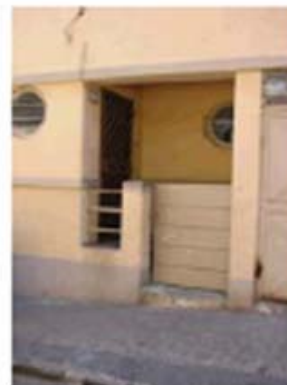
General condition Good

Roof gen. condition Good

Structure gen. condition Good

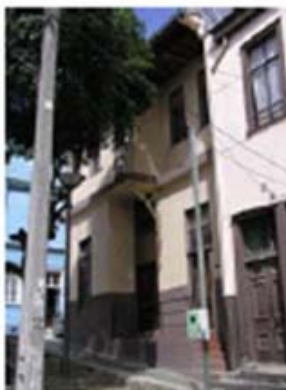
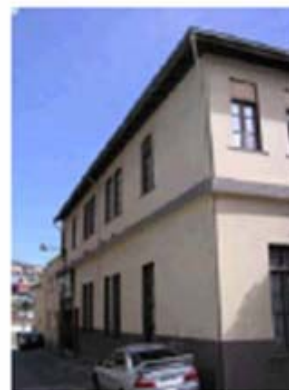
<u>Arch. Style</u>	<u>Local-high</u>
<u>Typology</u>	<u>Row house</u>
<u>Num. of floors</u>	<u>2</u>
<u>Occupancy</u>	<u>Lived</u>
<u>Function - GF</u>	<u>Residence</u>
<u>Function - US</u>	<u>Residence</u>
<u>Functional characteristic</u>	<u>Residential</u>

<u>Manzana</u>	<u>2024</u>
<u>Roles</u>	<u>2024-9</u>
<u>Roles</u>	
<u>Roles</u>	
<u>Property</u>	<u>Private</u>
<u>Landmark</u>	<u>In</u>

<u>Recent transformation</u>	<u>Renovation</u>
<u>Undergoing transformation</u>	
<u>Overall architectural quality</u>	<u>Medium</u>
<u>General condition</u>	<u>Good</u>

<u>Roof gen. condition</u>	<u>Good</u>
<u>Structure gen. condition</u>	<u>Good</u>
<u>Still house</u>	<u>No</u>
<u>Still house (structure)</u>	
<u>Still house (condition)</u>

<u>Level of integration</u>	<u>Strong identity</u>
<u>Intervention categories</u>	<u>Ordinary maintenance</u>

<u>Level of interest</u>	<u>Medium</u>
<u>Vulnerability (%)</u>	<u>56</u>

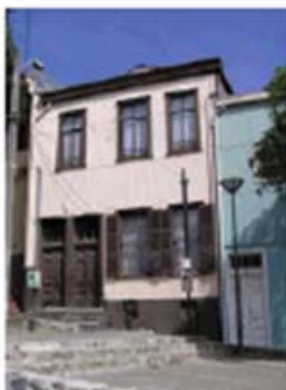
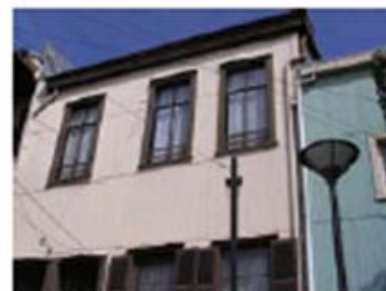
General condition Ordinary

Roof gen. condition Ordinary

Structure gen. condition Ordinary

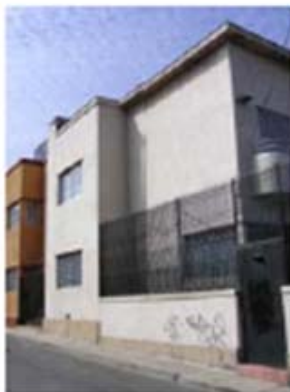
Arch. Style	Rationalism	Manzana	2024
Typology	Block building	Roles	2024-6
Num. of floors	2	Roles	2024-7
Occupancy	Lived	Roles	
Function - GF	Residence	Property	Private
Function - US	Residence	Landmark	
Functional characteristic	Residential	Roof gen. condition	Ordinary
Recent transformation	Renovation	Structure gen. condition	Ordinary
Undergoing transformation		Still house	No
Overall architectural quality	Medium	Still house (structure)	
General condition	Ordinary	Still house (condition)	
Level of integration	Good integration	Level of interest	Low
Intervention categories	Ordinary maintenance	Vulnerability (%)

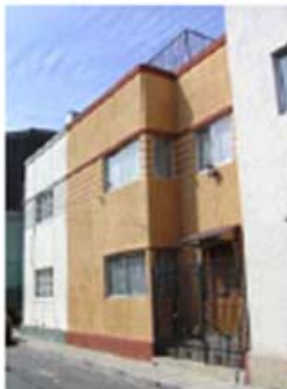
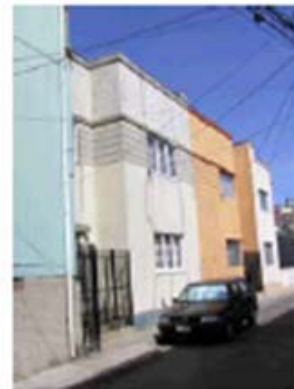
General condition	Good
-------------------	------

Roof gen. condition	Ordinary
---------------------	----------

Structure gen. condition	Good
--------------------------	------

Vulnerability (%)	57
-------------------	----

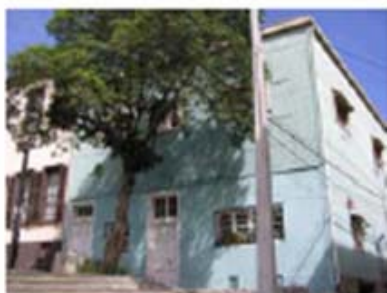
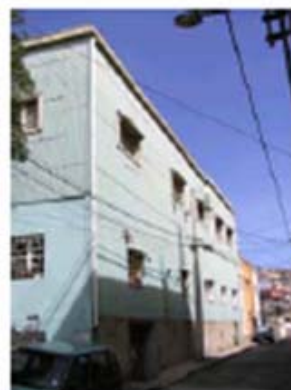
General condition Ordinary

Roof gen. condition Ordinary

Structure gen. condition Ordinary

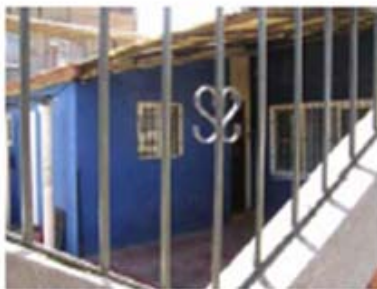
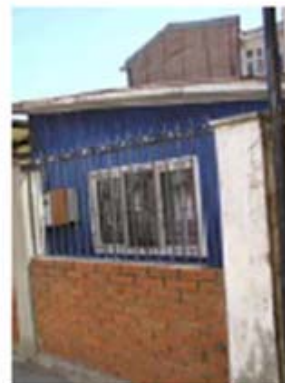
General condition Ordinary

Roof gen. condition Ordinary

Structure gen. condition Ordinary

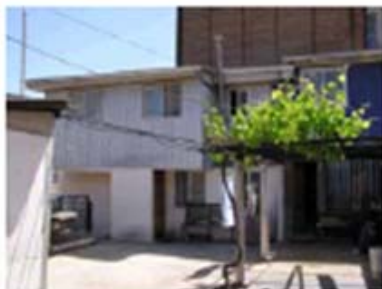
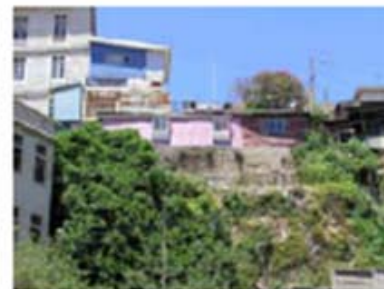
General condition Ordinary

Roof gen. condition Ordinary

Structure gen. condition Ordinary

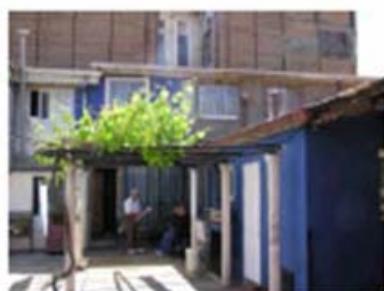
General condition Bad

Roof gen. condition Ordinary

Structure gen. condition Bad

Level of Interest High

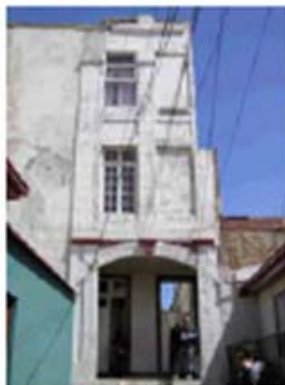
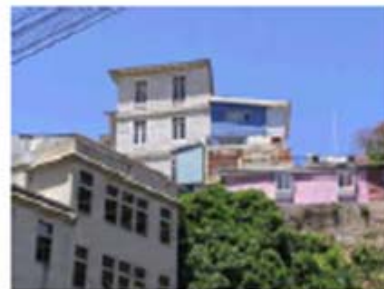
General condition Ordinary

Roof gen. condition Ordinary

Structure gen. condition Ordinary

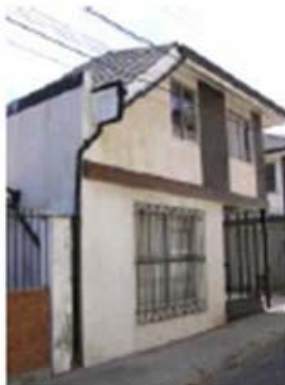
General condition Ordinary

Roof gen. condition Ordinary

Structure gen. condition Ordinary

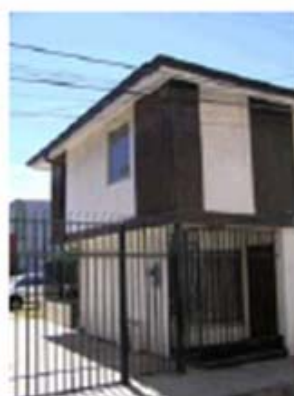
Arch. Style	Local-high
Typology	Block building
Num. of floors	2
Occupancy	Lived
Function - GF	Residence
Function - US	Residence
Functional characteristic	Residential

Manzana	2011
Roles	2011-14
Roles	
Roles	
Property	Private
Landmark

Recent transformation	Renovation
Undergoing transformation	
Overall architectural quality	High
General condition	Good

Roof gen. condition	Ordinary
Structure gen. condition	Ordinary
Still house	No
Still house (structure)	
Still house (condition)

Level of integration	Strong identity
Intervention categories	Restoration

Level of interest	High
Vulnerability (%)	54

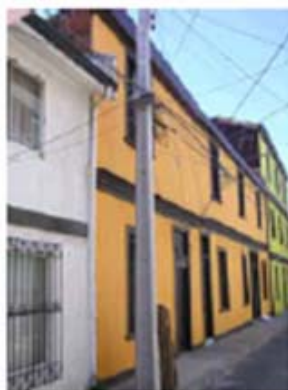
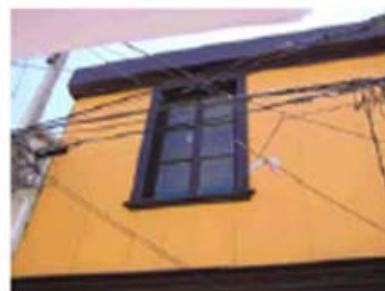
Arch. Style	Local-high
Typology	Block building
Num. of floors	3
Occupancy	Lived
Function - GF	Neighbourhood's commerce
Function - US	Residence
Functional characteristic	Multifunctional

Manzana	2011
Roles	2011-15
Roles	
Roles	
Property	Private
Landmark	Out

Recent transformation	Renovation
Undergoing transformation	
Overall architectural quality	Medium
General condition	Good

Roof gen. condition	Ordinary
Structure gen. condition	Ordinary
Still house	No
Still house (structure)	
Still house (condition)

Level of Integration	Strong identity
Intervention categories	Restoration

Level of Interest	Medium
Vulnerability (%)	44

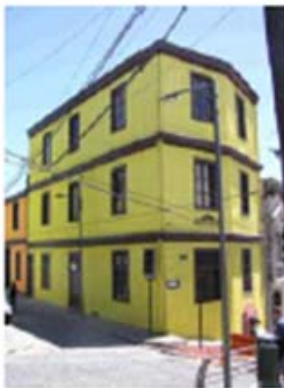
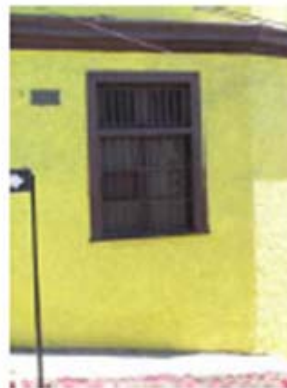
<u>Arch. Style</u>	<u>Neo-classic</u>
<u>Typology</u>	<u>Row house</u>
<u>Num. of floors</u>	<u>2</u>
<u>Occupancy</u>	<u>Lived</u>
<u>Function - GF</u>	<u>Residence</u>
<u>Function - US</u>	<u>Residence</u>
<u>Functional characteristic</u>	<u>Residential</u>

<u>Manzana</u>	<u>2011</u>
<u>Roles</u>	<u>2011-28</u>
<u>Roles</u>	
<u>Roles</u>	
<u>Property</u>	<u>Private</u>
<u>Landmark</u>

<u>Recent transformation</u>	<u>Rehabilitation</u>
<u>Undergoing transformation</u>	<u>Rehabilitation</u>
<u>Overall architectural quality</u>	<u>High</u>
<u>General condition</u>	<u>Good</u>

<u>Roof gen. condition</u>	<u>Ordinary</u>
<u>Structure gen. condition</u>	<u>Good</u>
<u>Still house</u>	<u>No</u>
<u>Still house (structure)</u>	
<u>Still house (condition)</u>

<u>Level of Integration</u>	<u>Strong identity</u>
<u>Intervention categories</u>	<u>Ordinary maintenance</u>

<u>Level of Interest</u>	<u>High</u>
<u>Vulnerability (%)</u>	<u>28</u>

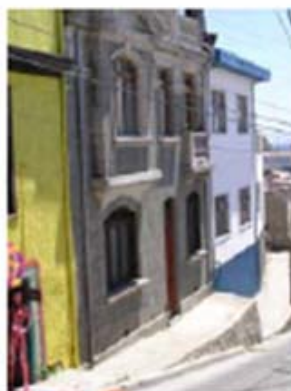
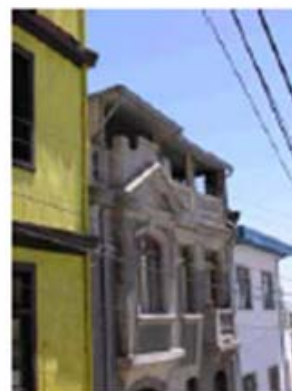
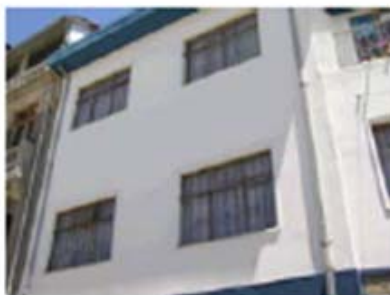
General condition	Ordinary
-------------------	----------

Roof gen. condition	Ordinary
---------------------	----------

Structure gen. condition	Ordinary
--------------------------	----------

Vulnerability (%)	12
-------------------	----

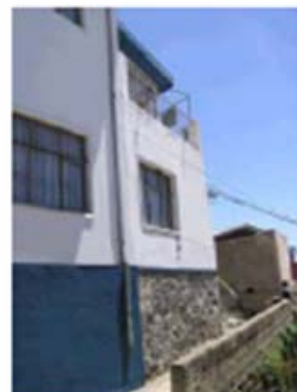
General condition Ordinary

Roof gen. condition Ordinary

Structure gen. condition Ordinary

Vulnerability (%) 60

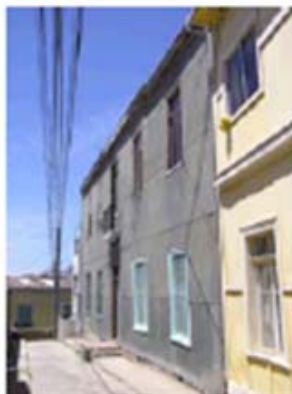
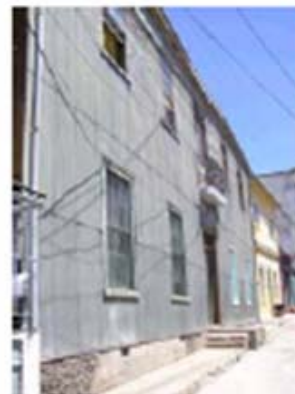
General condition Good

Roof gen. condition Good

Structure gen. condition Good

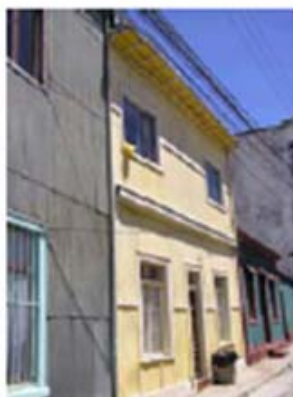
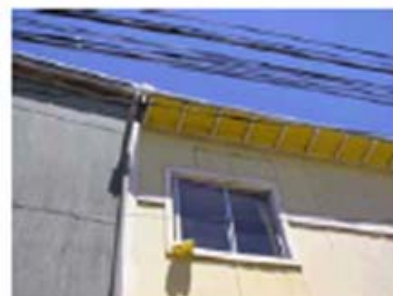
Level of Interest Medium

Vulnerability (%) 46

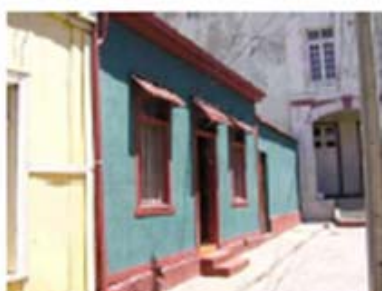
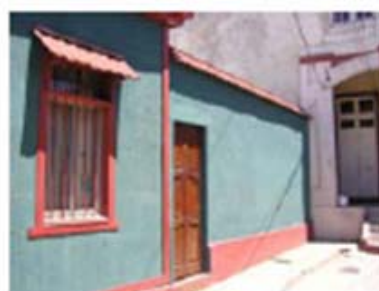
<u>Recent transformation</u>	<u>Rehabilitation</u>
<u>Undergoing transformation</u>	
<u>Overall architectural quality</u>	<u>Medium</u>
<u>General condition</u>	<u>Good</u>

<u>Roof gen. condition</u>	<u>Good</u>
<u>Structure gen. condition</u>	<u>Good</u>
<u>Still house</u>	<u>No</u>
<u>Still house (structure)</u>	
<u>Still house (condition)</u>

<u>Level of interest</u>	<u>Medium</u>
<u>Vulnerability (%)</u>	<u>42</u>

<u>Level of integration</u>	<u>Strong identity</u>
<u>Intervention categories</u>	<u>Restoration</u>

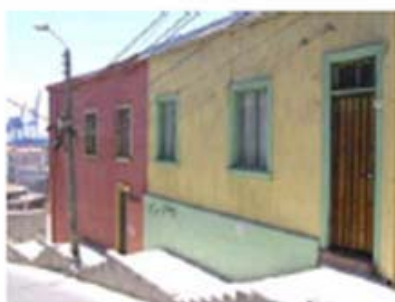
Manzana 0089

Roof gen. condition Ordinary

Structure gen. condition Bad

Level of Interest High

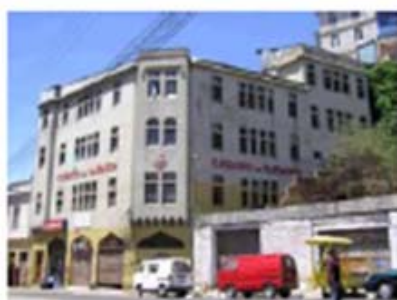
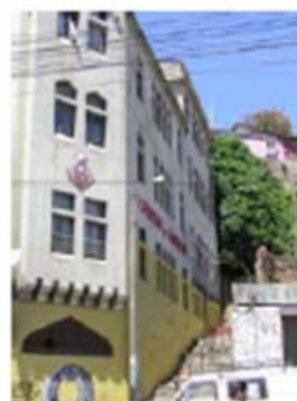
General condition Bad

Roof gen. condition Ordinary

Structure gen. condition Ordinary

Vulnerability (%) 58

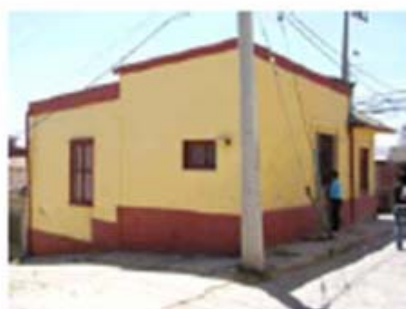
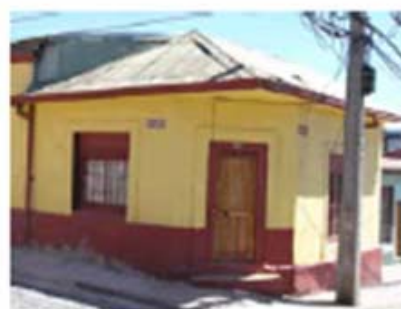
General condition Bad

Roof gen. condition Bad

Structure gen. condition Bad

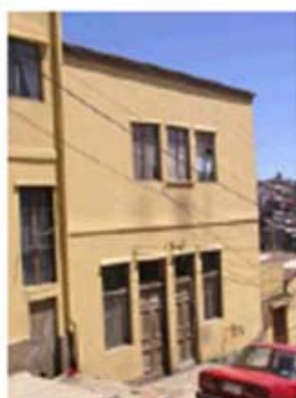
Recent transformation	
Undergoing transformation	
Overall architectural quality	Low
General condition	Bad

Roof gen. condition	Bad
Structure gen. condition	Bad
Still house	No
Still house (structure)	
Still house (condition)

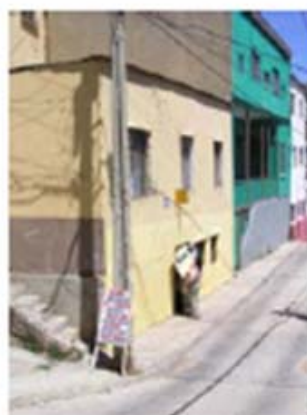
Recent transformation	Renovation
Undergoing transformation	
Overall architectural quality	Medium
General condition	Good

Roof gen. condition	Ordinary
Structure gen. condition	Good
Still house	No
Still house (structure)	
Still house (condition)

Level of Interest	High
Vulnerability (%)	53

Level of Integration	Strong identity
Intervention categories	Restoration

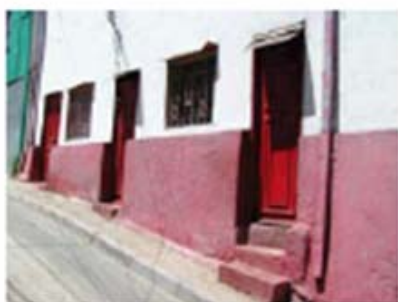
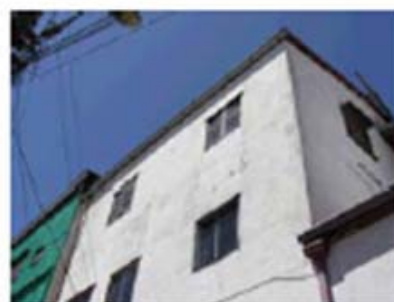
Recent transformation	Renovation
Undergoing transformation	
Overall architectural quality	Medium
General condition	Ordinary

Roof gen. condition	Ordinary
Structure gen. condition	Ordinary
Still house	No
Still house (structure)	
Still house (condition)

Level of interest	Medium
Vulnerability (%)	64

Level of integration	Strong identity
Intervention categories	Restoration

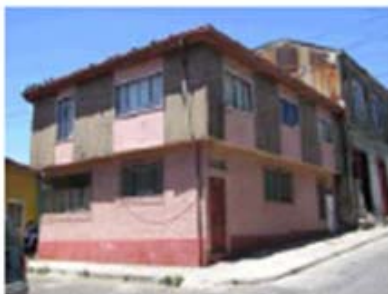
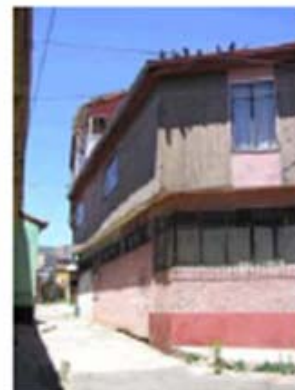
<u>Recent transformation</u>	<u>Renovation</u>
<u>Undergoing transformation</u>	
<u>Overall architectural quality</u>	<u>Low</u>
<u>General condition</u>	<u>Ordinary</u>

<u>Roof gen. condition</u>	<u>Ordinary</u>
<u>Structure gen. condition</u>	<u>Ordinary</u>
<u>Still house</u>	<u>No</u>
<u>Still house (structure)</u>	
<u>Still house (condition)</u>

<u>Level of integration</u>	<u>Good integration</u>
<u>Intervention categories</u>	<u>Re-development</u>

<u>Level of interest</u>	<u>Low</u>
<u>Vulnerability (%)</u>	<u>44</u>

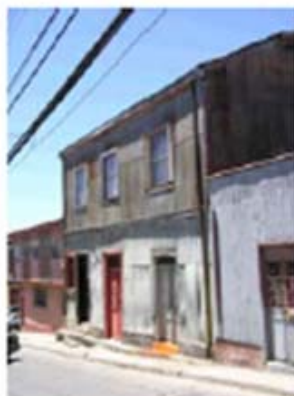
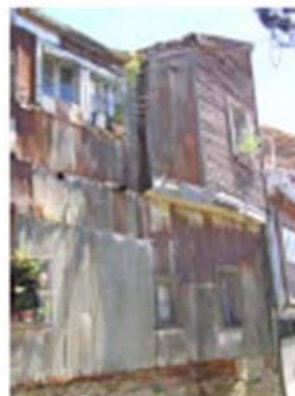
General condition Bad

Roof gen. condition Bad

Structure gen. condition Bad

Vulnerability (%) 70

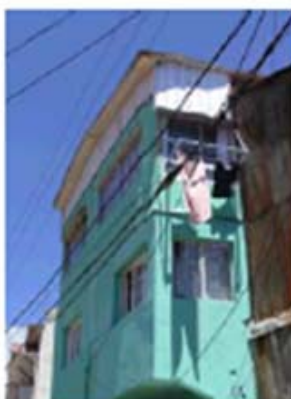
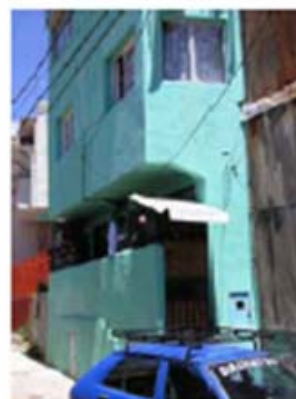
Recent transformation	Renovation
Undergoing transformation	
Overall architectural quality	Low
General condition	Ordinary

Roof gen. condition	Ordinary
Structure gen. condition	Ordinary
Still house	No
Still house (structure)	
Still house (condition)

Level of integration	Good integration
Intervention categories	Rehabilitation

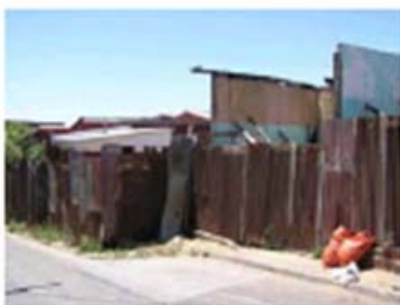
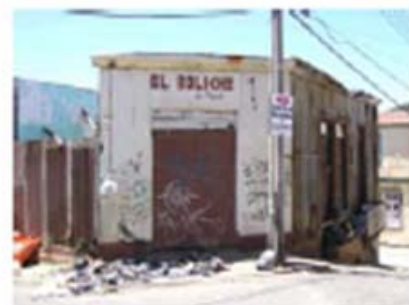
Manzana	2089
Roles	2089-11
Roles	
Roles	
Property	Private
Landmark

Recent transformation	Renovation
Undergoing transformation	
Overall architectural quality	Medium
General condition	Good

Roof gen. condition	Good
Structure gen. condition	Good
Still house	No
Still house (structure)	
Still house (condition)

Level of integration	Strong identity
Intervention categories	Restoration

Level of interest	Medium
Vulnerability (%)	29

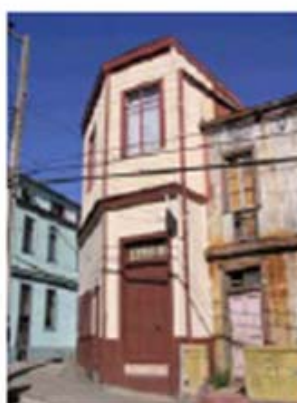
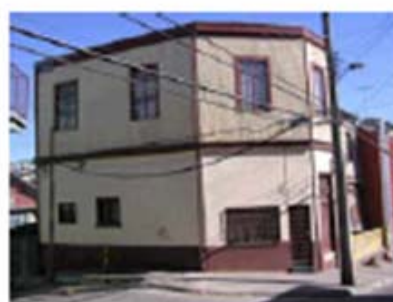
Manzana	2089
Roles	2089-10
Roles	
Roles	
Property	Private
Landmark

Recent transformation	
Undergoing transformation	
Overall architectural quality	Medium
General condition	Bad

Roof gen. condition	Bad
Structure gen. condition	Bad
Still house	No
Still house (structure)	
Still house (condition)

Level of Integration	Strong identity
Intervention categories	Rehabilitation

Level of Interest	High
Vulnerability (%)	63

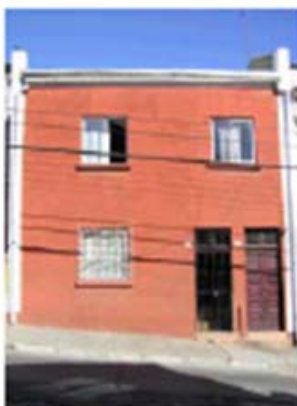
Manzana	2089
Roles	2089-8
Roles	
Roles	
Property	Private
Landmark

Recent transformation	
Undergoing transformation	
Overall architectural quality	High
General condition	Ordinary

Roof gen. condition	Good
Structure gen. condition	Ordinary
Still house	No
Still house (structure)	
Still house (condition)

Level of integration	Strong identity
Intervention categories	Restoration

Level of interest	High
Vulnerability (%)	46

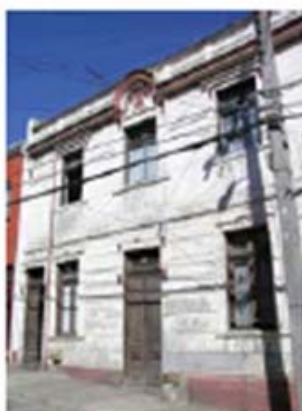
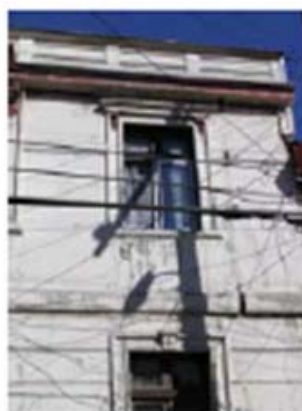
Arch. Style	Other	Manzana	2089
Typology	Row house	Roles	2089-7
Num. of floors	2	Roles	
Occupancy	Lived	Roles	
Function - GF	Neiborough's commerce	Property	Private
Function - US	Residence		
Functional characteristic	Multifunctional	Landmark	
Recent transformation	Rehabilitation	Roof gen. condition	Good
Undergoing transformation		Structure gen. condition	Good
Overall architectural quality	Low	Still house	No
General condition	Good	Still house (structure)	
		Still house (condition)	
Level of Integration	Contrast	Level of Interest	Low
Intervention categories	Rehabilitation	Vulnerability (%)	13

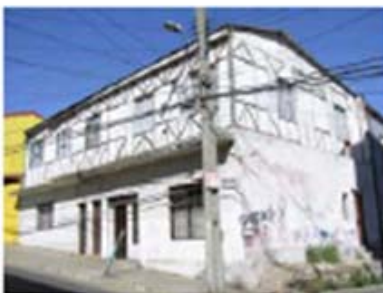
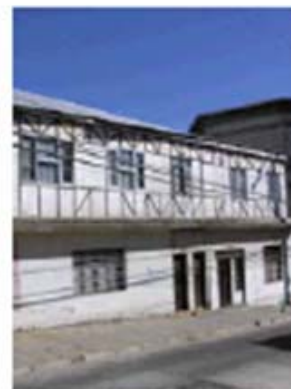
Manzana	2089
Roles	2089-4
Roles	
Roles	
Property	Private
Landmark

Recent transformation	
Undergoing transformation	
Overall architectural quality	Medium
General condition	Bad

Roof gen. condition	Bad
Structure gen. condition	Bad
Still house	No
Still house (structure)	
Still house (condition)

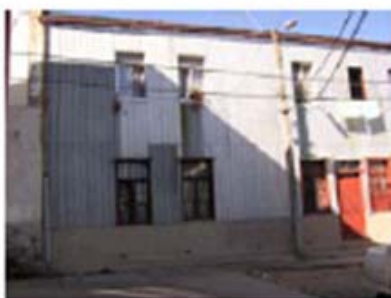
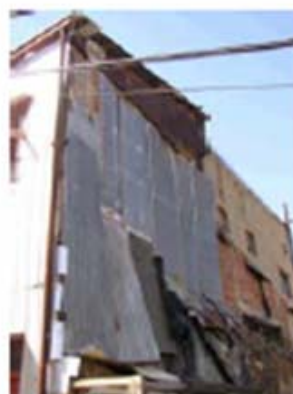
Manzana 2089

Roof gen. condition

Structure gen. condition

General condition Ruin

Intervention categories Rehabilitation

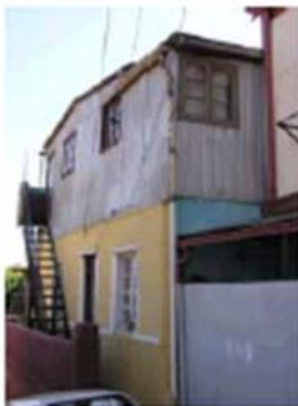
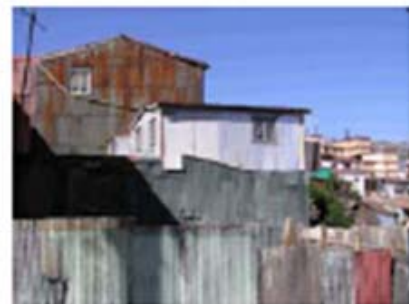
General condition Ordinary

Roof gen. condition Bad

Structure gen. condition Ordinary

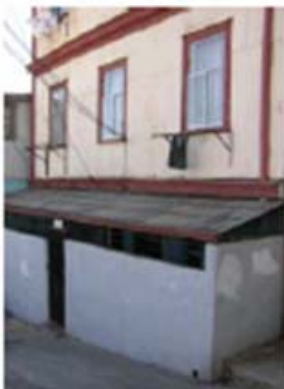
General condition Bad

Roof gen. condition Bad

Structure gen. condition Bad

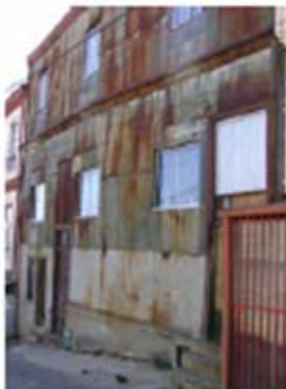
Manzana 2089

Roof gen. condition Ordinary

Structure gen. condition Ordinary

General condition Ordinary

Intervention categories Rehabilitation

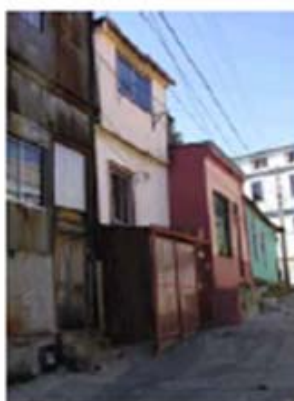
<u>Manzana</u>	<u>2089</u>
<u>Roles</u>	<u>2089-2</u>
<u>Roles</u>	
<u>Roles</u>	
<u>Property</u>	<u>Private</u>
<u>Landmark</u>	
<u>Roof gen. condition</u>	<u>Ordinary</u>
<u>Structure gen. condition</u>	<u>Ordinary</u>
<u>Still house</u>	<u>No</u>
<u>Still house (structure)</u>	
<u>Still house (condition)</u>	
<u>Level of Interest</u>	<u>Low</u>
<u>Vulnerability (%)</u>

<u>Arch. Style</u>	<u>Other</u>
<u>Typology</u>	<u>Row house</u>
<u>Num. of floors</u>	<u>1</u>
<u>Occupancy</u>	<u>Lived</u>
<u>Function - GF</u>	<u>Residence</u>
<u>Function - US</u>	<u>Residence</u>
<u>Functional characteristic</u>	<u>Residential</u>
<u>Recent transformation</u>	<u>Renovation</u>
<u>Undergoing transformation</u>	
<u>Overall architectural quality</u>	<u>Low</u>
<u>General condition</u>	<u>Ordinary</u>
<u>Level of Integration</u>	<u>Good Integration</u>
<u>Intervention categories</u>	<u>Ordinary maintenance</u>

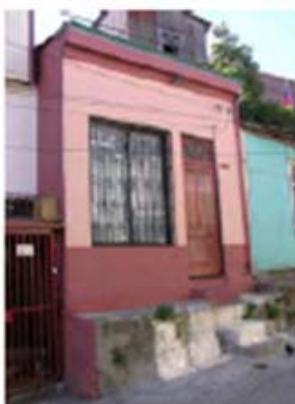
General condition Bad

Roof gen. condition Bad

Structure gen. condition Bad

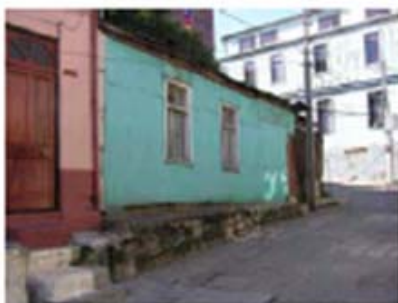
Arch. Style OtherTypology Row houseNum. of floors 1Occupancy Not livedFunction - GF OtherFunction - USFunctional characteristicRecent transformationUndergoing transformationOverall architectural quality LowGeneral condition BadLevel of integration ContrastIntervention categories Re-developmentManzana 2089Roles 2089-10RolesRolesProperty PrivateLandmarkRoof gen. condition BadStructure gen. condition BadStill house NoStill house (structure)Still house (condition)Level of interest LowVulnerability (%)

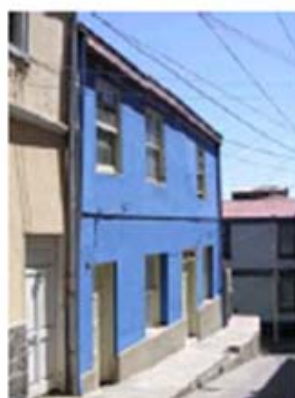
Manzana 2046

General condition Ruin

Intervention categories Re-development

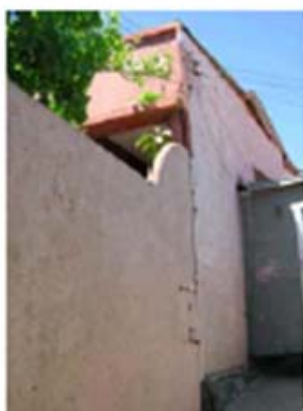
Manzana	2046
Roles	2046-9
Roles	
Roles	
Property	Private
Landmark

Recent transformation	
Undergoing transformation	
Overall architectural quality	Low
General condition	Bad

Roof gen. condition	Bad
Structure gen. condition	Bad
Still house	No
Still house (structure)	
Still house (condition)

Level of interest	Low
Vulnerability (%)	51

Level of integration	Good integration
Intervention categories	Re-development

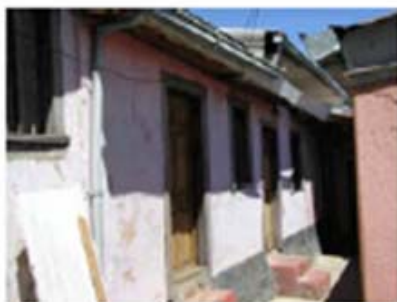
<u>Manzana</u>	2046
<u>Roles</u>	2046-9
<u>Roles</u>	
<u>Roles</u>	
<u>Property</u>	Private
<u>Landmark</u>

<u>Recent transformation</u>	
<u>Undergoing transformation</u>	
<u>Overall architectural quality</u>	Low
<u>General condition</u>	Ordinary

<u>Roof gen. condition</u>	Bad
<u>Structure gen. condition</u>	Ordinary
<u>Still house</u>	No
<u>Still house (structure)</u>	
<u>Still house (condition)</u>

<u>Level of interest</u>	Low
<u>Vulnerability (%)</u>	36

<u>Level of integration</u>	Good integration
<u>Intervention categories</u>	Re-development

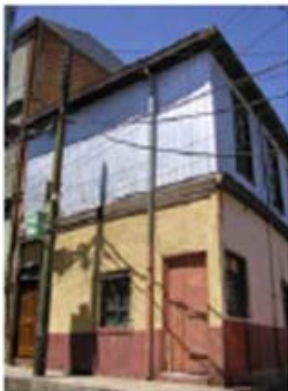
<u>Manzana</u>	<u>2046</u>
<u>Roles</u>	<u>2046-2</u>
<u>Roles</u>	
<u>Roles</u>	
<u>Property</u>	<u>Private</u>
<u>Landmark</u>

<u>Recent transformation</u>	
<u>Undergoing transformation</u>	
<u>Overall architectural quality</u>	<u>Low</u>
<u>General condition</u>	<u>Bad</u>

<u>Roof gen. condition</u>	<u>Bad</u>
<u>Structure gen. condition</u>	<u>Bad</u>
<u>Still house</u>	<u>No</u>
<u>Still house (structure)</u>	
<u>Still house (condition)</u>

<u>Level of interest</u>	<u>Low</u>
<u>Vulnerability (%)</u>	<u>90</u>

<u>Level of integration</u>	<u>Good integration</u>
<u>Intervention categories</u>	<u>Rehabilitation</u>

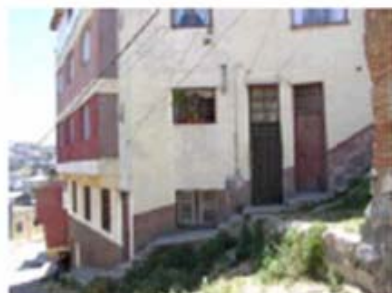
<u>Manzana</u>	<u>2046</u>
<u>Roles</u>	<u>2046-6</u>
<u>Roles</u>	
<u>Roles</u>	
<u>Property</u>	<u>Private</u>
<u>Landmark</u>	<u>In</u>
<u>Roof gen. condition</u>	<u>Bad</u>
<u>Structure gen. condition</u>	<u>Bad</u>
<u>Still house</u>	<u>No</u>
<u>Still house (structure)</u>	
<u>Still house (condition)</u>	
<u>Level of Interest</u>	<u>High</u>
<u>Vulnerability (%)</u>	<u>84</u>

<u>Arch. Style</u>	<u>Local-high</u>
<u>Typology</u>	<u>Block building</u>
<u>Num. of floors</u>	<u>2</u>
<u>Occupancy</u>	<u>Lived</u>
<u>Function - GF</u>	<u>Residence</u>
<u>Function - US</u>	<u>Residence</u>
<u>Functional characteristic</u>	<u>Residential</u>
<u>Recent transformation</u>	
<u>Undergoing transformation</u>	
<u>Overall architectural quality</u>	<u>High</u>
<u>General condition</u>	<u>Bad</u>
<u>Level of Integration</u>	<u>Strong identity</u>
<u>Intervention categories</u>	<u>Rehabilitation</u>

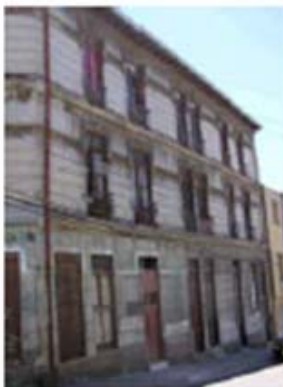
General condition Bad

Roof gen. condition Bad

Structure gen. condition Bad

Vulnerability (%) 48

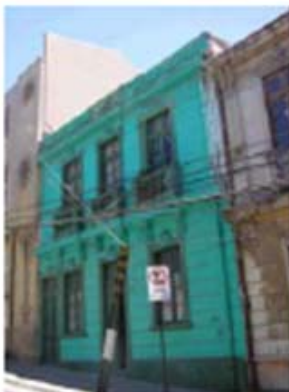
<u>Manzana</u>	<u>2048</u>
<u>Roles</u>	<u>2048-3</u>
<u>Roles</u>	<u>2048-2</u>
<u>Roles</u>	
<u>Property</u>	<u>Private</u>
<u>Landmark</u>	<u>In</u>

<u>Recent transformation</u>	
<u>Undergoing transformation</u>	
<u>Overall architectural quality</u>	<u>High</u>
<u>General condition</u>	<u>Bad</u>

<u>Roof gen. condition</u>	<u>Bad</u>
<u>Structure gen. condition</u>	<u>Ordinary</u>
<u>Still house</u>	<u>No</u>
<u>Still house (structure)</u>	
<u>Still house (condition)</u>

<u>Level of Interest</u>	<u>High</u>
<u>Vulnerability (%)</u>	<u>22</u>

<u>Level of Integration</u>	<u>Strong identity</u>
<u>Intervention categories</u>	<u>Rehabilitation</u>

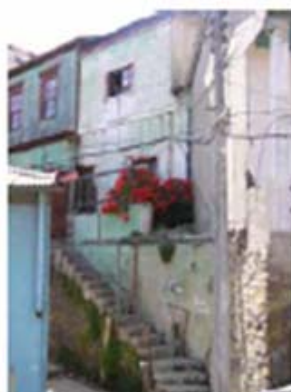
General condition Ordinary

Roof gen. condition Good

Structure gen. condition Ordinary

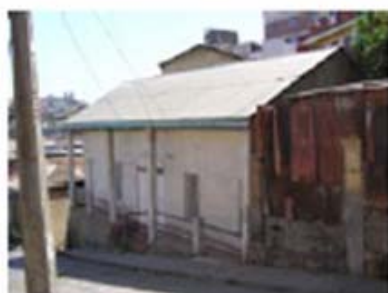
General condition Bad

Roof gen. condition Bad

Structure gen. condition Bad

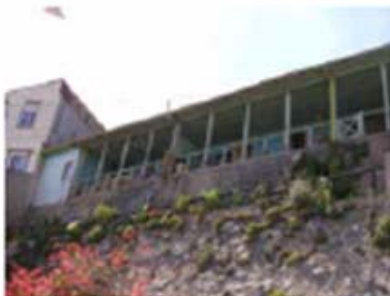
Manzana	2088
Roles	2088-4
Roles	
Roles	
Property	Private
Landmark	In

Recent transformation	Renovation
Undergoing transformation	
Overall architectural quality	Medium
General condition	Bad

Roof gen. condition	Ordinary
Structure gen. condition	Bad
Still house	No
Still house (structure)	
Still house (condition)

Level of integration	Strong identity
Intervention categories	Rehabilitation

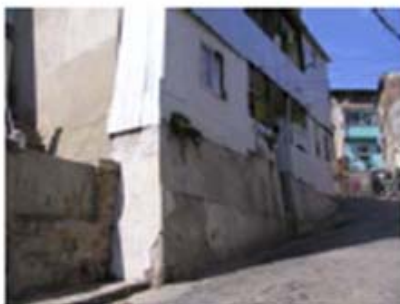
Manzana	2088
Roles	2088-5
Roles	
Roles	
Property	Private
Landmark	In

Recent transformation	
Undergoing transformation	
Overall architectural quality	Medium
General condition	Bad

Roof gen. condition	Bad
Structure gen. condition	Ordinary
Still house	Yes
Still house (structure)	Wood frame
Still house (condition)	Ordinary

Level of Integration	Strong identity
Intervention categories	Rehabilitation

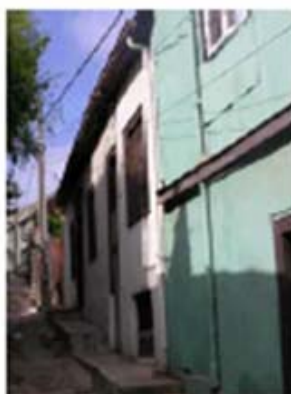
Manzana	2088
Roles	2088-10
Roles	
Roles	
Property	Private
Landmark

Recent transformation	
Undergoing transformation	
Overall architectural quality	High
General condition	Bad

Roof gen. condition	Bad
Structure gen. condition	Bad
Still house	Yes
Still house (structure)	Wood frame
Still house (condition)	Ordinary

Level of integration	Strong identity
Intervention categories	Rehabilitation

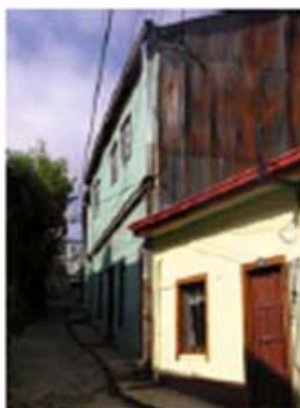
General condition Good

Roof gen. condition Good

Structure gen. condition Good

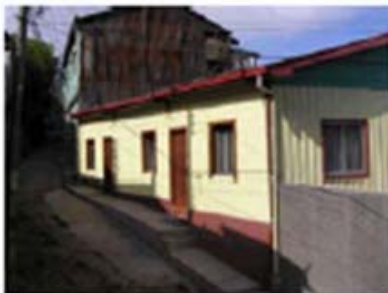
General condition Bad

Roof gen. condition Bad

Structure gen. condition Bad

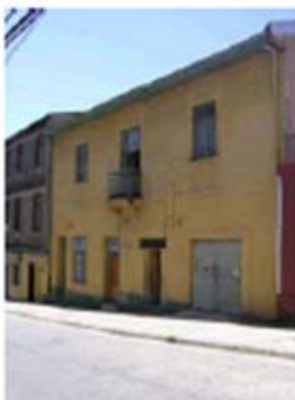
General condition Bad

Roof gen. condition Bad

Structure gen. condition Bad

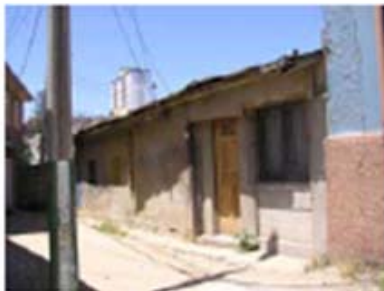
<u>Manzana</u>	<u>2091</u>
<u>Roles</u>	<u>2091-2</u>
<u>Roles</u>	
<u>Roles</u>	
<u>Property</u>	<u>Private</u>
<u>Landmark</u>

<u>Recent transformation</u>	
<u>Undergoing transformation</u>	
<u>Overall architectural quality</u>	<u>Medium</u>
<u>General condition</u>	<u>Bad</u>

<u>Roof gen. condition</u>	<u>Bad</u>
<u>Structure gen. condition</u>	<u>Bad</u>
<u>Still house</u>	<u>Yes</u>
<u>Still house (structure)</u>	<u>Wood frame</u>
<u>Still house (condition)</u>	<u>Bad</u>

<u>Level of integration</u>	<u>Strong identity</u>
<u>Intervention categories</u>	<u>Re-development</u>

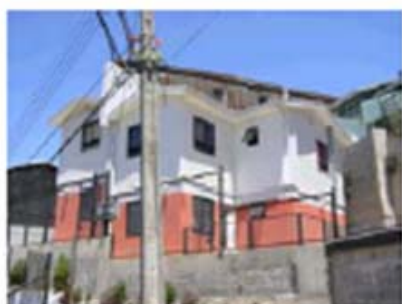
General condition Ruin

Roof gen. condition Bad

Structure gen. condition Good

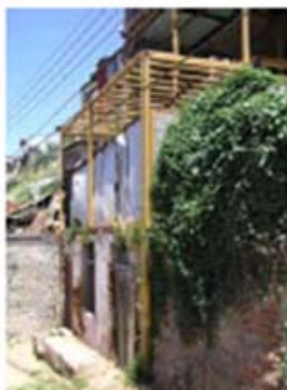
Roof gen. condition Bad

Structure gen. condition Bad

General condition Bad

Intervention categories Demolition

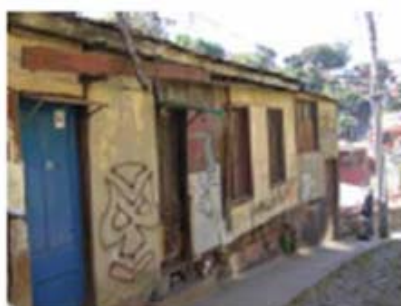
<u>Manzana</u>	<u>2091</u>
<u>Roles</u>	<u>2091-13</u>
<u>Roles</u>	
<u>Roles</u>	
<u>Property</u>	<u>Private</u>
<u>Landmark</u>	<u>In</u>

<u>Recent transformation</u>	
<u>Undergoing transformation</u>	
<u>Overall architectural quality</u>	<u>High</u>
<u>General condition</u>	<u>Bad</u>

<u>Roof gen. condition</u>	<u>Bad</u>
<u>Structure gen. condition</u>	<u>Bad</u>
<u>Still house</u>	<u>No</u>
<u>Still house (structure)</u>	
<u>Still house (condition)</u>

Intervention categories Rehabilitation

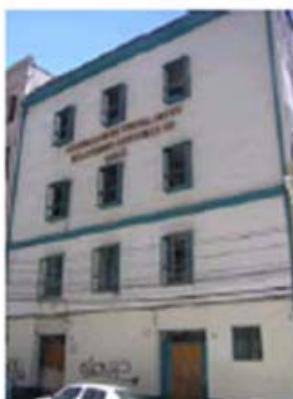
<u>Manzana</u>	<u>0090</u>
<u>Roles</u>	<u>0090-23</u>
<u>Roles</u>	
<u>Roles</u>	
<u>Property</u>	<u>Public</u>
<u>Landmark</u>

<u>Recent transformation</u>	
<u>Undergoing transformation</u>	
<u>Overall architectural quality</u>	<u>Medium</u>
<u>General condition</u>	<u>Ordinary</u>

<u>Roof gen. condition</u>	<u>Ordinary</u>
<u>Structure gen. condition</u>	<u>Ordinary</u>
<u>Still house</u>	<u>No</u>
<u>Still house (structure)</u>	
<u>Still house (condition)</u>

<u>Level of integration</u>	<u>Good integration</u>
<u>Intervention categories</u>	<u>Restoration</u>

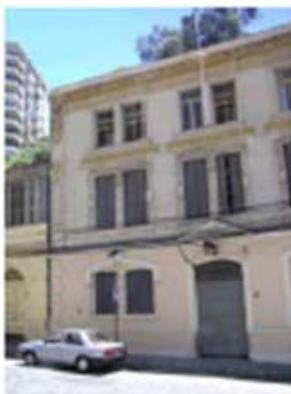
General condition Good

Roof gen. condition Good

Structure gen. condition Good

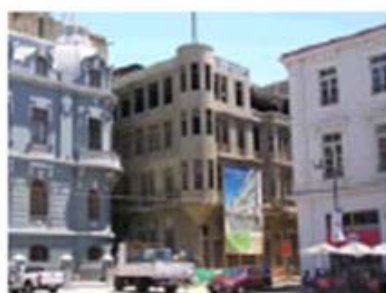
General condition Bad

Roof gen. condition Ordinary

Structure gen. condition Bad

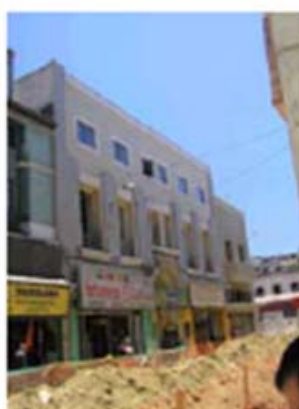
<u>Manzana</u>	<u>0089</u>
<u>Roles</u>	<u>0089-8</u>
<u>Roles</u>	<u>0089-7</u>
<u>Roles</u>	
<u>Property</u>	<u>Private</u>
<u>Landmark</u>

<u>Recent transformation</u>	<u>Renovation</u>
<u>Undergoing transformation</u>	
<u>Overall architectural quality</u>	<u>Medium</u>
<u>General condition</u>	<u>Good</u>

<u>Roof gen. condition</u>	<u>Ordinary</u>
<u>Structure gen. condition</u>	<u>Good</u>
<u>Still house</u>	<u>No</u>
<u>Still house (structure)</u>	
<u>Still house (condition)</u>

<u>Level of Integration</u>	<u>Good integration</u>
<u>Intervention categories</u>	<u>Rehabilitation</u>

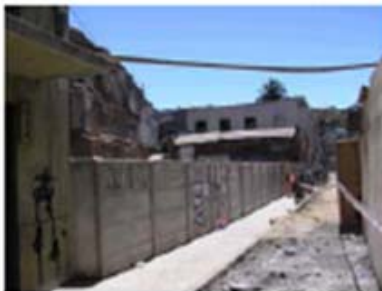
Manzana 0089

General condition Ruin

Intervention categories Re-development

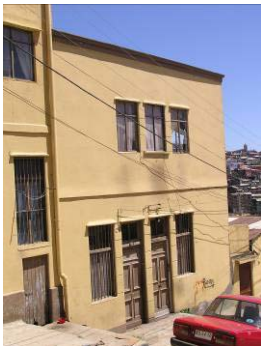
BUILDING E11		CLASS	QUAL. INF.
1		D	M
2		B	M
3	a) 0,33 b) 0,75 c) 1 d) 2 e) 36 f) 2000 C 0,5 α 0,65	C	M
4	a) 15% b) 0,9 c) S d) N e) N	B	M
5	a) N b) 4	D	M
6	a) a 6 1,00 l 6 b) b 0 0,00 l 6	A	M
7	a) 0% b) 0% c) 0,00	A	M
8	s 0,2 15 l 3	A	M
9	a) N b) N	B	M
10		A	M
11		A	M

$I_v = 0.28$

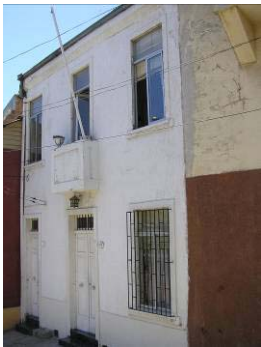
BUILDING F37		CLASS	QUAL. INF.
1		C	M
2		D	M
3	a) 0,33 b) 1 c) 0,5 d) 2 e) 49,6 f) 1200 C 0,5 α 0,58	C	M
4	a) 50% b) 4,0 c) S d) N e) N	D	B
5	a) N b) 4	C	M
6	a) a 6,2 0,78 l 8 b) b 0 0,00 l 8	A	B
7	a) 0% b) 0% c) 0,00	A	M
8	s 0,2 30 l 6	D	B
9	a) N b) N	B	B
10		D	M
11		B	M

$I_v = 0.90$

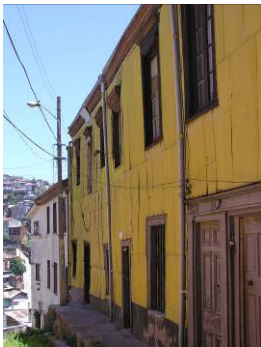
BUILDING F39		CLASS	QUAL. INF.
1		D	M
2		D	M
3	a) 0,33 b) 1 c) 0,5 d) 2 e) 216 f) 1200 C 0,5 α 0,58	C	M
4	a) 7% b) 1,5 c) S d) N e) N	D	M
5	a) N b) 4	D	M
6	a) a 3 0,14 l 22 b) b 8 0,36 l 22	D	B
7	a) 0% b) 0% c) 0,00	A	M
8	s 0,2 22,5 l 4,5	B	M
9	a) S b) N	D	B
10		C	M
11		D	M

$I_v = 0.64$
