Manejo de Riesgos en Valparaiso, Servicios Técnicos

Acronym: "MAR VASTO"

CERRO CORDILLERA PILOT PROJECT (VALPARAISO)

INDEX

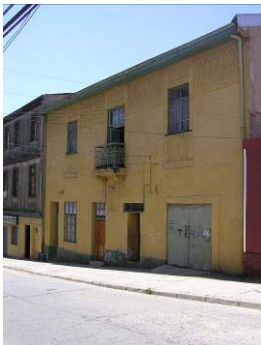
BUILDING H11		CLASS	QUAL. INF.
1		C	B
2		D	B
3	a) 1 b) 1 c) 0,5 d) 2 e) 160 f) 1200 C 0,5 α 0,75	C	B
4	a) 0,11 b) 0,5 c) S d) N e) N	C	M
5	a) N b) 2	C	B
6	a) a 11 0,777 l 14 b) b 0 0,00 l 1	A/B	E
7	a) <10% b) 0% c) 0,00	A	E
8	s 0,2 20 l 4	B	B
9	a) N b) N	C	B
10		B	M
11		B	M

$I_v = 0.55$

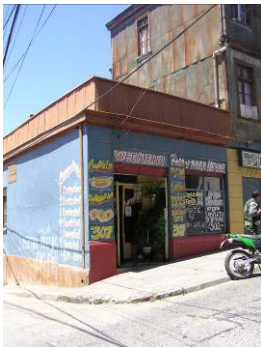
BUILDING H13		CLASS	QUAL. INF.
1		C/D	E
2		D	E
3	a) 1 b) 1 c) 1 d) 3 e) 72 f) 1200 C 0,5 α 0,88	C	E
4	a) 0,08 b) 0,5 c) S d) N e) N	C	E
5	a) N b) 2	C	B
6	a) a 6 0,5 l 12 b) b 0 0,00 l 1	C	E
7	a) <10% b) 0% c) 0,00	A	E
8	s 0,2 30 l 6	C/D	B
9	a) N b) N	D	B
10		B	E
11		B	E

$I_v = 0.58$

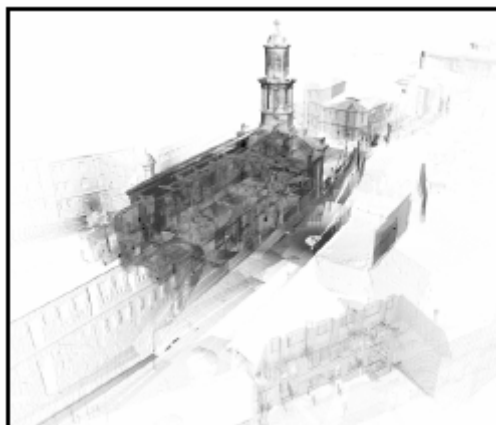
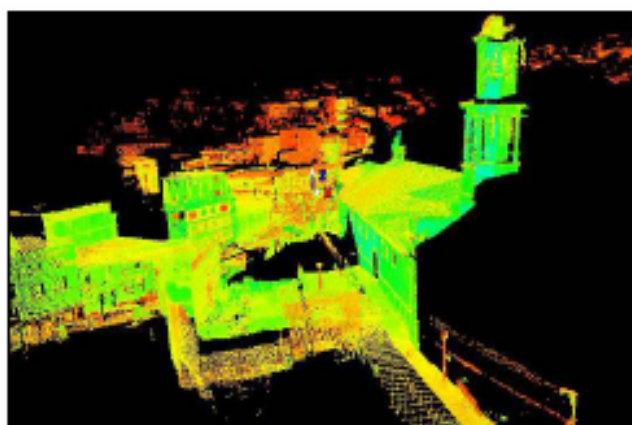
Proyecto “MAR VASTO”
Estado de vulnerabilidad Iglesia “La Matriz”

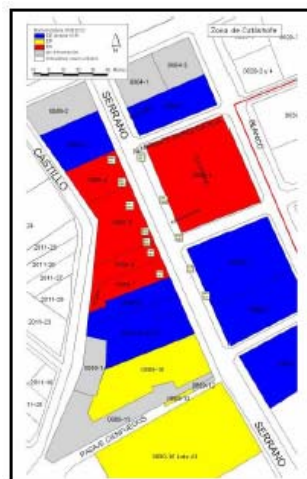
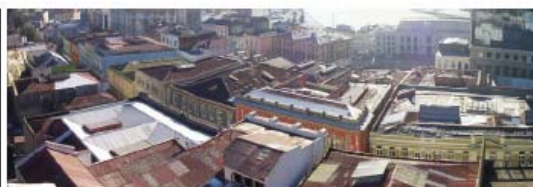
Situación anterior al 3 de febrero del 2007

Situación de catástrofe, por explosión de gas el día 3 de febrero del 2007
