Manejo de Riesgos en Valparaiso, Servicios Técnicos

Acronym: "MAR VASTO"

EVALUATION OF THE VULNERABILITY OF THREE CHURCHES IN VALPARAISO AND NUMERICAL CALCULATIONS

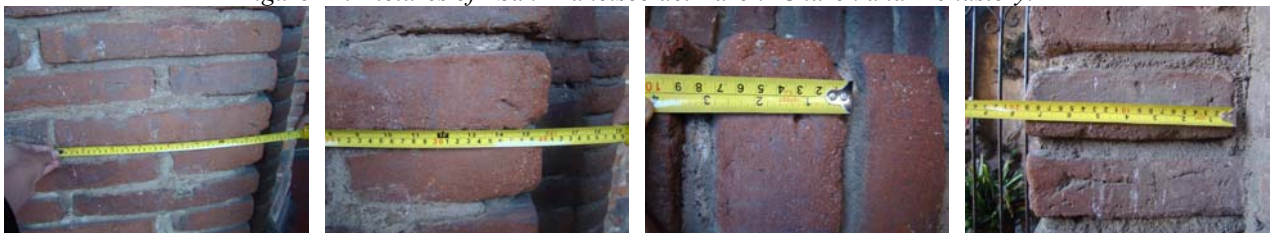
Figure 13: Masonry bricks of “San Francisco del Barón” Church.

The masonry bricks (40 x 19 x 0.7 cm, Fig. 13) were measured by Arch. Claudia Zuñiga (OGP).

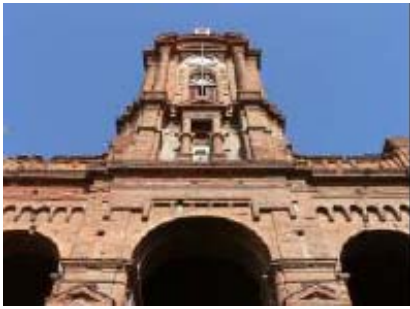
Fa)

The damage assessment is shown by Fig. 18. Pictures *Fa* and *Fb* are overall views of the church façade. Pictures from *Fc* to *Ff* highlight the damage present in the vault key of the lateral nave arch (hinge and shift); the crack runs upwards along almost all the façade. Same damage is evident in the vault key of the central nave (pictures from *Fg* to *Fj*). Pictures *Fk* and *Fl* show vertical cracks in a bearing column. Damage in the battlements at the façade top is reported by *Fm* and *Fn* (diagonal cracks and material detachment).

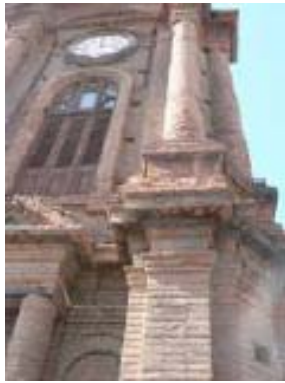
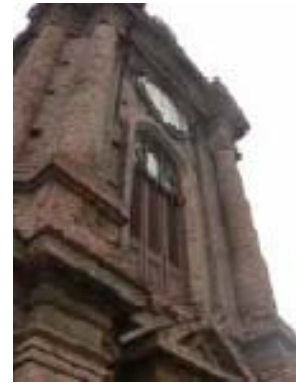
The damage assessment is shown by Fig. 19. Pictures *BTa* and *BTb* are overall views of the bell-tower. Pictures from *BTc* to *BTg* highlight very worrying vertical cracks starting from the bell-tower basis, crossing all the masonry width, as shown by *BTi* and *BTj*.

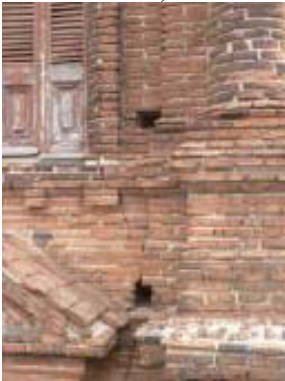
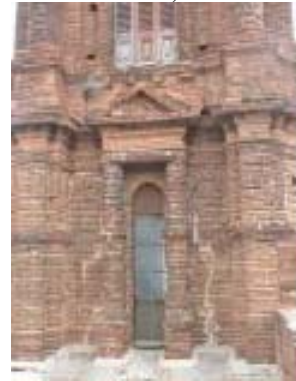
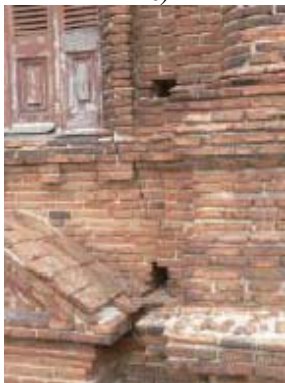
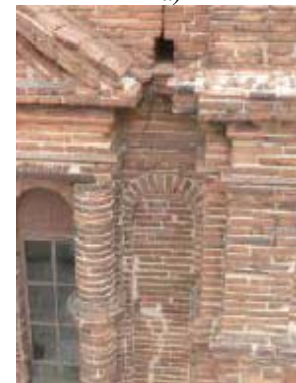
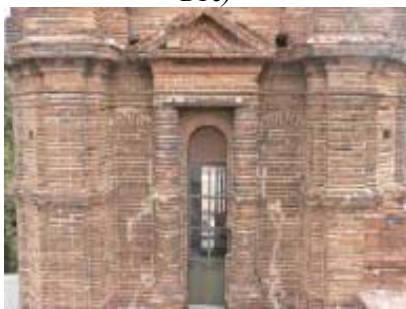
The present damage situation of the San Francisco Church must be considered very worrying, because partial or total collapse (especially in the bell-tower and in the façade) can occur in case of earthquake (i.e. medium to high magnitude seismic excitations, as expected in the Valparaiso area); in fact, the church is unsafe and urgently must be closed partially or totally, planning a strengthening intervention as soon as possible.

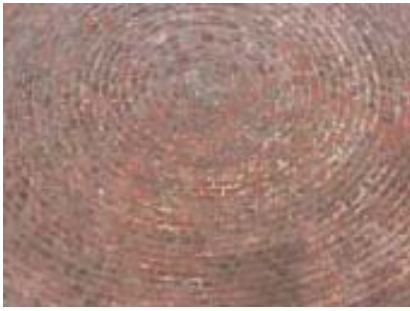
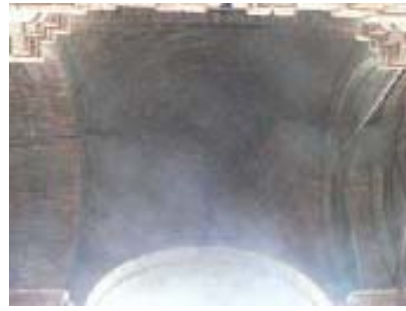
The damage assessment is shown by Fig. 20. Pictures *Da* and *Db* show the entire central dome, while pictures from *Dc* to *Dh* summarize the worrying crack status along the whole dome meridian; being not possible to check if this crack is passing through the masonry thickness, anyway its depth measures at least a couple of cm (*Dg*).

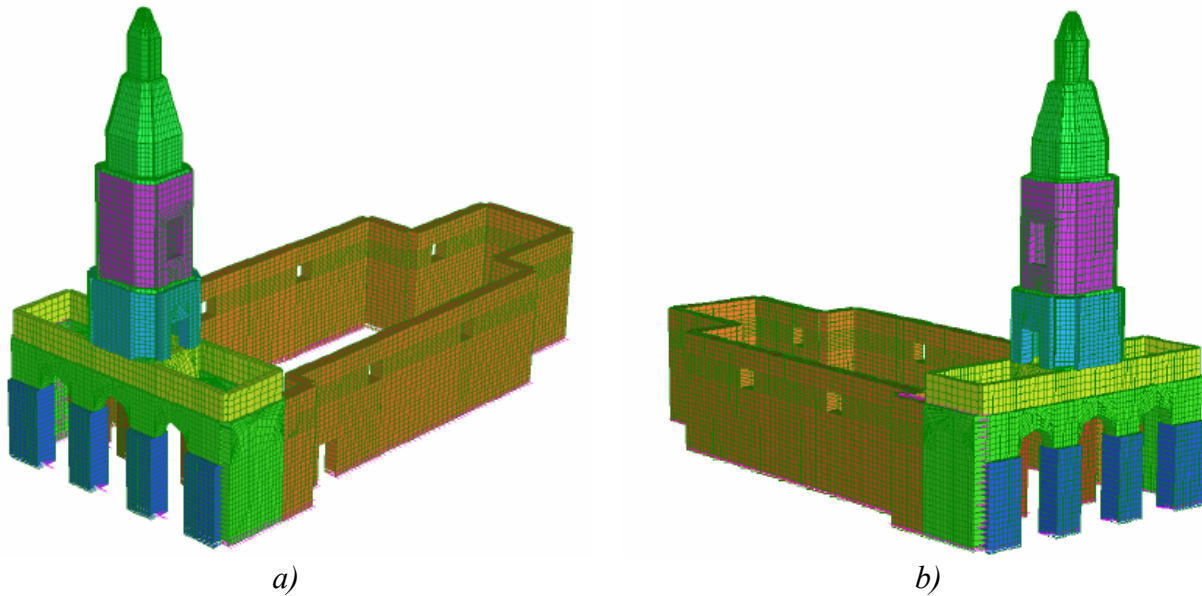
Figure 23: Visualization of the FEM model of the San Francisco Church.

The FEM model principal features are shown by Fig. 23 and Table 2. Modal analysis by response spectrum method has been used. About the brick masonry, lacking experimental tests, the following data have been considered:

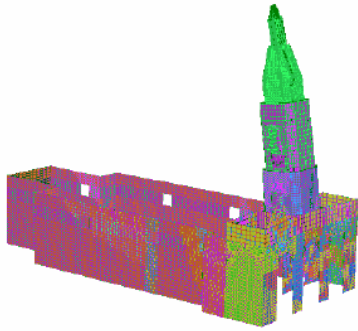
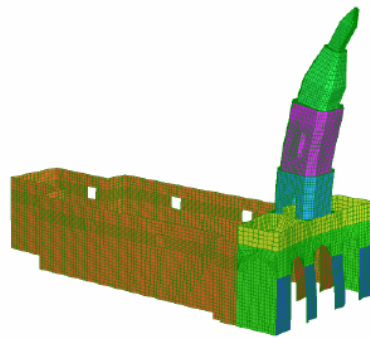
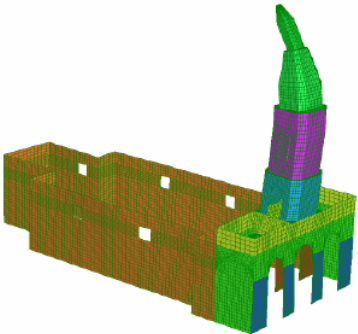
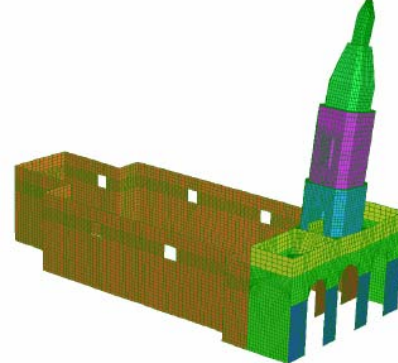
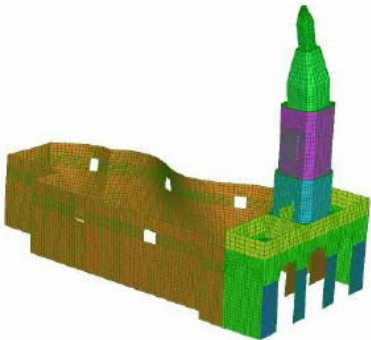
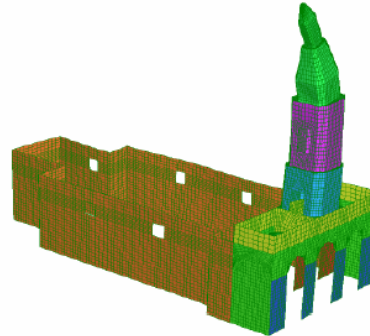
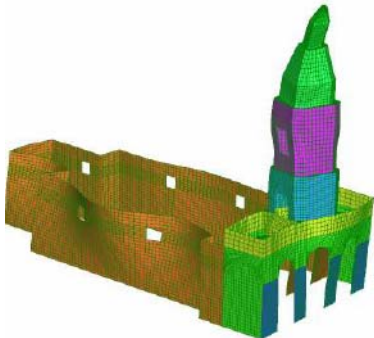
Figure 24: Vibration modes with a significant contribution to the dynamic response.

For each principal horizontal direction taken into account, vibration modes with a significant contribution to the dynamic response (Fig. 24) have been considered (mass participation factors $> 1\%$; antiseismic codes are usually less conservative: $> 5\%$). In order to calculate displacements and actions on the structure, thanks to the modal combination method, the Complete Quadratic Combination (CQC) has been utilized.

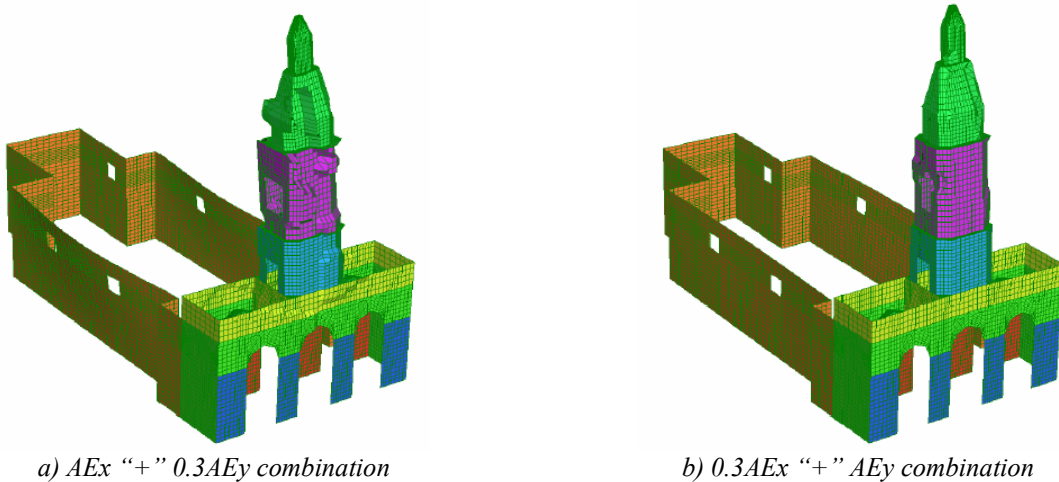
Taking into account only the significant mass participation factors (in our case $> 1\%$), the deformation shapes for the two selected load combinations have been carried out (Fig. 25). It is evident that the most affected structural part is really the bell-tower (due to flexural and torsional actions), with important top displacements, worsened by the damage found during the investigation.

- reinforcement of part or all the resistant elements, increasing selectively resistance, stiffness, ductility or a combination of these (always paying careful attention to induced modifications to the structural scheme); it can be done: increasing the strength of masonry, through local repairs to cracked or deteriorated parts; reconstructing masonry unity in the most weak or deteriorated parts, utilizing materials with analogous physical-chemical and mechanical properties; common non-invasive techniques used in Italy are *rip and sew*, *injections of mixed bonding agents*, *redrafting the junctions*; the insertion of post-tightened vertical tie-rods is applicable only in specific cases and when the masonry has been proven to be able to support the increase in vertical load;

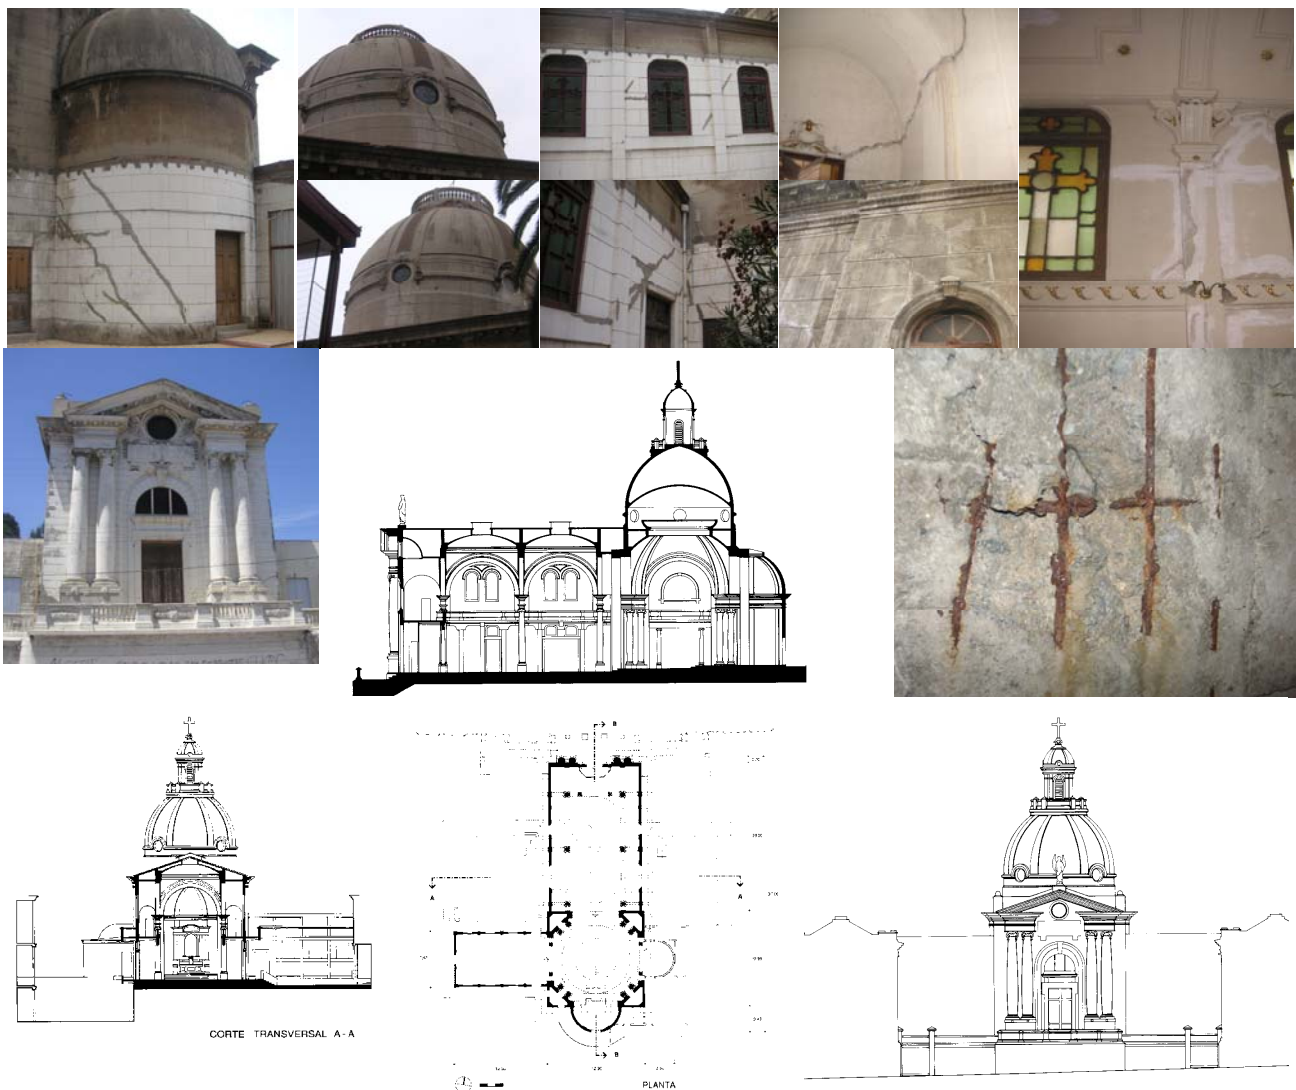
Figure 28: Same pictures and drawings of the Las Hermanas Chapel.

Figs. 28-29 show structural and damage details of the church. The church was severely damaged by the 1985 seismic event: because the church still presents the cracks caused by the 1985 earthquake without any rehabilitation, it is now declared unsafe and closed to the public. A specific report [08], dedicated to the evaluation of the seismic hazard in Valparaiso, focuses the seismic input also in the church's place.

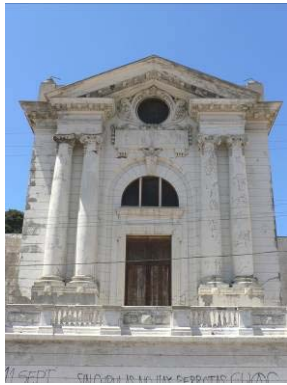
View of the main façade

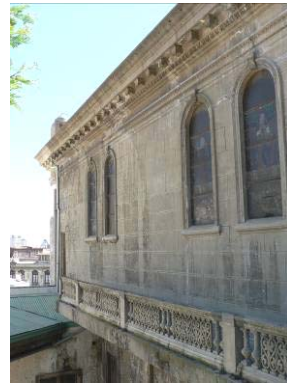
View of the West side of the Church

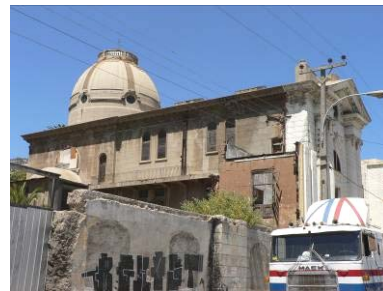
View of the East side of the church

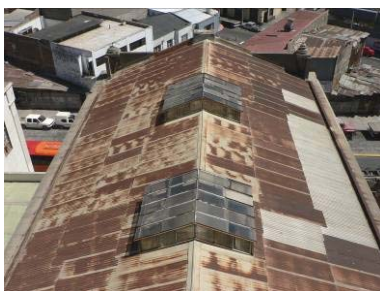
View of the roof covering

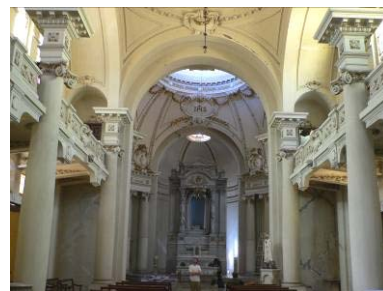
View of the main nave and of the area of the presbytery

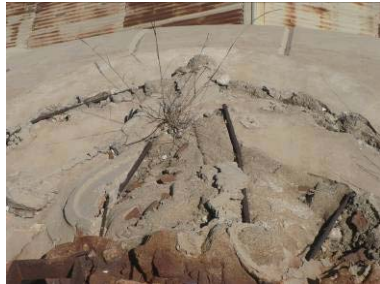
View of one of the decorative elements of the main dome of the church: some reinforcement steel bars are visible

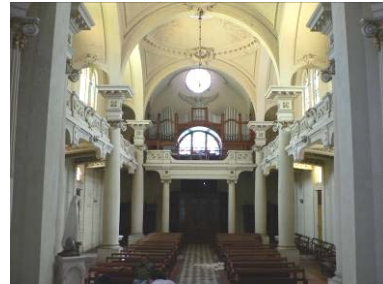
Internal view of the façade area

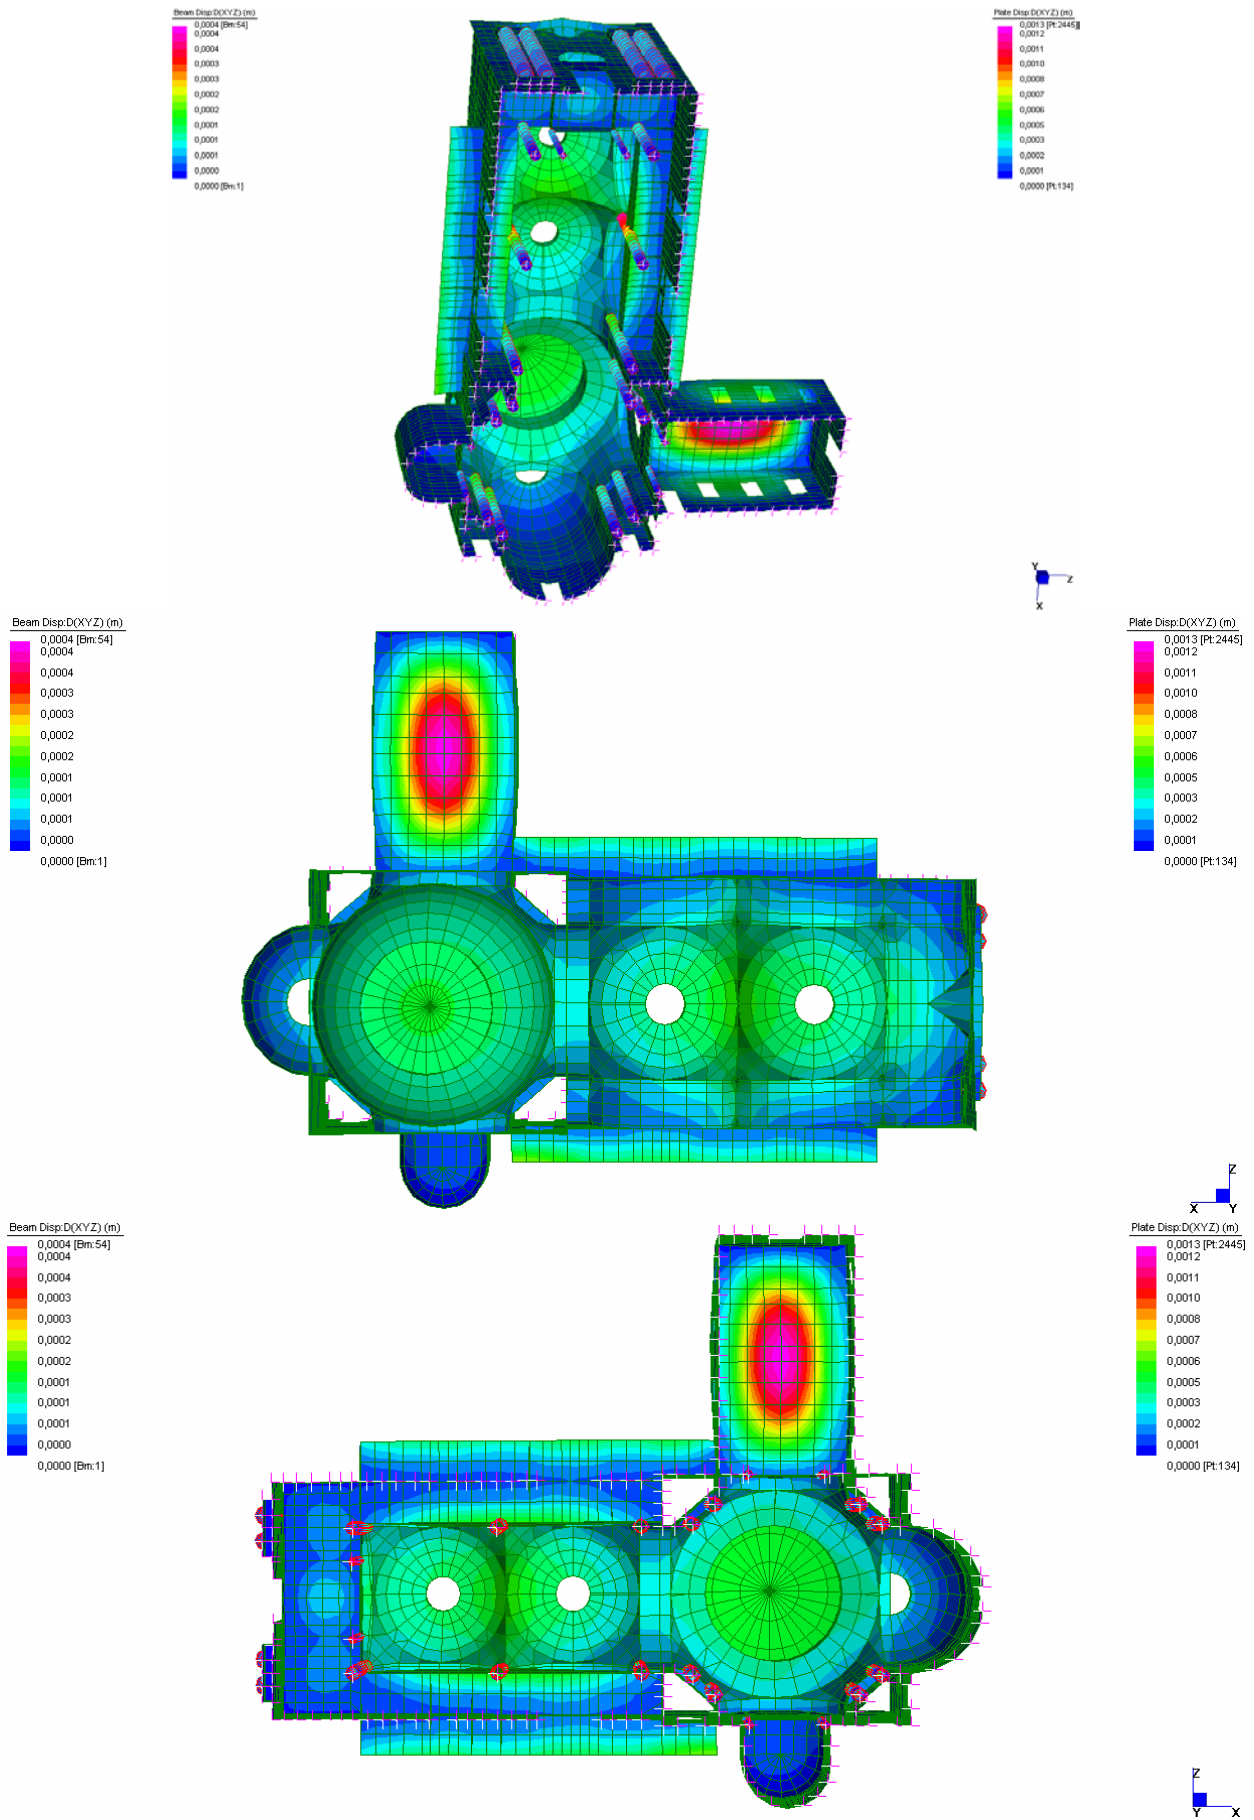
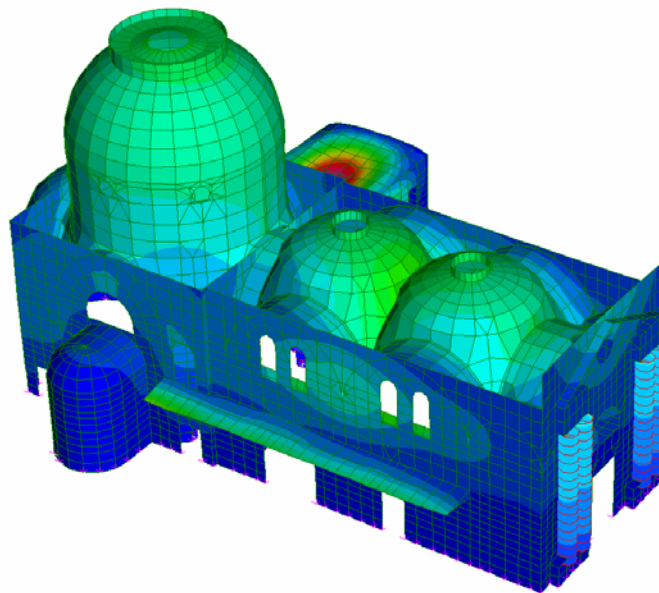
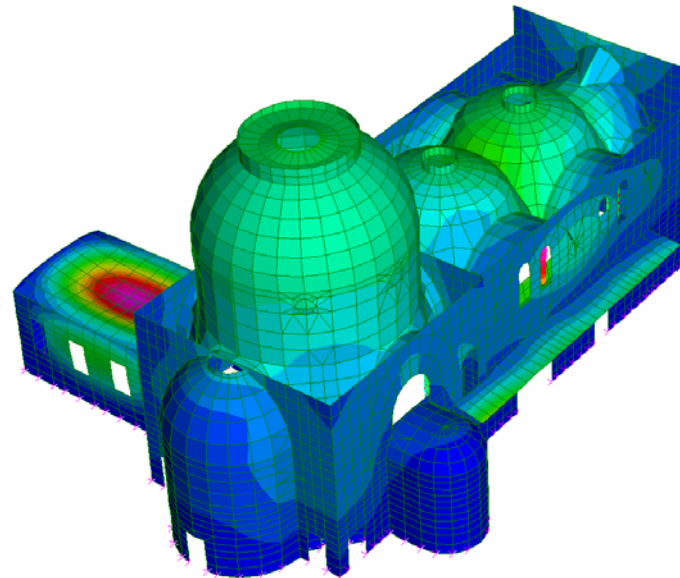
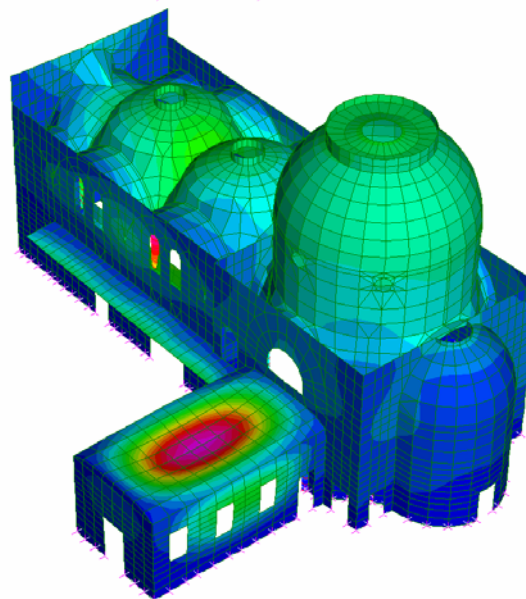
Figure 35: Displacements under the gravity load of the Las Hermanas de la Providencia Church FEM model.

Once defined the frame geometry and the section and material properties, the static analysis of the gravity load can be performed. Some views of the results in terms of maximum displacements (Fig. 35) and element stresses (Fig. 36) follow. The deformed shape of the model and the magnitude of the displacements and of the stresses suggest that the material properties and loads are correct and that no errors have been made with elements: the two central columns of the main nave present a high compressive-bending stress.

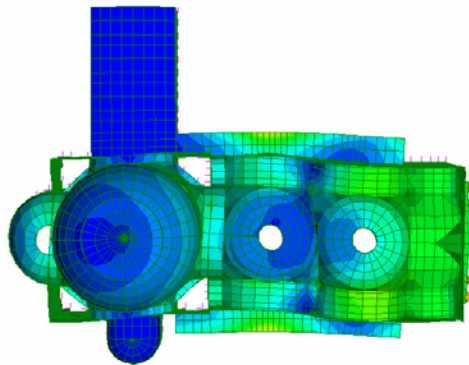
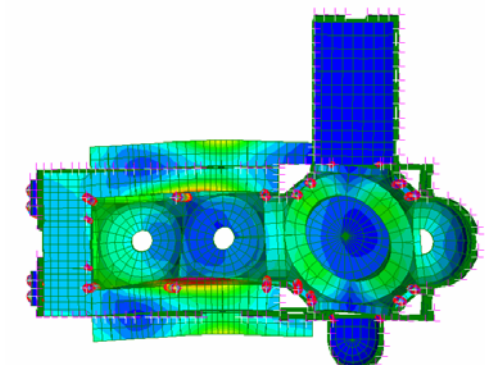
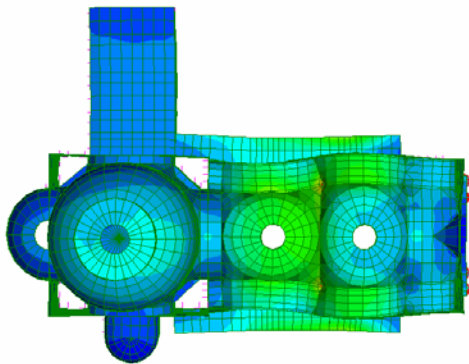
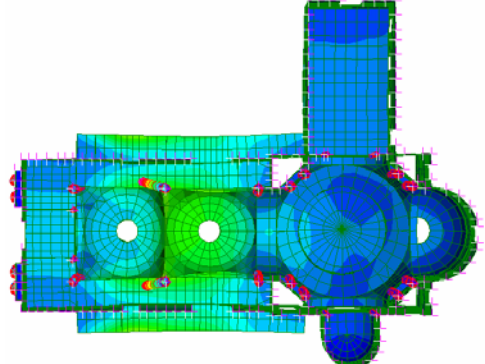
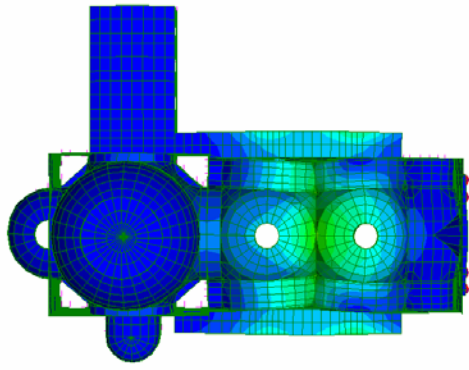
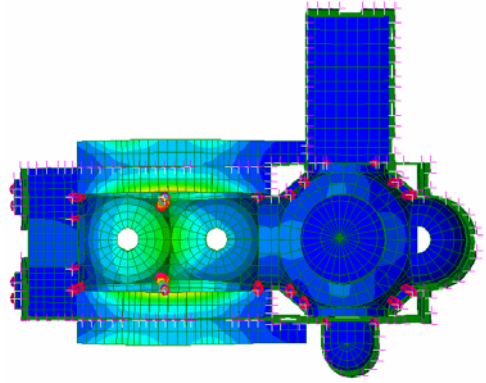
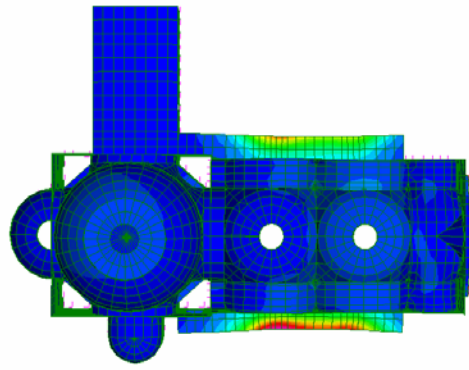
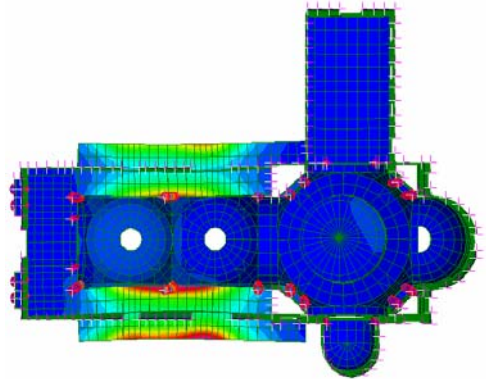
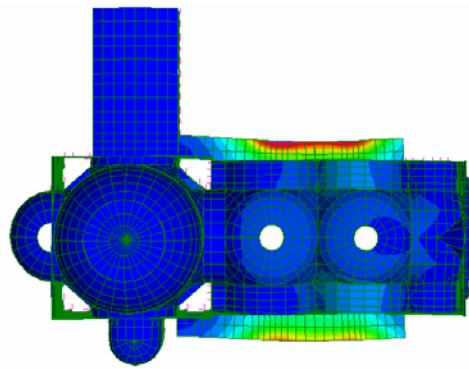
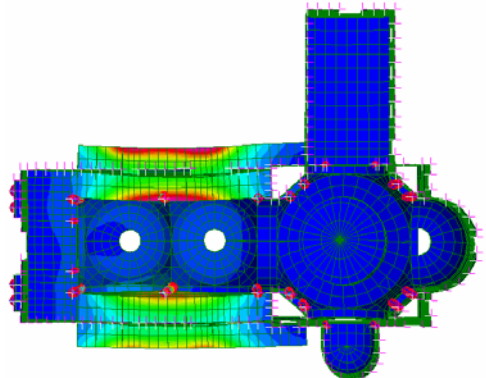
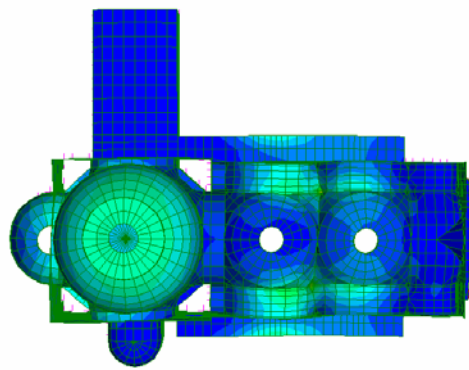
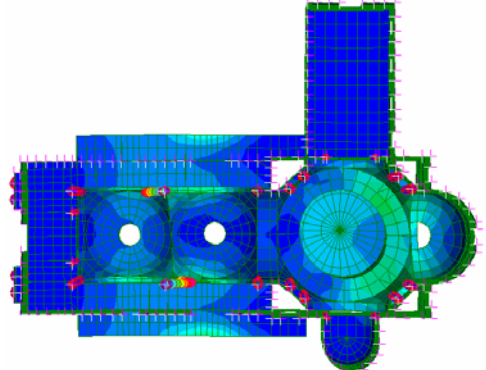
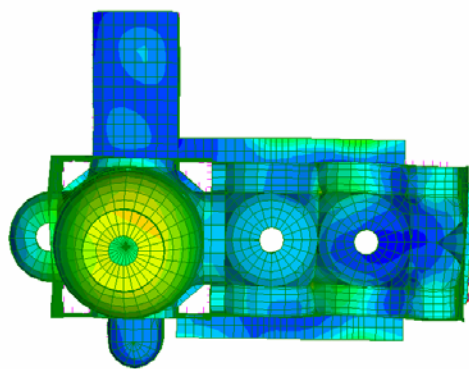
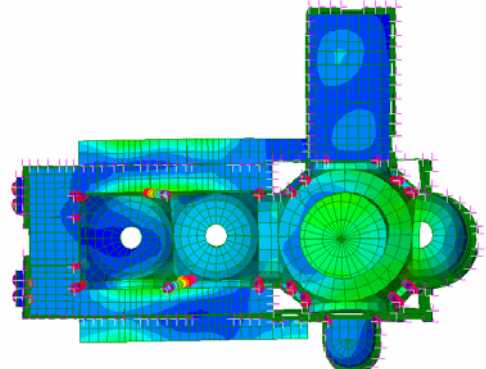
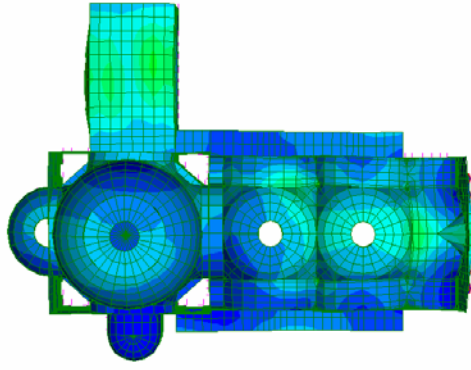
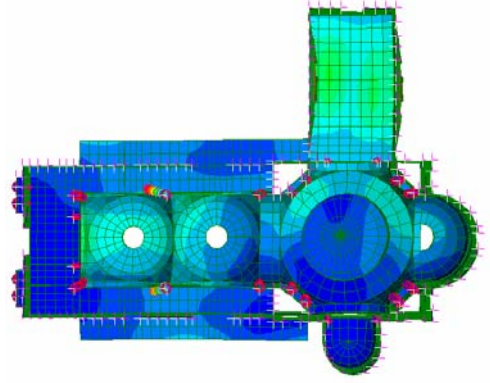
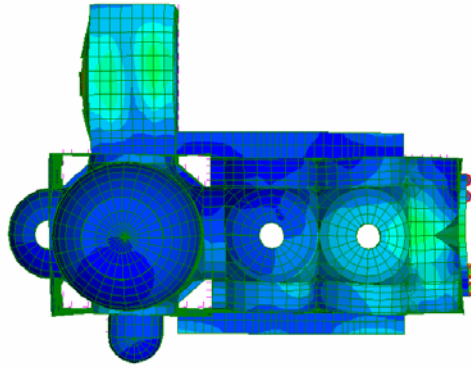
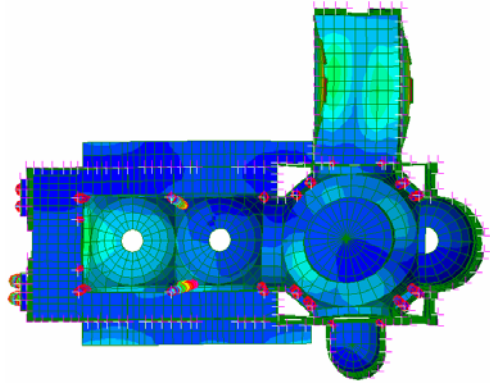
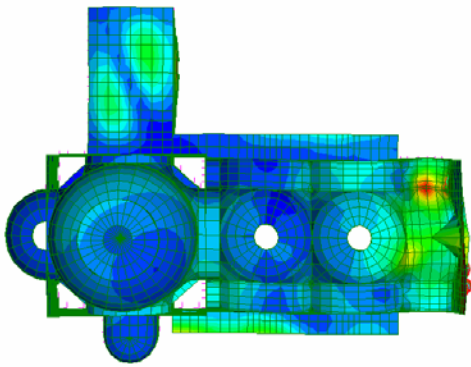
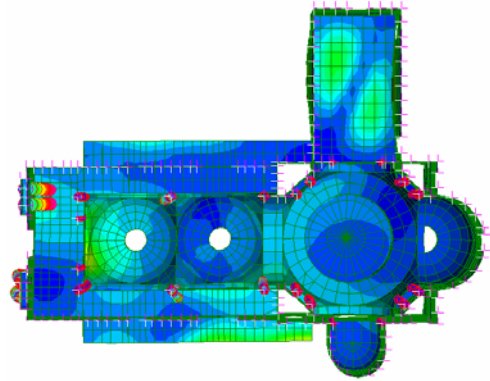
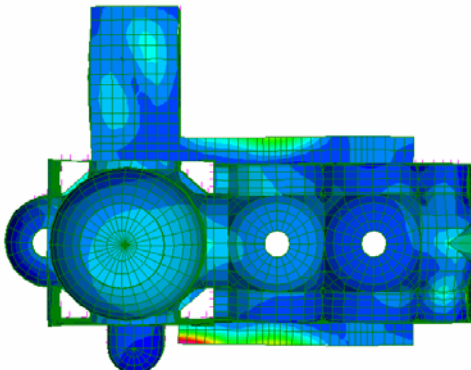
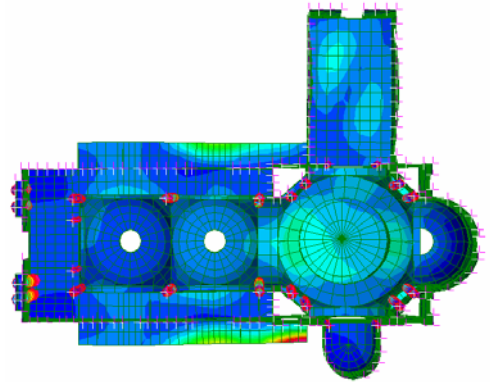
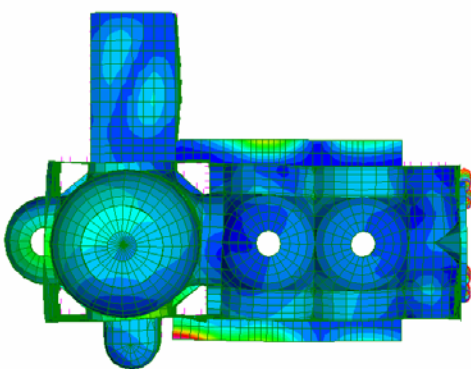
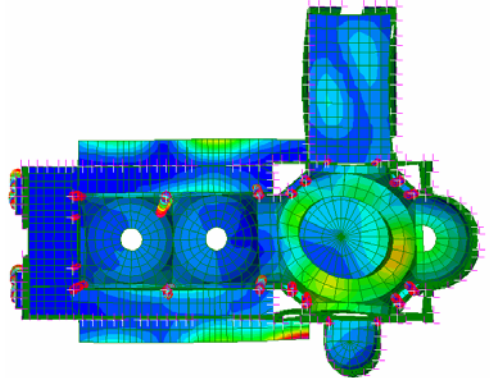
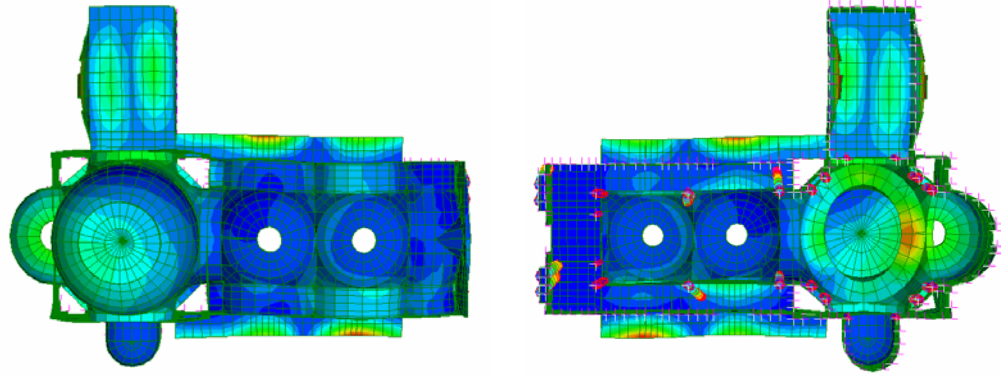
Figure 37: First twenty mode shapes of the Las Hermanas de la Providencia Church.

Before executing the Spectral Response Solver, a Natural Frequency Analysis must be performed: in fact, the Spectral Response Solver uses a mode superposition technique that requires the mode shapes and corresponding natural frequencies and participating masses of the structure. The results for the twenty natural frequencies are displayed in Table 3 and in Fig. 37. After the 20th mode, the mass participation factor becomes lower than 2%, denoting local modes.

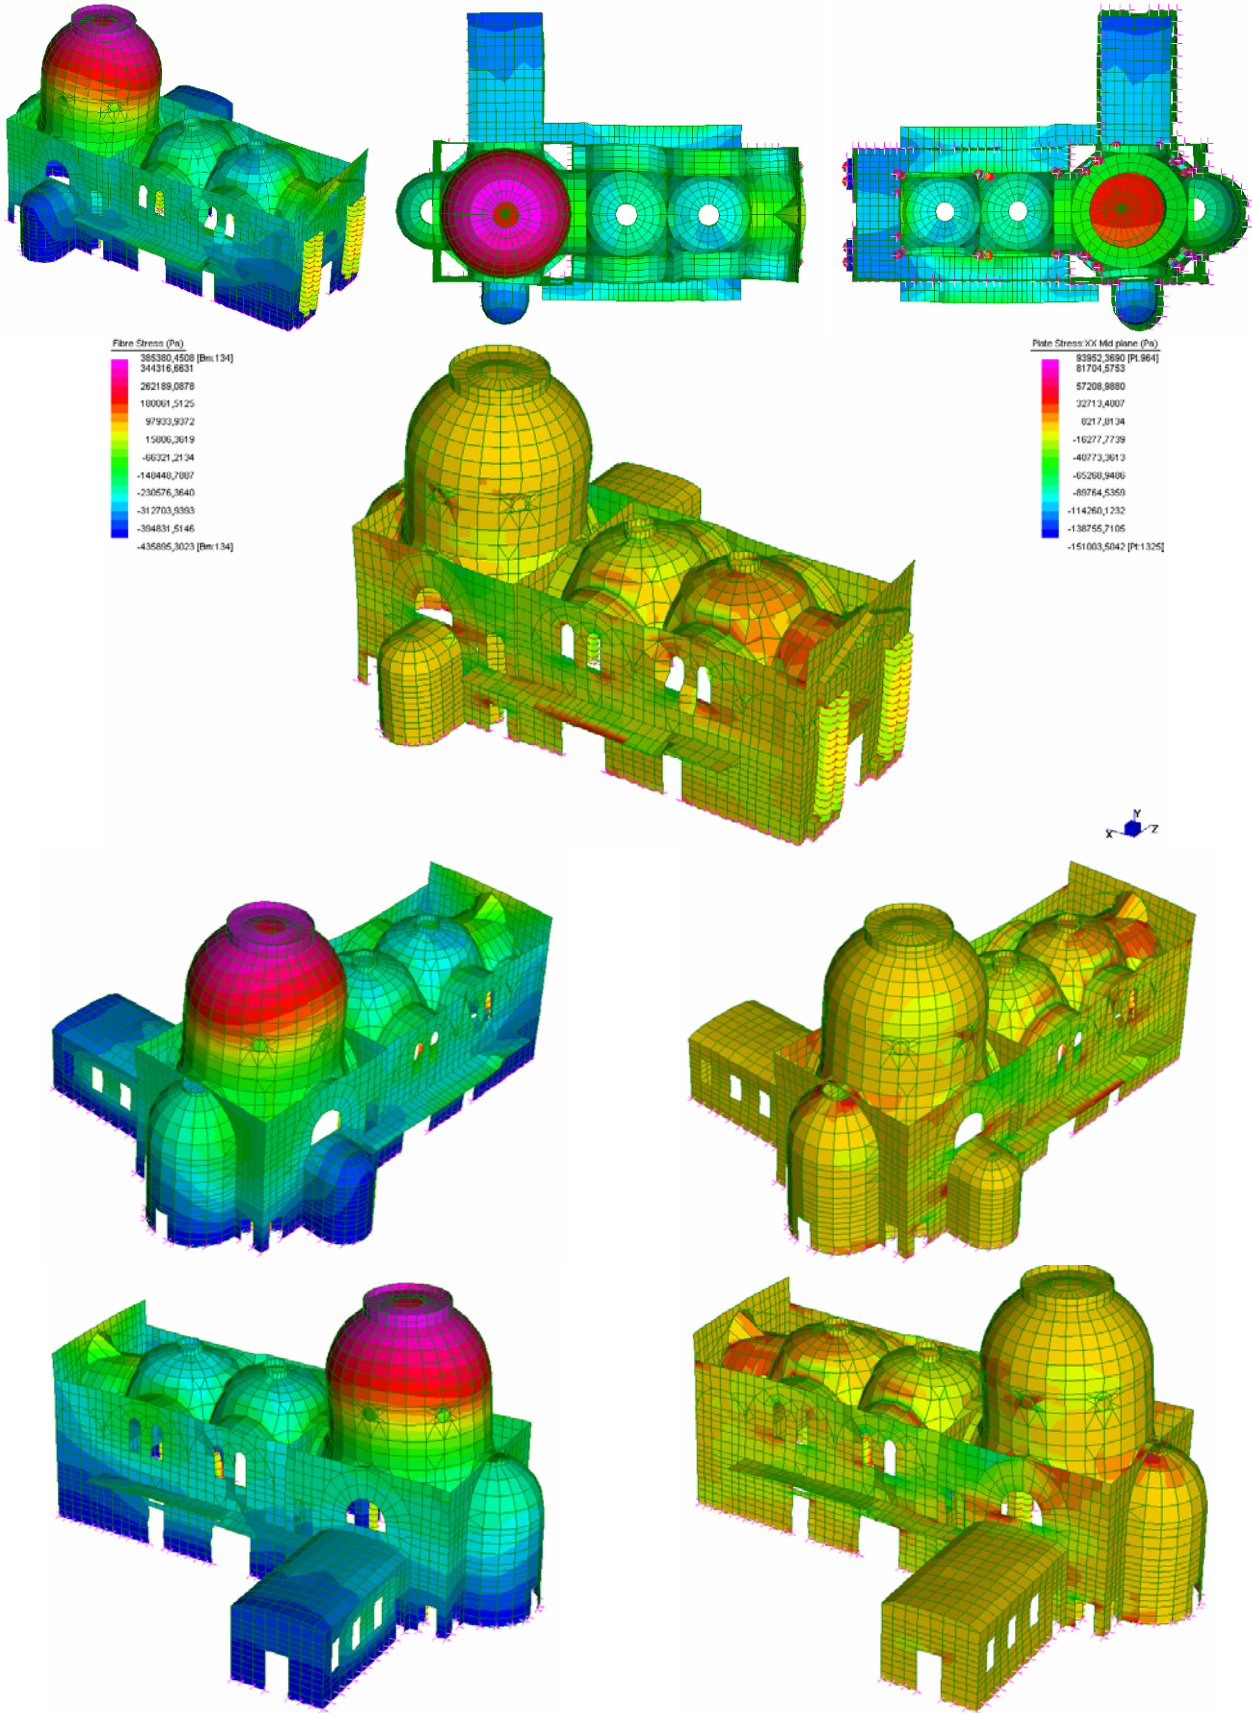
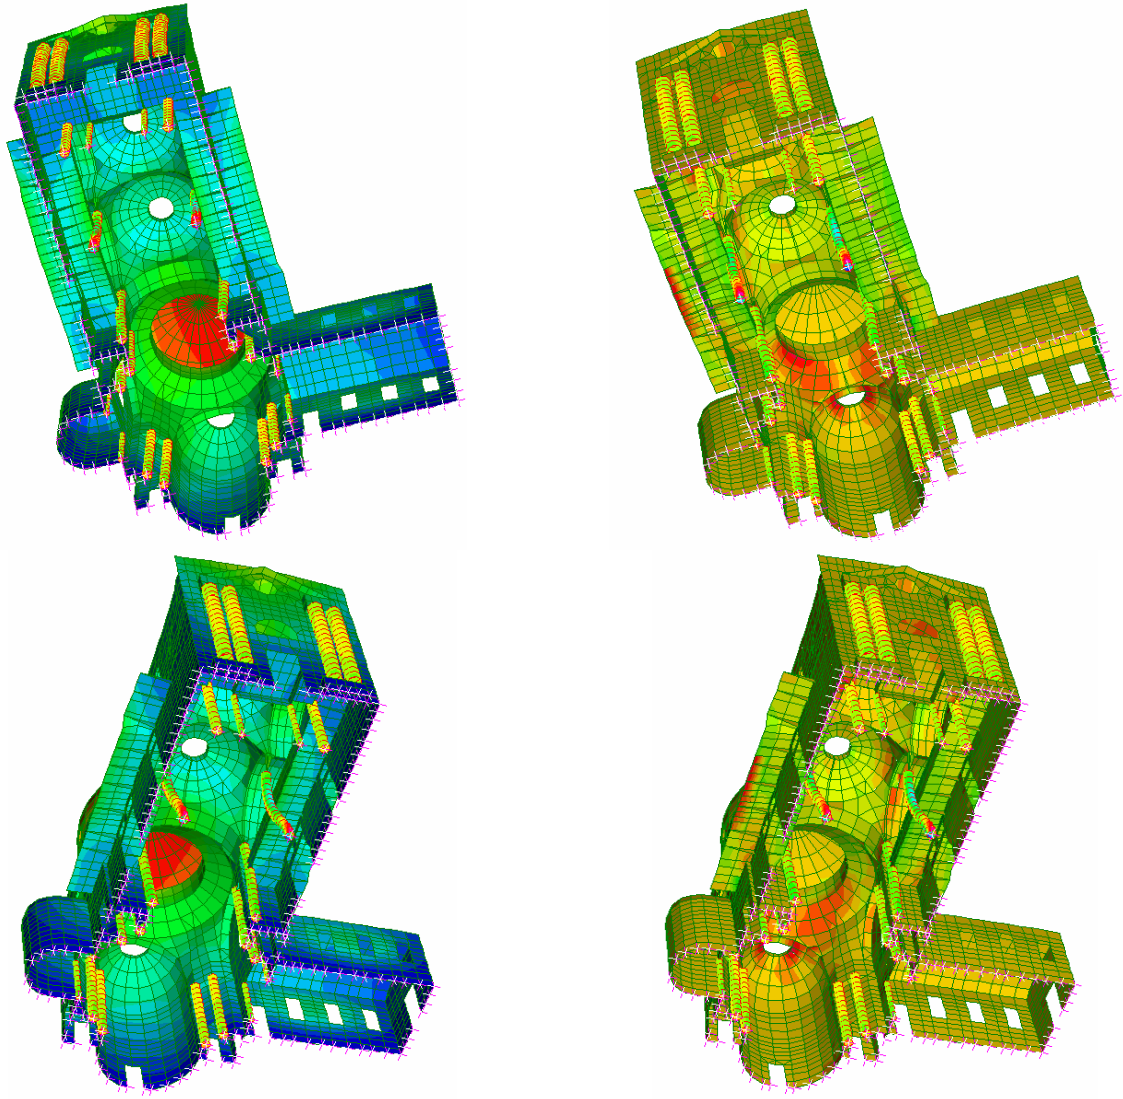
Figure 38a: Case 1, Magnitude 7.5 Bilateral – X (North-South) direction.

The results of the Spectral Response Analysis in terms of deformed shape, maximum displacements and maximum element stresses are given in Fig. 38. The Total Mass Participation factor (Table 4) indicates that the number of included natural modes is sufficient enough to adequately represent the dynamic behaviour of the structure.

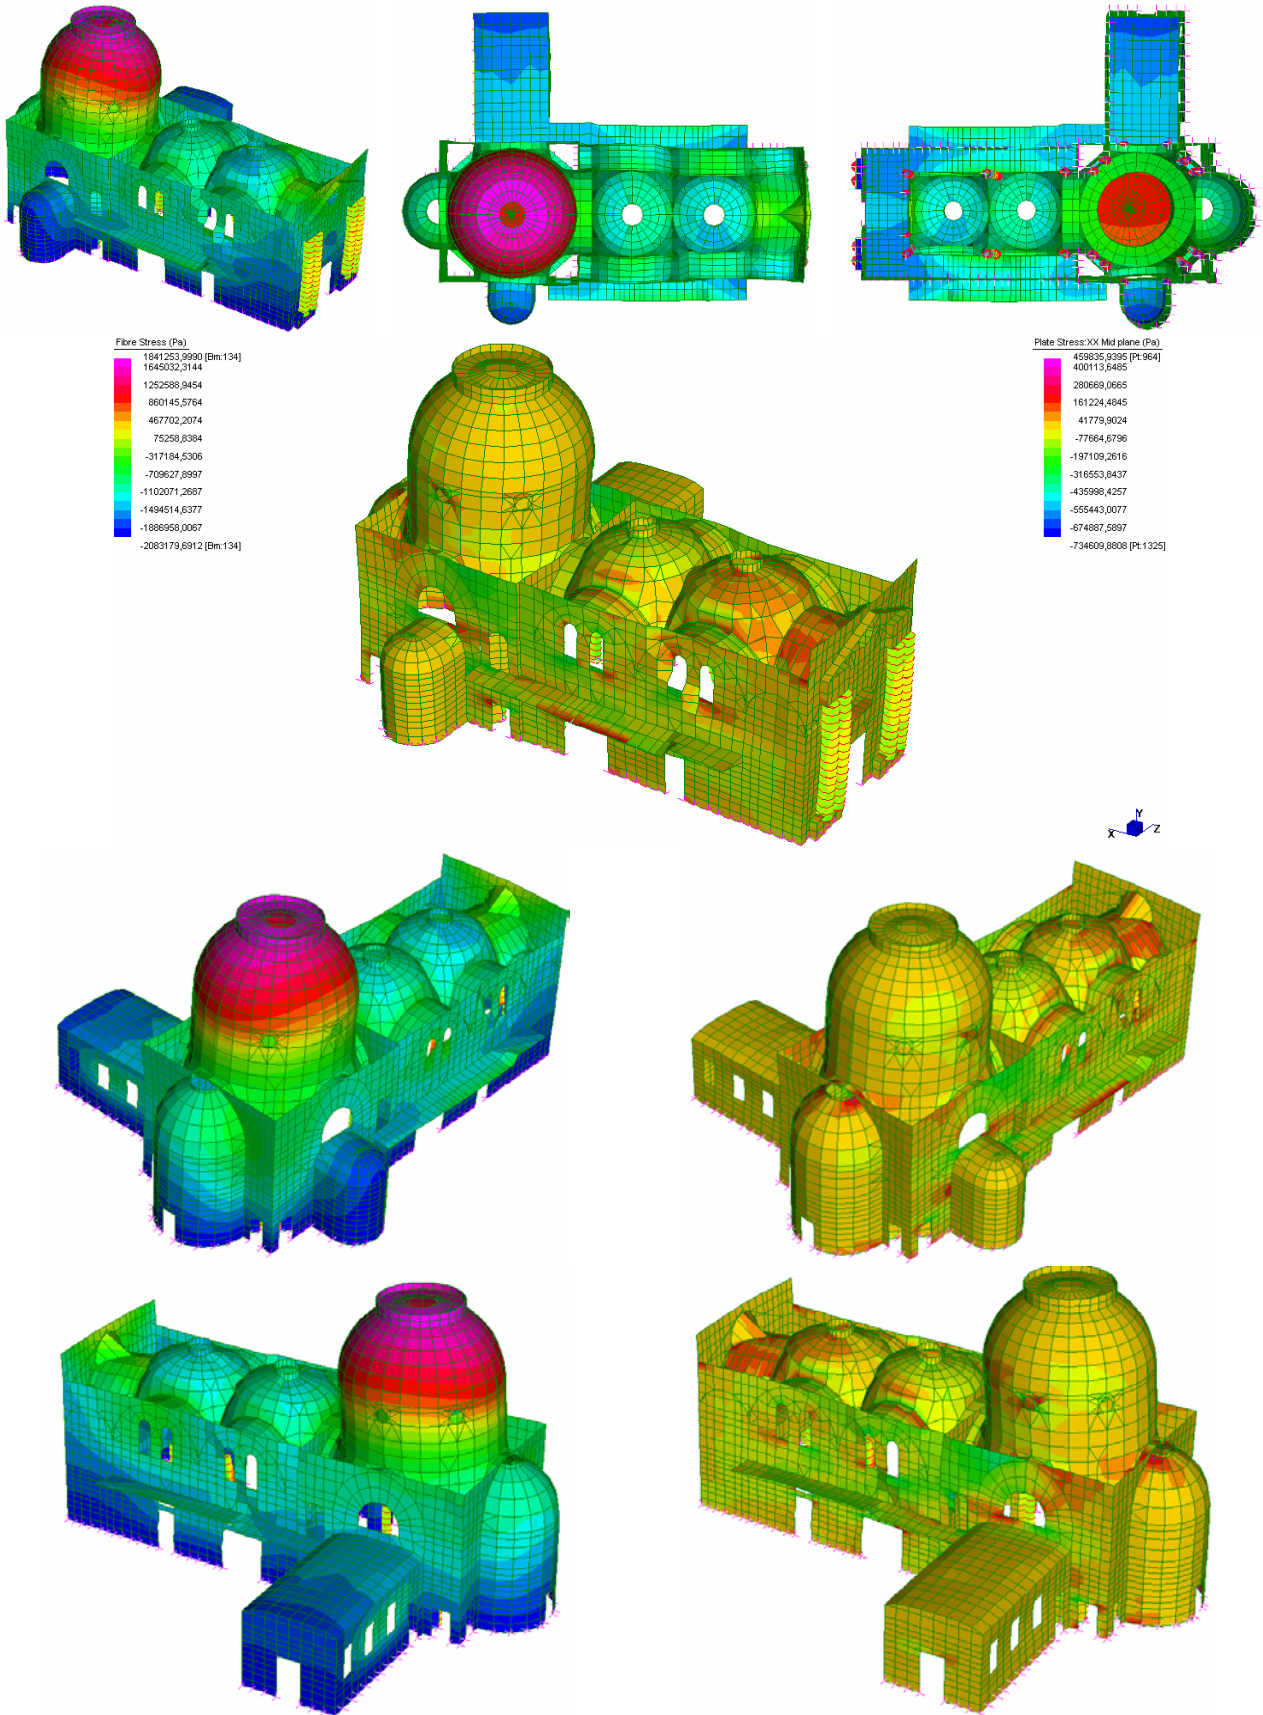
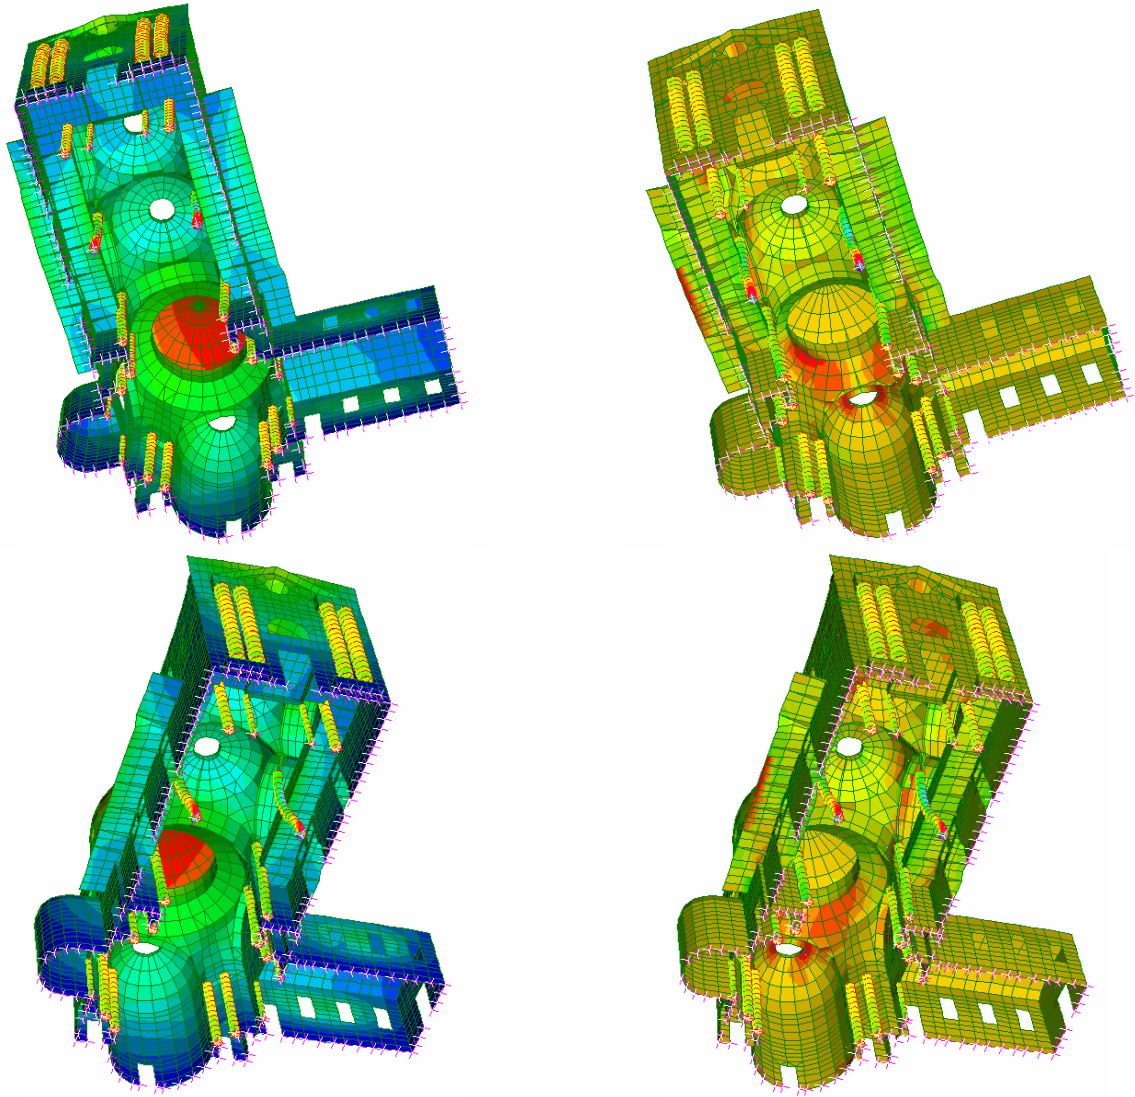
Figure 38e: Case 5, Magnitude 8.5 Bilateral – X (North-South) direction.

Taking into account the results of the heaviest considered seismic actions (Case 5, Case 6, Combination 1, Combination 2), the Spectral Response Analysis denote that the number of included natural modes is sufficient enough to adequately represent the dynamic behaviour of the structure. Some portions of the structure of the Church present a high status of stress, that is related to the observed cracks: in particular, it is worth noticing the tensile stresses that result in the West and South apse, near the round openings of the main dome, near the openings of the East and West apses and of the lateral walls of the main nave, in the triumphal arch between the presbytery and the South apse, between the main nave and the presbytery and between the two domes of the main nave, in the lateral arches of the main nave.
