Manejo de Riesgos en Valparaiso, Servicios Técnicos

Acronym: "MAR VASTO"

EVALUATION OF THE VULNERABILITY OF THREE CHURCHES IN VALPARAISO AND NUMERICAL CALCULATIONS

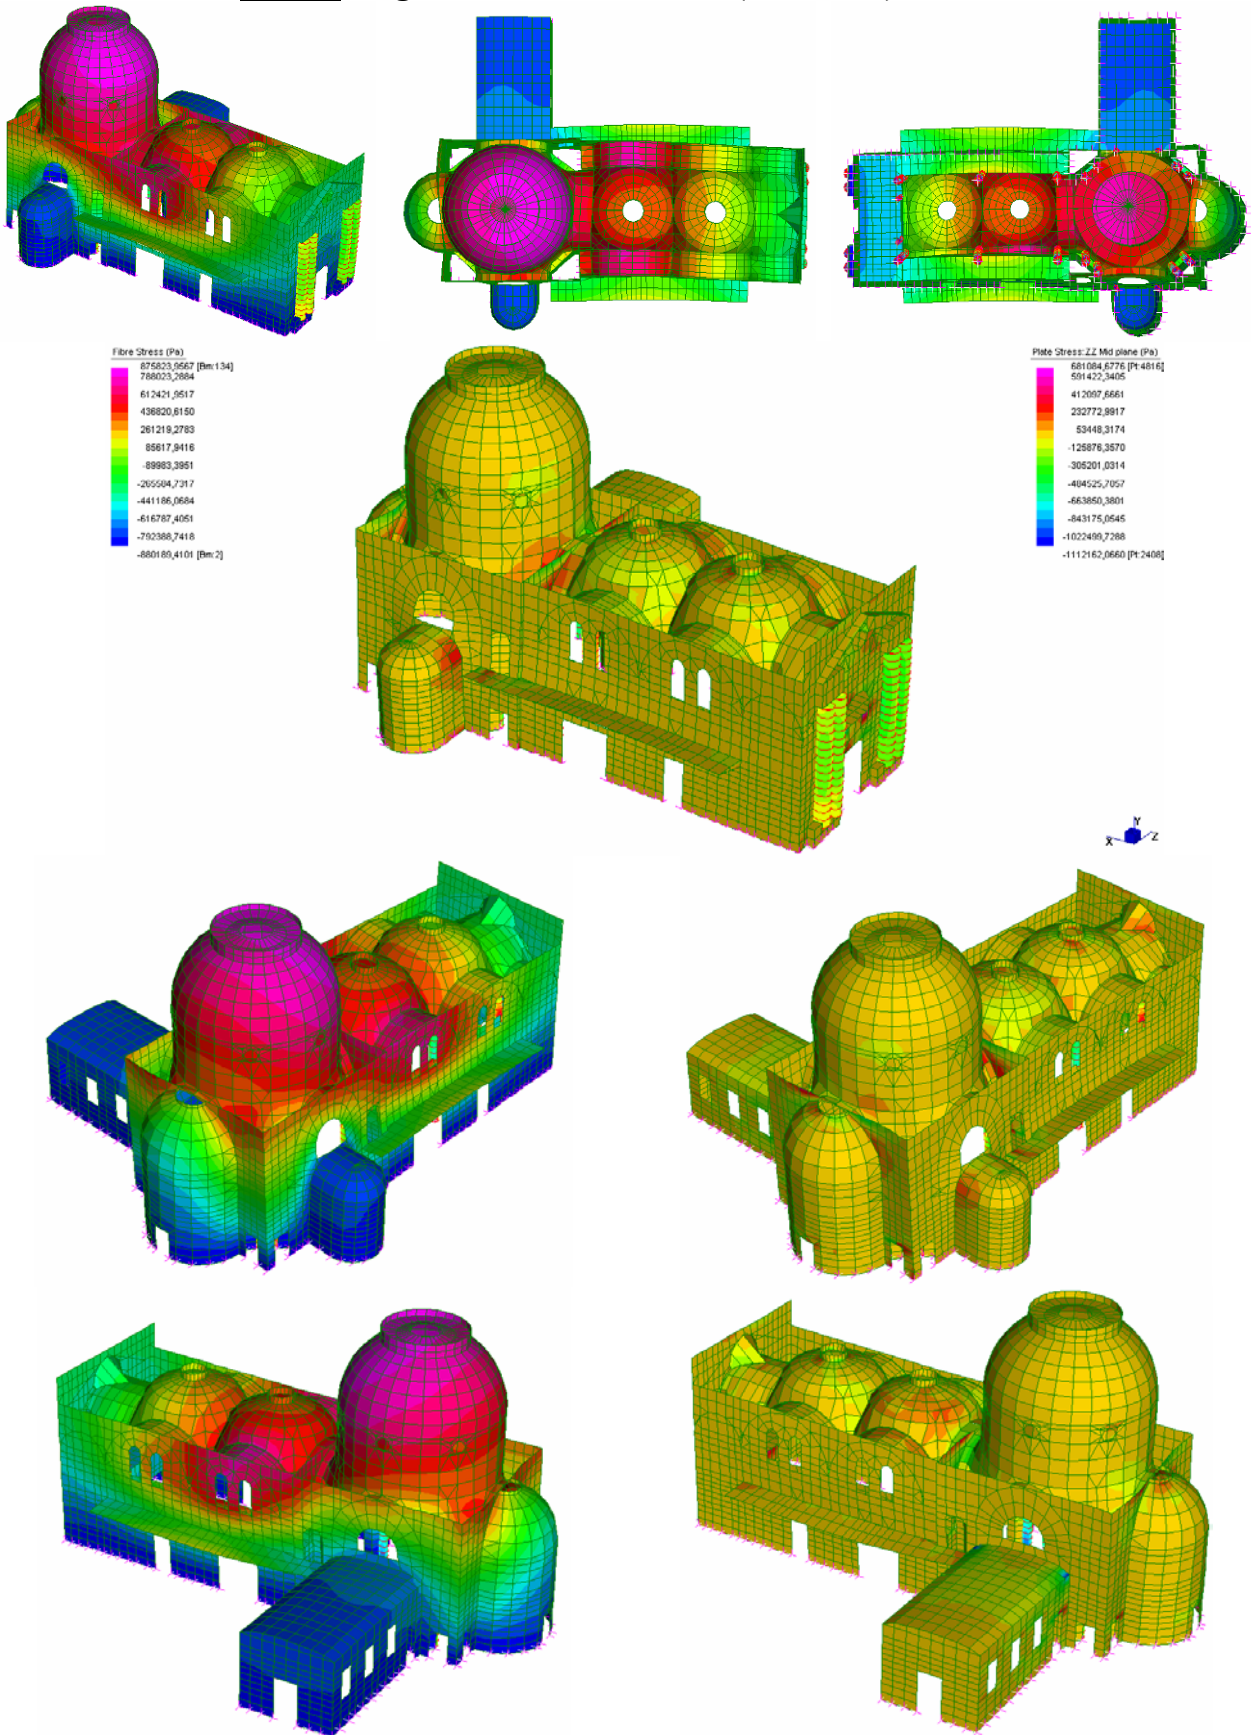
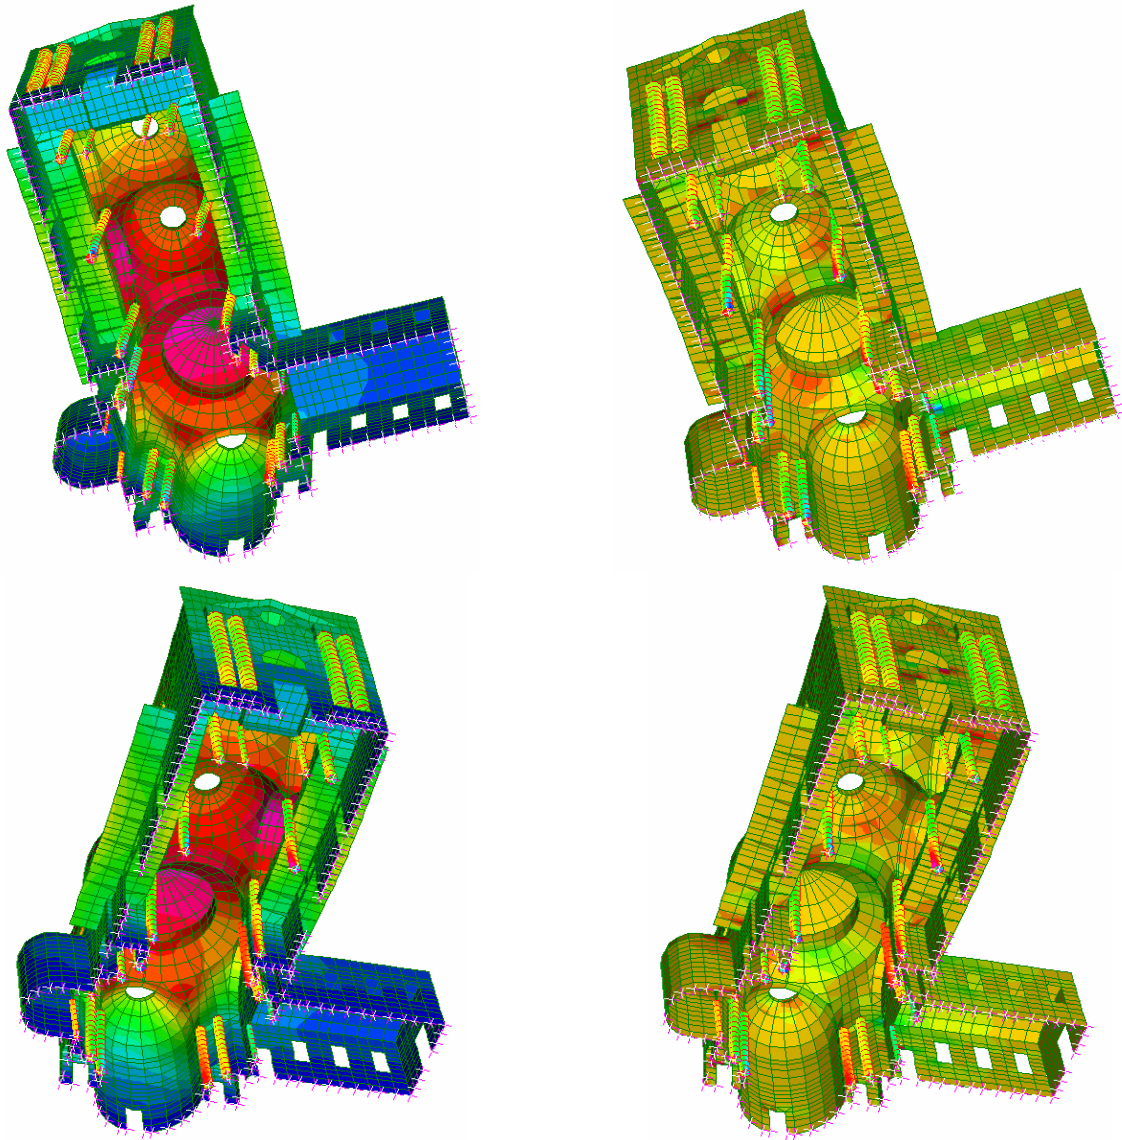
Figure 38f: Case 6, Magnitude 8.5 Bilateral – Z (East-West) direction.

The results of the Spectral Response Analysis in terms of deformed shape, maximum displacements and maximum element stresses are given in Fig. 38. The Total Mass Participation factor (Table 4) indicates that the number of included natural modes is sufficient enough to adequately represent the dynamic behaviour of the structure.

Taking into account the results of the heaviest considered seismic actions (Case 5, Case 6, Combination 1, Combination 2), the Spectral Response Analysis denote that the number of included natural modes is sufficient enough to adequately represent the dynamic behaviour of the structure. Some portions of the structure of the Church present a high status of stress, that is related to the observed cracks: in particular, it is worth noticing the tensile stresses that result in the West and South apse, near the round openings of the main dome, near the openings of the East and West apses and of the lateral walls of the main nave, in the triumphal arch between the presbytery and the South apse, between the main nave and the presbytery and between the two domes of the main nave, in the lateral arches of the main nave.

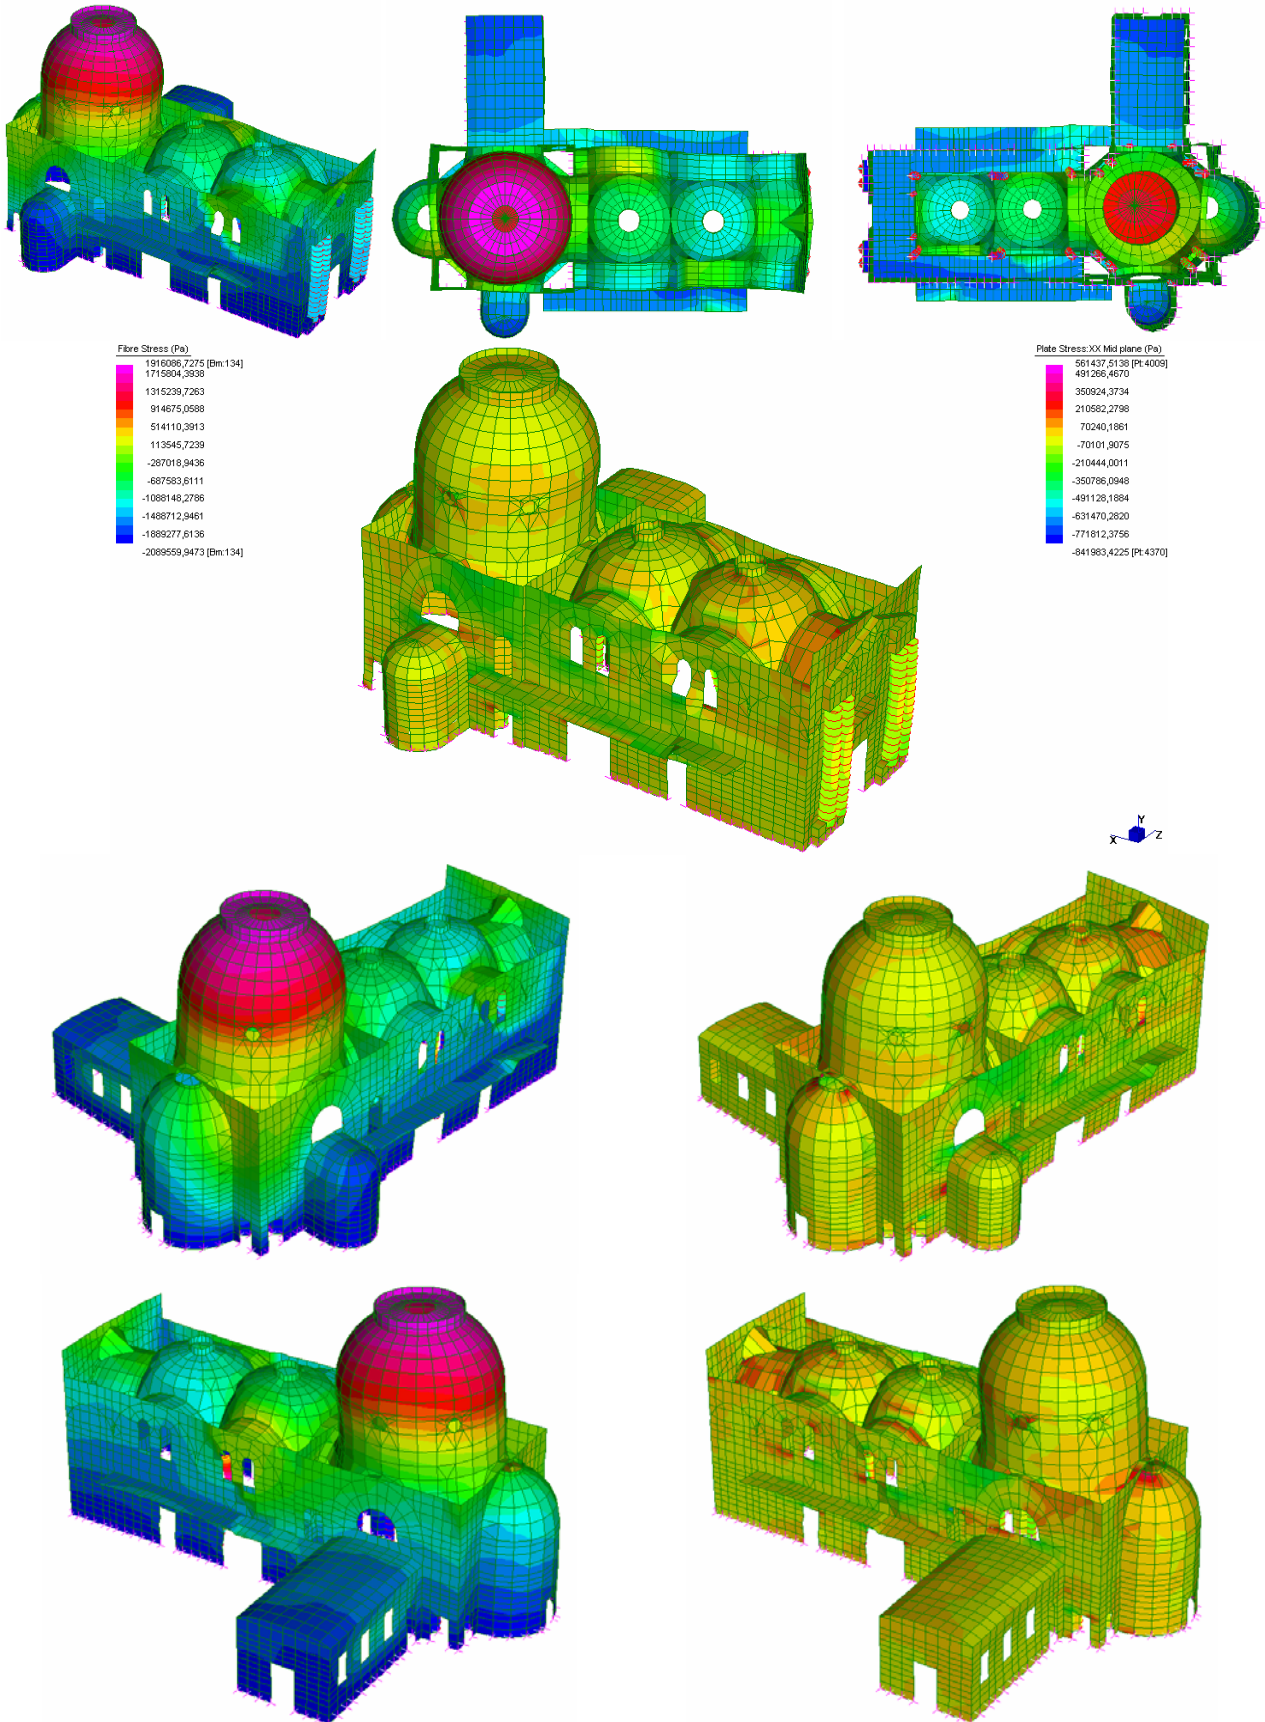
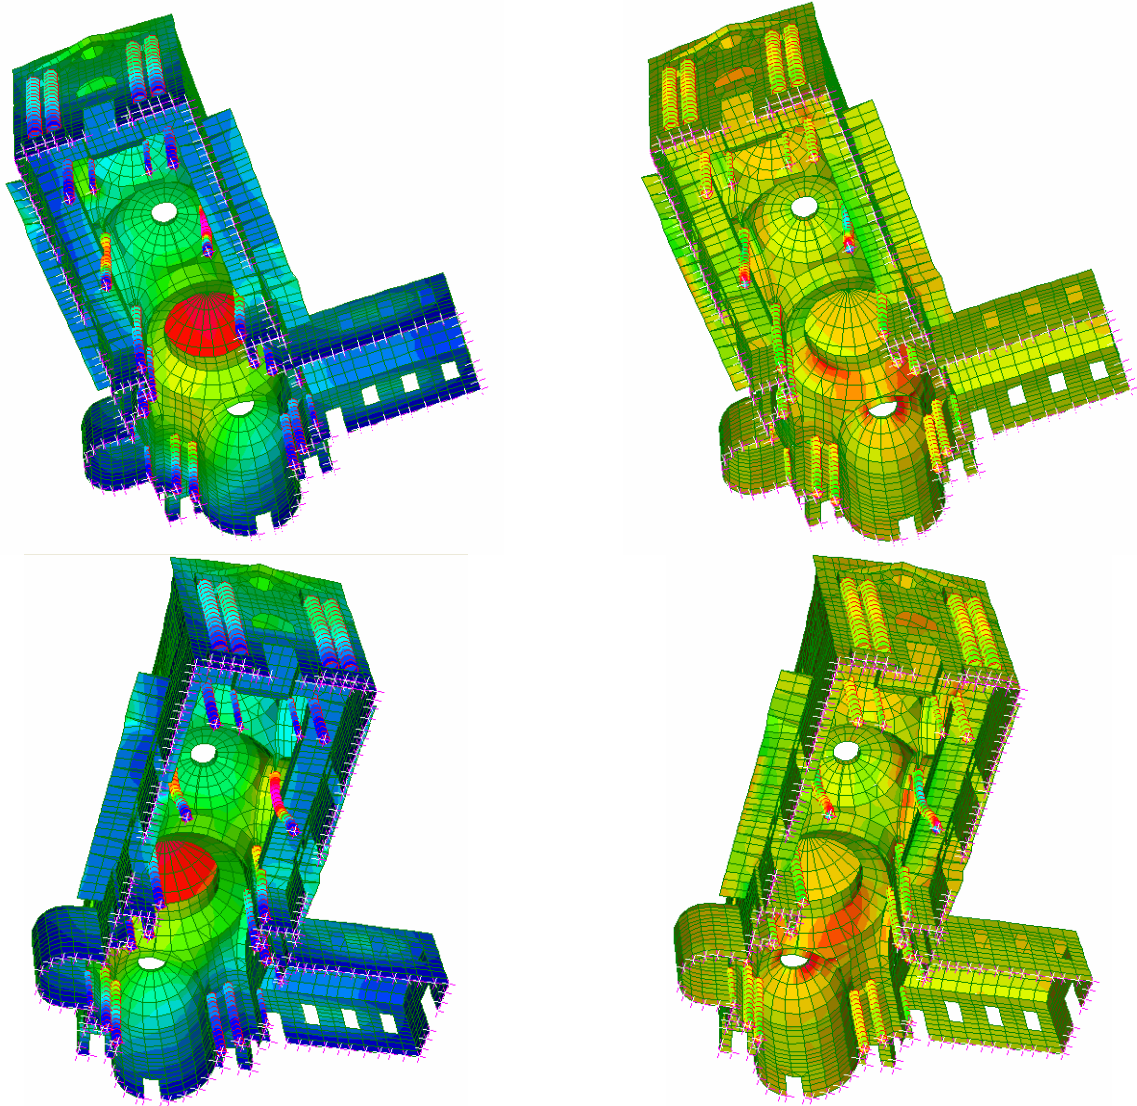
Figure 39a: Combination 1, Magnitude 8.5 Bilateral, 100% X (North-South) direction + 30% Z (East-West) direction.

Two other cases have been taken into account, combining the results of Case 5 and Case 6: in Combination 1 the 100% of the actions in the horizontal X-X direction of the FEM model of the Church (Case 5) and the 30% of the actions in the horizontal Z-Z direction (Case 6) were applied; in Combination 2 the 100% of the actions in the horizontal Z-Z direction of the FEM model of the Church (Case 6) and the 30% of the actions in the horizontal X-X direction (Case 5) were applied. The earthquake will not be considered acting in the Y direction. The results of the Spectral Response Analysis in terms of deformed shape, maximum displacements and maximum element stresses are shown by Fig. 39.

However, the results of the Spectral Response Analysis of the Las Hermanas de la Providencia Church are not always fully complying with the actual damage status: this is essentially due to the lack of knowledge about the Church's structure and materials. For example, the position of the steel bars in the reinforced concrete is not known and for this reason a reliable analysis of the resistance of the structural elements is not possible now.

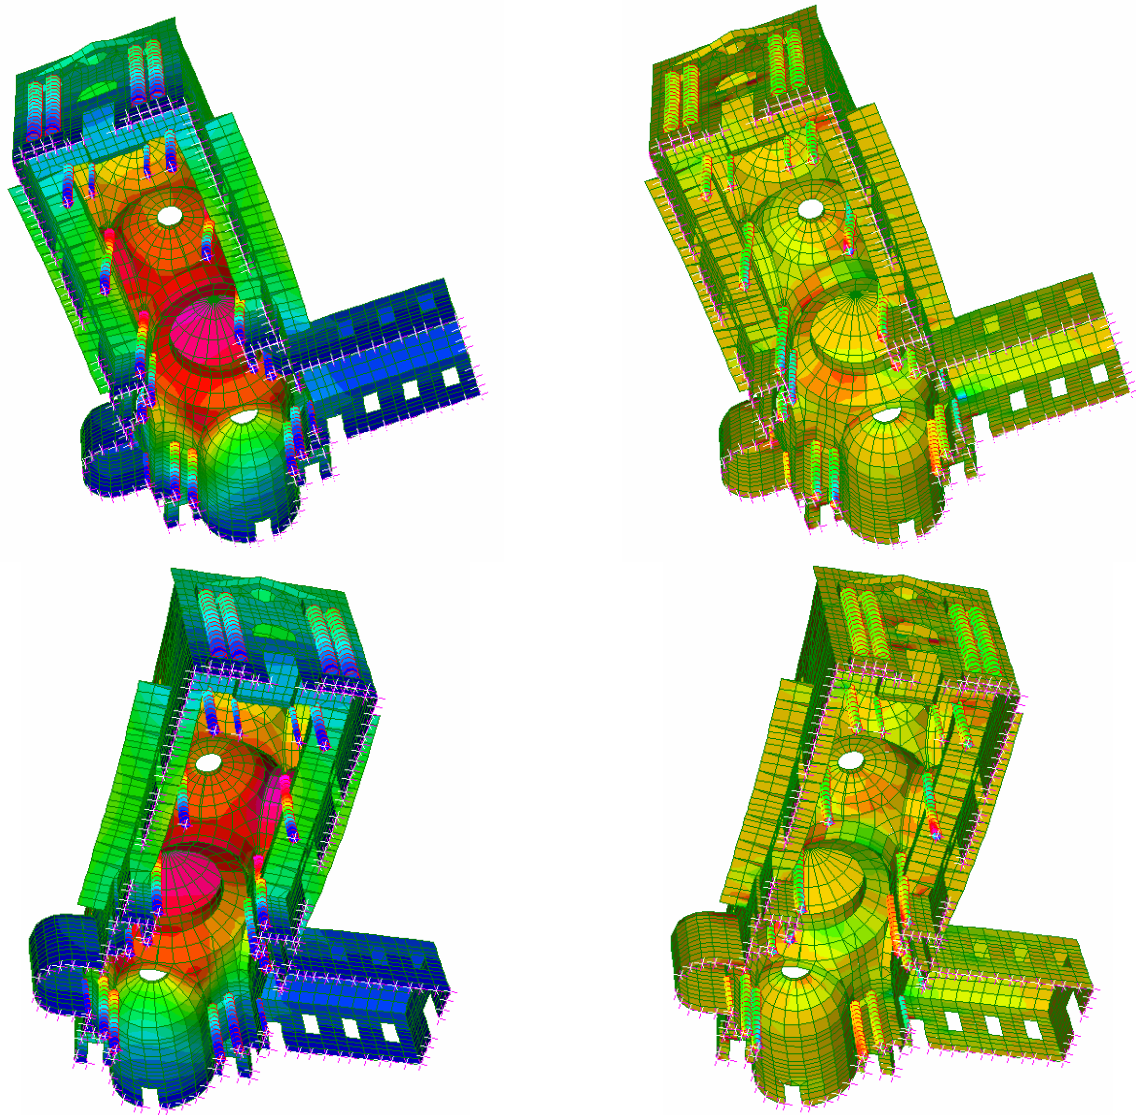
Figure 39b: Combination 2, Magnitude 8.5 Bilateral, 100% Z (East-West) direction + 30% X (North-South) direction.
