PROGETTO MAR VASTO
“Manejo de riesgos en Valparaiso”
Conferenza finale del Progetto BID

Chiesa e Convento di San Fransisco, Cerro Baron, Valparaiso, Chile
29 Settembre 2008

L'investigazione sulle tre chiese (San Francisco,
Hermanas de La Providencia, La Matriz):
indagine di vulnerabilità

Ing. Marco Munari
Dipartimento di Costruzioni e Trasporti
Università di Padova – Italia

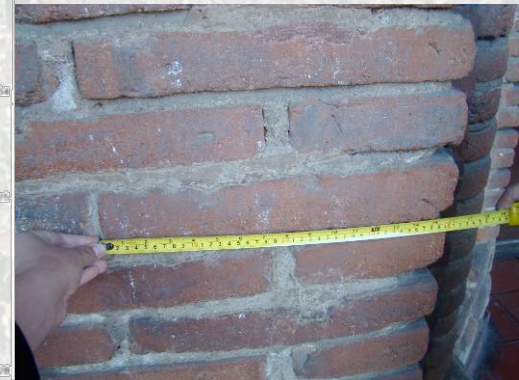
Pareti in adobe
