PROGETTO MAR VASTO
“Manejo de riesgos en Valparaiso”
Conferenza finale del Progetto BID

Chiesa e Convento di San Fransisco, Cerro Baron, Valparaiso, Chile
29 Settembre 2008

L'investigazione sulle tre chiese (San Francisco,
Hermanas de La Providencia, La Matriz):
indagine di vulnerabilità

Ing. Marco Munari
Dipartimento di Costruzioni e Trasporti
Università di Padova – Italia

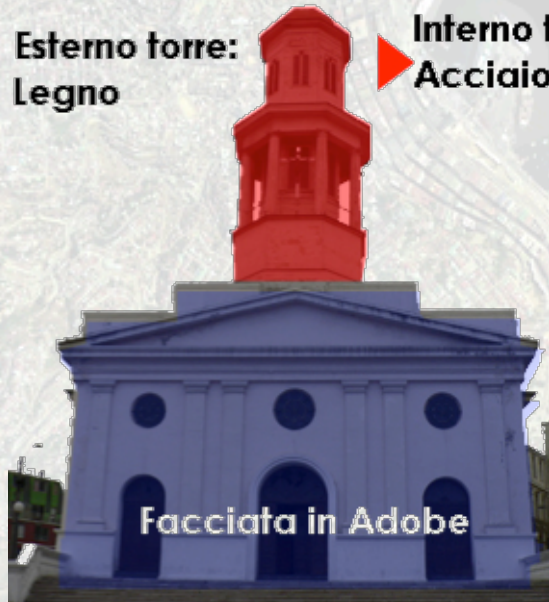
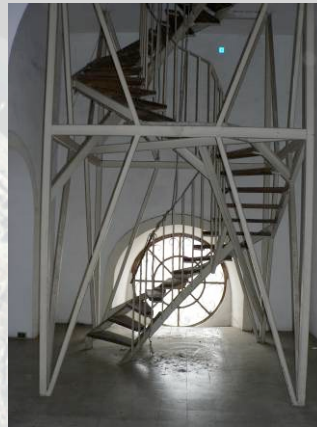
IGLESIA DEL SALVADOR – MATRIZ DE VALPARAISO

Interno torre
Acciaio

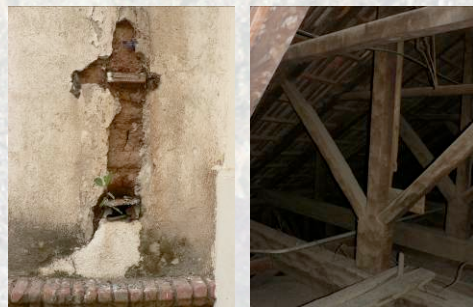
Volta a botte
in listelli di
legno

Muratura
in adobe

Capriata in legno

Colonne
in legno

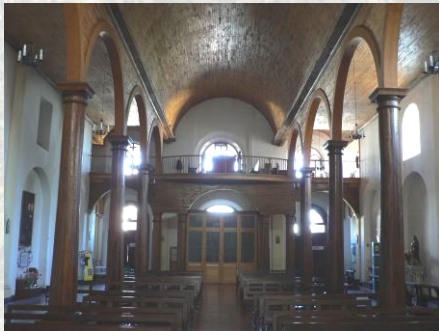
IGLESIA SAN FRANCISCO DEL BARON

Colonne in legno e volta a botte in listelli di legno

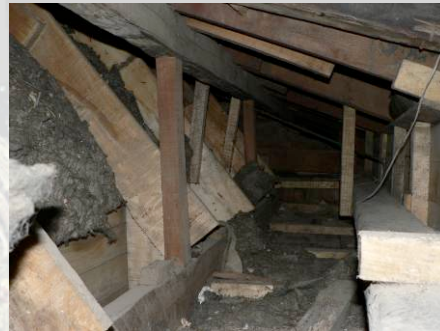
Capriate in legno

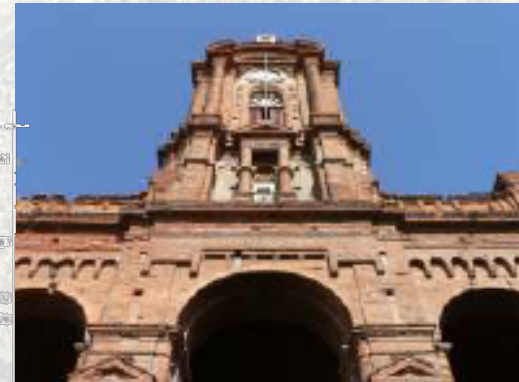
Pareti in adobe

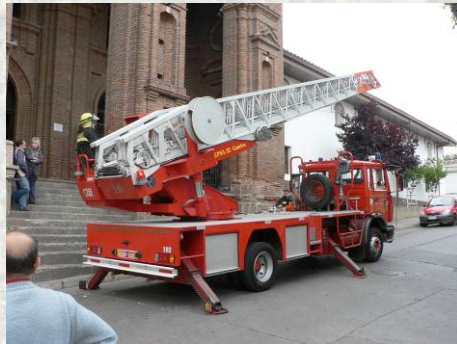
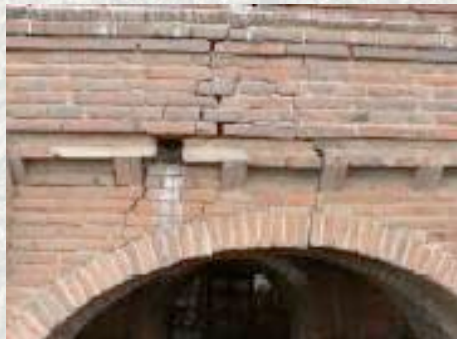
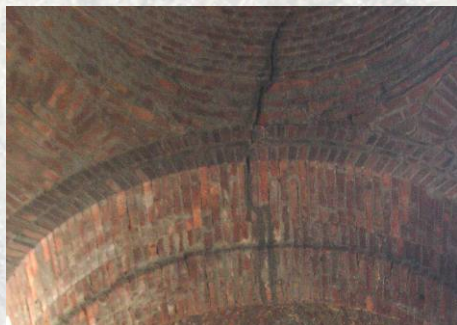
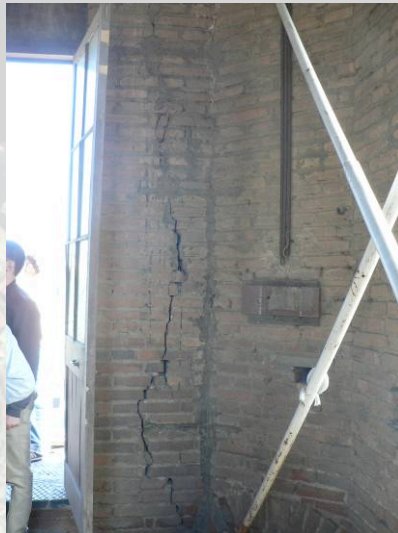
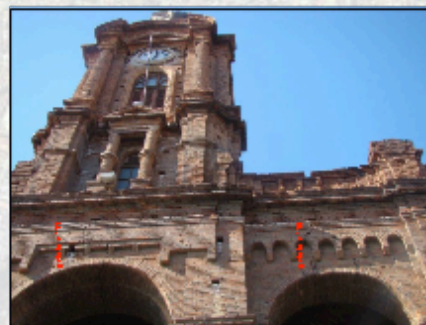
Facciata in muratura di mattoni e malta di calce
